[Docket No. FAA-2011-0994; Directorate Identifier 2010-NM-143-AD; Amendment 39-16949; AD 2012-03-08]

Airworthiness Directives; Bombardier, Inc. Airplanes

2012-03-08 Bombardier Inc.: Amendment 39-16949; Docket No. FAA-2011-0994; Directorate Identifier 2010-NM-143-AD.

Air Transport Association (ATA) of America Code 32: Landing gear.

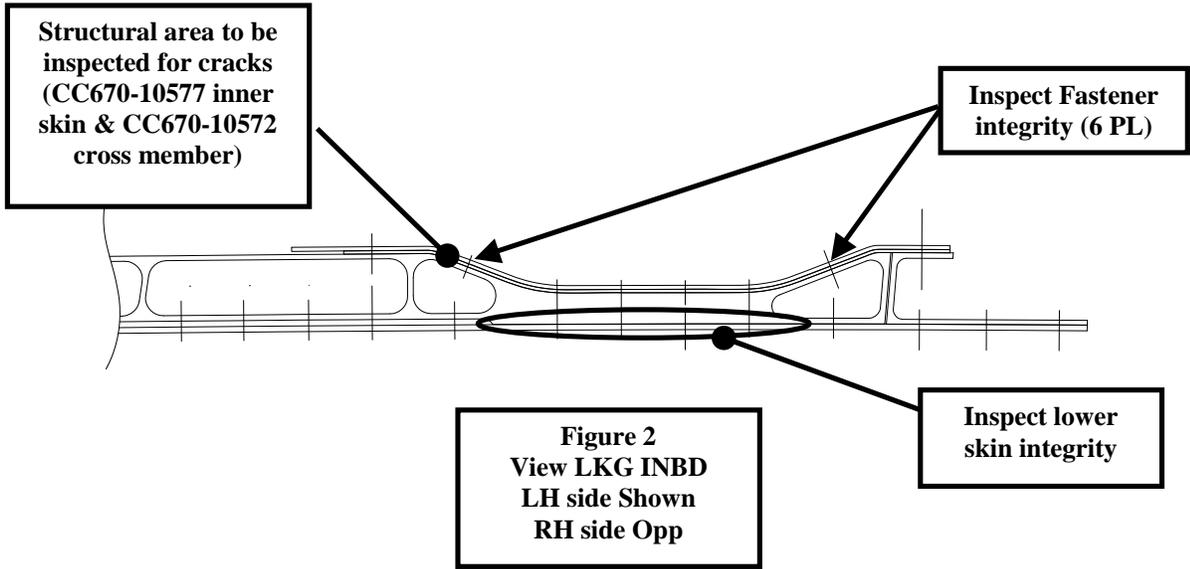
Figure 2
 View LKG INBD
 LH side Shown
 RH side Opp

(1) Inspect the cross member, P/N CC670-10572, of the MLG door lower panel for cracking or deformation, in accordance with Figure 2 of this AD.

(2) Inspect the inner skin, P/N CC670-10577, of the MLG door lower panel at the cross member (P/N CC670-10572) for cracking or deformation, or pulled or missing fasteners, in accordance with Figure 2 of this AD.

(3) Inspect the outer skin, P/N CC670-10574, of the MLG door lower panel at the cross member (P/N CC670-10572) for cracking or deformation, or pulled or missing fasteners, in accordance with Figure 2 of this AD.

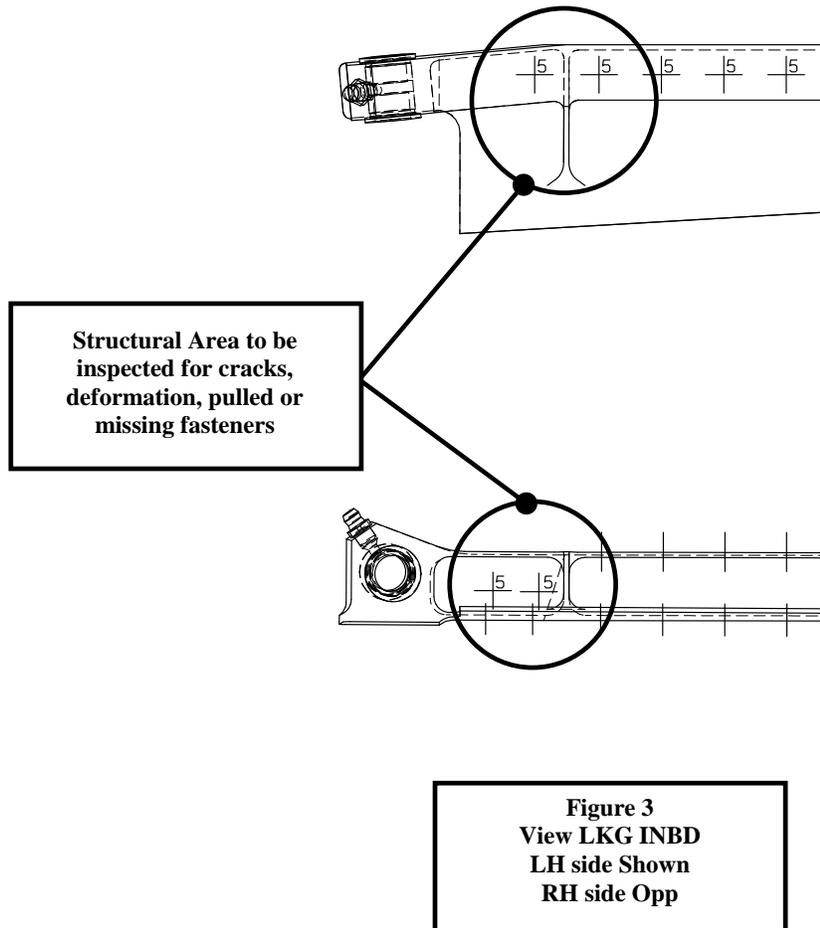
(4) Inspect the forward member, P/N CC670-10570, and aft member, P/N CC670-10571, of the MLG door lower panel for cracking or deformation, or pulled or missing fasteners, in accordance with Figure 3 of this AD. Figures 1 through 3 of this AD follow.
