**[Docket No. 2003-SW-23-AD; Amendment 39-13966; AD 2005-03-10]**

### **Airworthiness Directives; Bell Helicopter Textron, A Division of Textron Canada Model 222, 222B, 222U and 230 Helicopters**

**2005-03-10 Bell Helicopter Textron, a Division of Textron Canada:** Amendment 39-13966.  
Docket No. 2003-SW-23-AD. Supersedes AD 2002-08-54, Amendment 39-12835, Docket No. 2002-SW-22-AD.

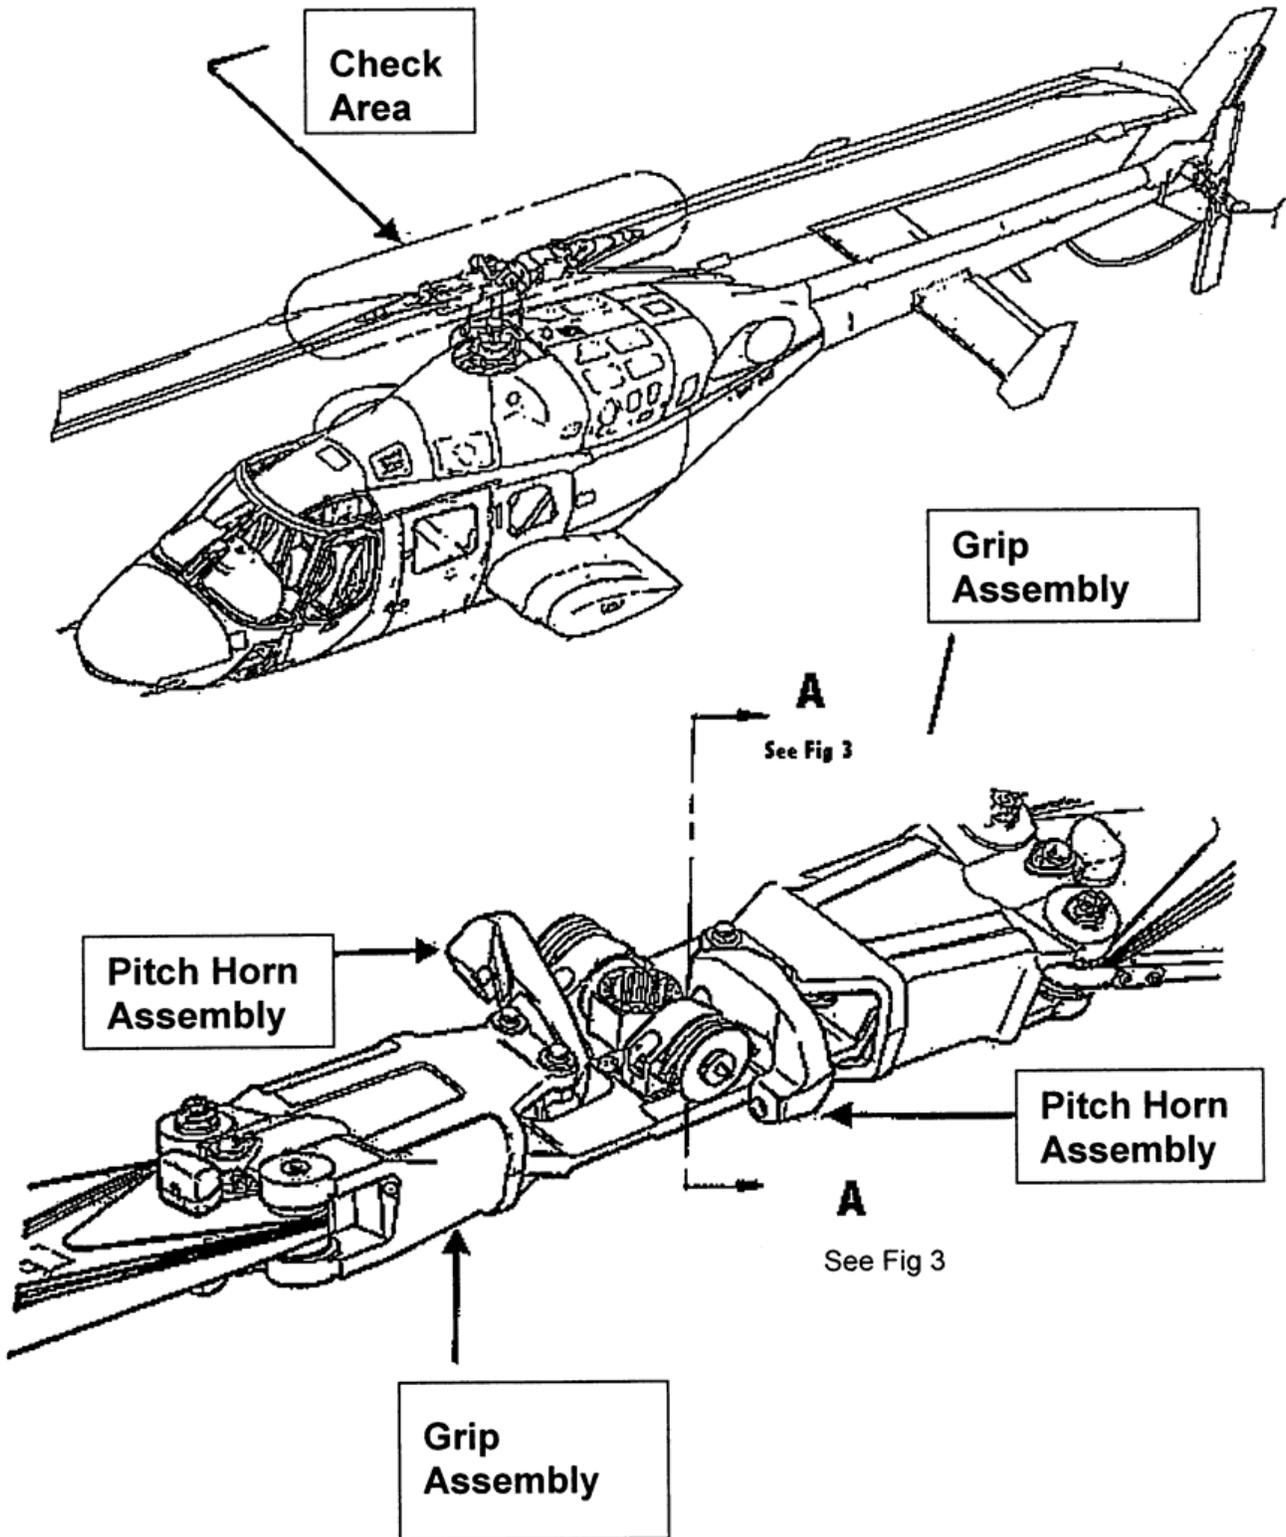
(1) Wipe clean the main rotor grip and pitch horn surfaces to remove grease and dirt in the check area as shown in Figure 1 of this AD:

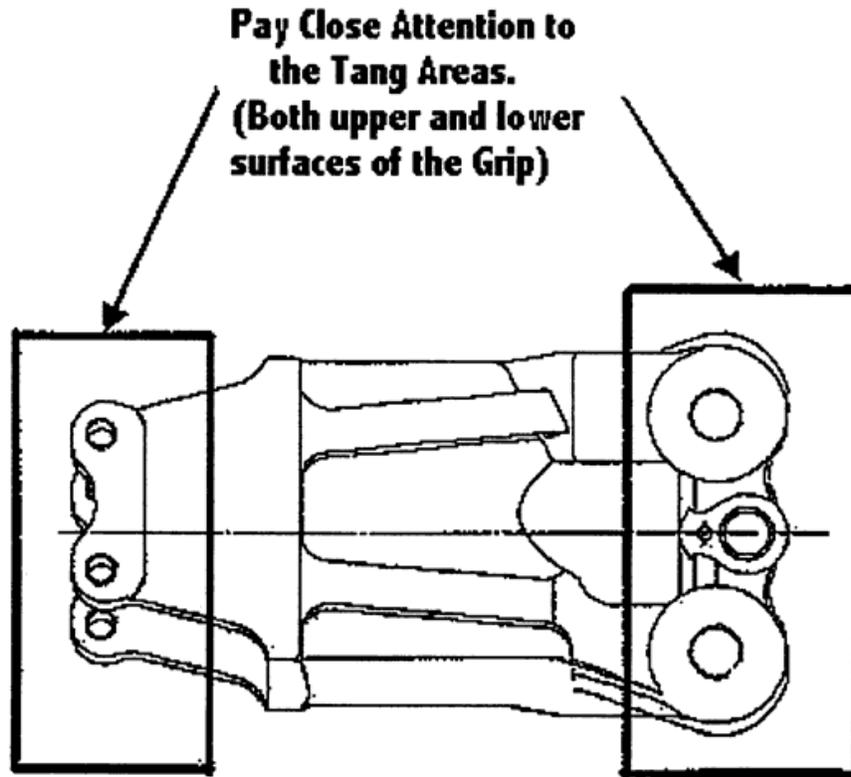
(2) Visually check both main rotor grips for a crack. Pay particular attention to the inboard and outboard tangs portions of the grip, which are in direct contact with the pitch horns and the main rotor blades and check the area to at least 3 inches beyond the grip to pitch and grip to blade contact areas as shown in Figure 2 of this AD:

**Entire surface of the grip must be checked**

(d) If a crack is found, replace the cracked part with an airworthy part before further flight.

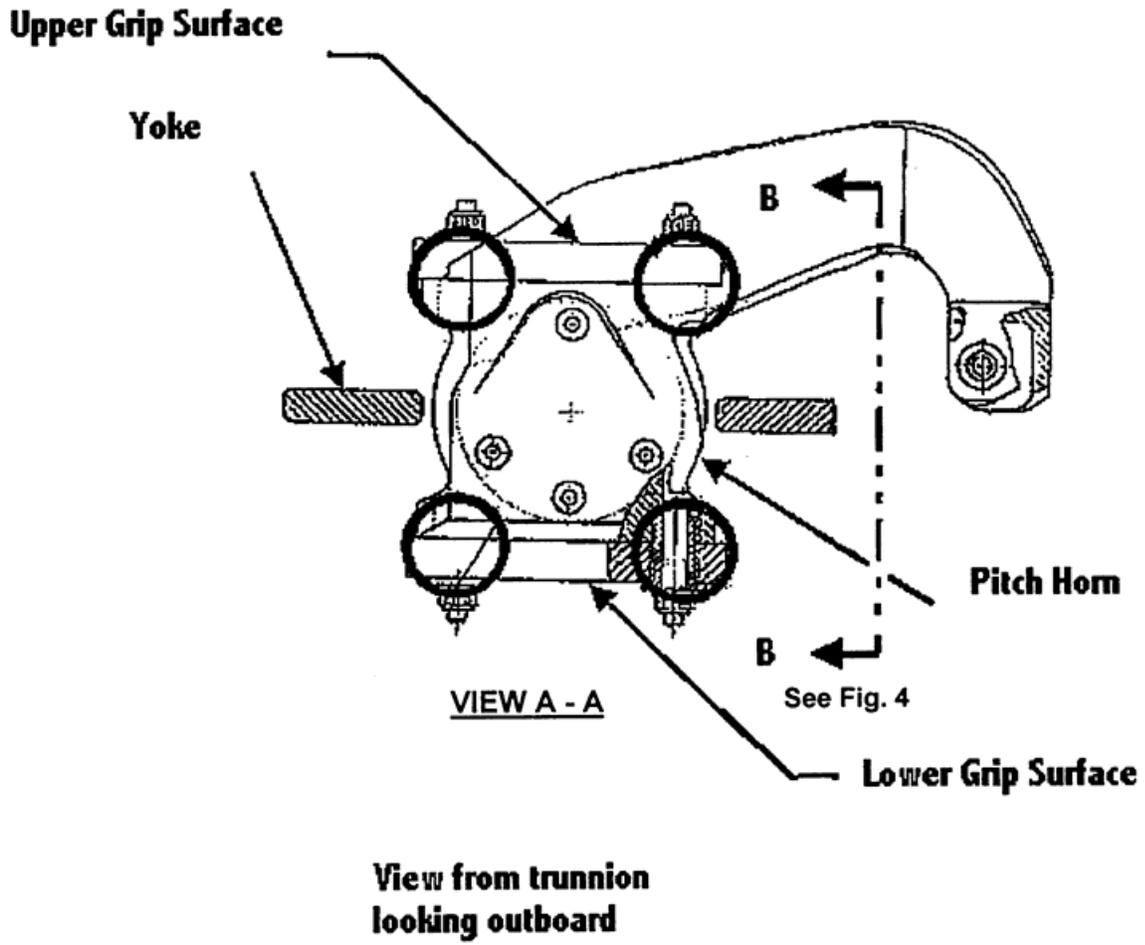
(3) Visually check all visible portions of each pitch horn for a crack. Pay particular attention to the attachment lugs of the pitch horns, which are in direct contact with the inboard tangs of the main rotor grips, as shown in Figure 3 of this AD, and the four large bolt cutouts, as shown in Figure 4 of this AD:

**All visible portions of the pitch horn must be checked.  
Pay particular attention to the circled areas shown above and View B-B, Fig. 4.**
