# EMERGENCY AIRWORTHINESS DIRECTIVE

**AD #: 2004-06-51**

Send to all U.S. owners and operators of Boeing Defense and Space Group (Boeing) Model 234 helicopters.

**2004-06-51 BOEING DEFENSE AND SPACE GROUP: Docket No. 2004-SW-09-AD.**

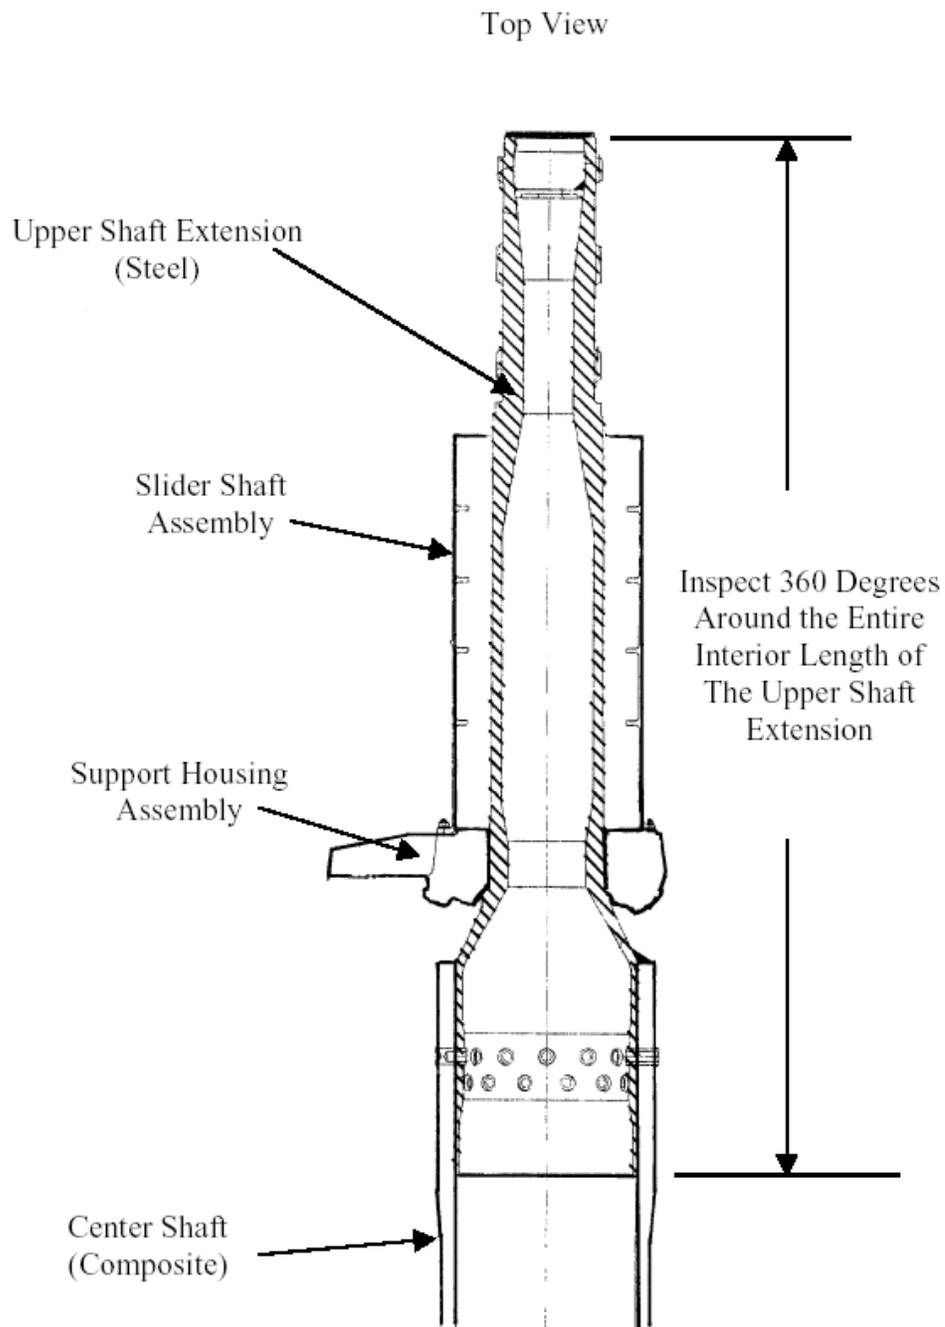
Aft Vertical Shaft  
Assembly Inspection Area  
Figure 1

This Emergency Airworthiness Directive (AD) is prompted by the discovery of a crack in the upper shaft extension of an aft vertical shaft assembly (assembly). The discovery was made by an operator who was in the process of troubleshooting a lateral vibration and noticed a slight wobble in the assembly when the rotors were turned by hand. The manufacturer subsequently determined that the crack initiated at an arc burn that occurred during the silver-plating process of the part. This is an interim action that is necessary until an arc-burn free replacement assembly is installed. A crack in the upper shaft extension could result in catastrophic failure of the assembly and subsequent loss of control of the helicopter.

(5) Inspect the upper shaft extension, P/N 114D3248, using a borescope or other lighted device that provides direct visual observation of the interior of the aft rotor shaft. Inspect 360 degrees around the entire interior length of the upper shaft extension. If any crack is found, replace the aft vertical shaft assembly, P/N 234D3300, with an airworthy assembly before further flight. See the following Figure 1 of this AD for the area to inspect:

(3) Inspect the upper shaft extension, P/N 114D3248, using a borescope or other lighted device that provides direct visual observation of the interior of the aft rotor shaft. Inspect 360 degrees around the entire interior length of the upper shaft extension (see Figure 1 of this AD). If any crack is found, replace the aft vertical shaft assembly, P/N 234D3300, with an airworthy assembly before further flight.
