[Docket No. FAA-2007-28661; Directorate Identifier 2007-NM-013-AD; Amendment 39-16785; AD 2011-18-03]

Airworthiness Directives; The Boeing Company Model 737-600, -700, -700C, -800, and -900 Series Airplanes

ACTION: Final rule.

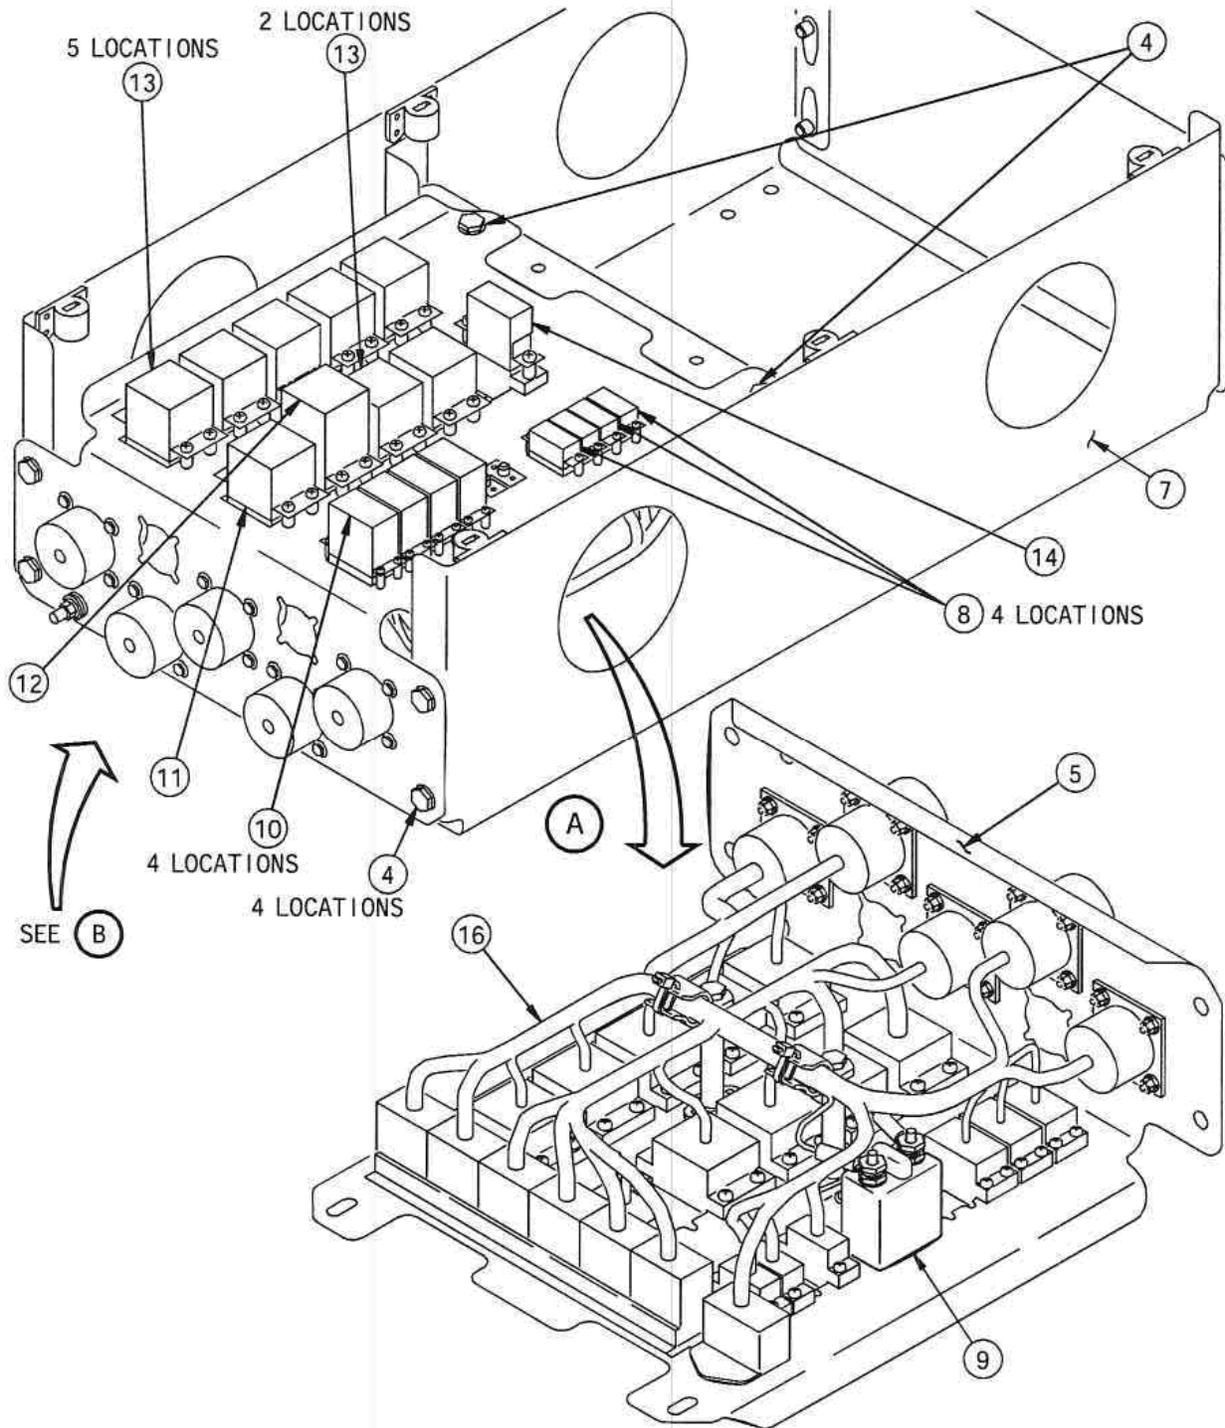
Note 2: Boeing Alert Service Bulletin 737-28A1206, Revision 2, dated May 21, 2009, refers to Boeing Component Service Bulletin 233A3202-28-03, dated January 12, 2006, as an additional source of guidance for replacing the left and right center boost pump switches of the P5-2 fuel control module assembly with new switches and changing the wiring of the P5-2 fuel control module assembly.

TYPICAL RELAY ARRANGEMENT SHOWN

(g) For airplanes identified in paragraph 1.A.1. of Boeing Alert Service Bulletin 737-28A1206, Revision 2, dated May 21, 2009: Within 36 months after the effective date of this AD, install an automatic shutoff system for the center tank fuel boost pumps, by accomplishing all of the actions specified in Part 1 and Part 2 of the Accomplishment Instructions of Boeing Alert Service Bulletin 737-28A1206, Revision 2, dated May 21, 2009, except that Figure 1 of this AD must be used in lieu of Sheet 2 of Figure 11 of Boeing Alert Service Bulletin 737-28A1206, Revision 2, dated May 21, 2009. If a placard has been previously installed on the airplane in accordance with paragraph (h) of this AD, the placard may be removed from the flight deck of only that airplane after the automatic shutoff system has been installed. Installing automatic shutoff systems on all airplanes in an operator's fleet, in accordance with this paragraph, terminates the placard installation required by paragraph (h) of this AD for all airplanes in an operator's fleet.
