**[Docket No. FAA-2007-28688; Directorate Identifier 2005-SW-21-AD; Amendment 39-15312; AD 2007-26-10]**

#### **Airworthiness Directives; Bell Helicopter Textron Canada Model 430 Helicopters**

**2007-26-10 Bell Helicopter Textron Canada:** Amendment 39-15312. Docket No. FAA-2007-28688; Directorate Identifier 2005-SW-21-AD.

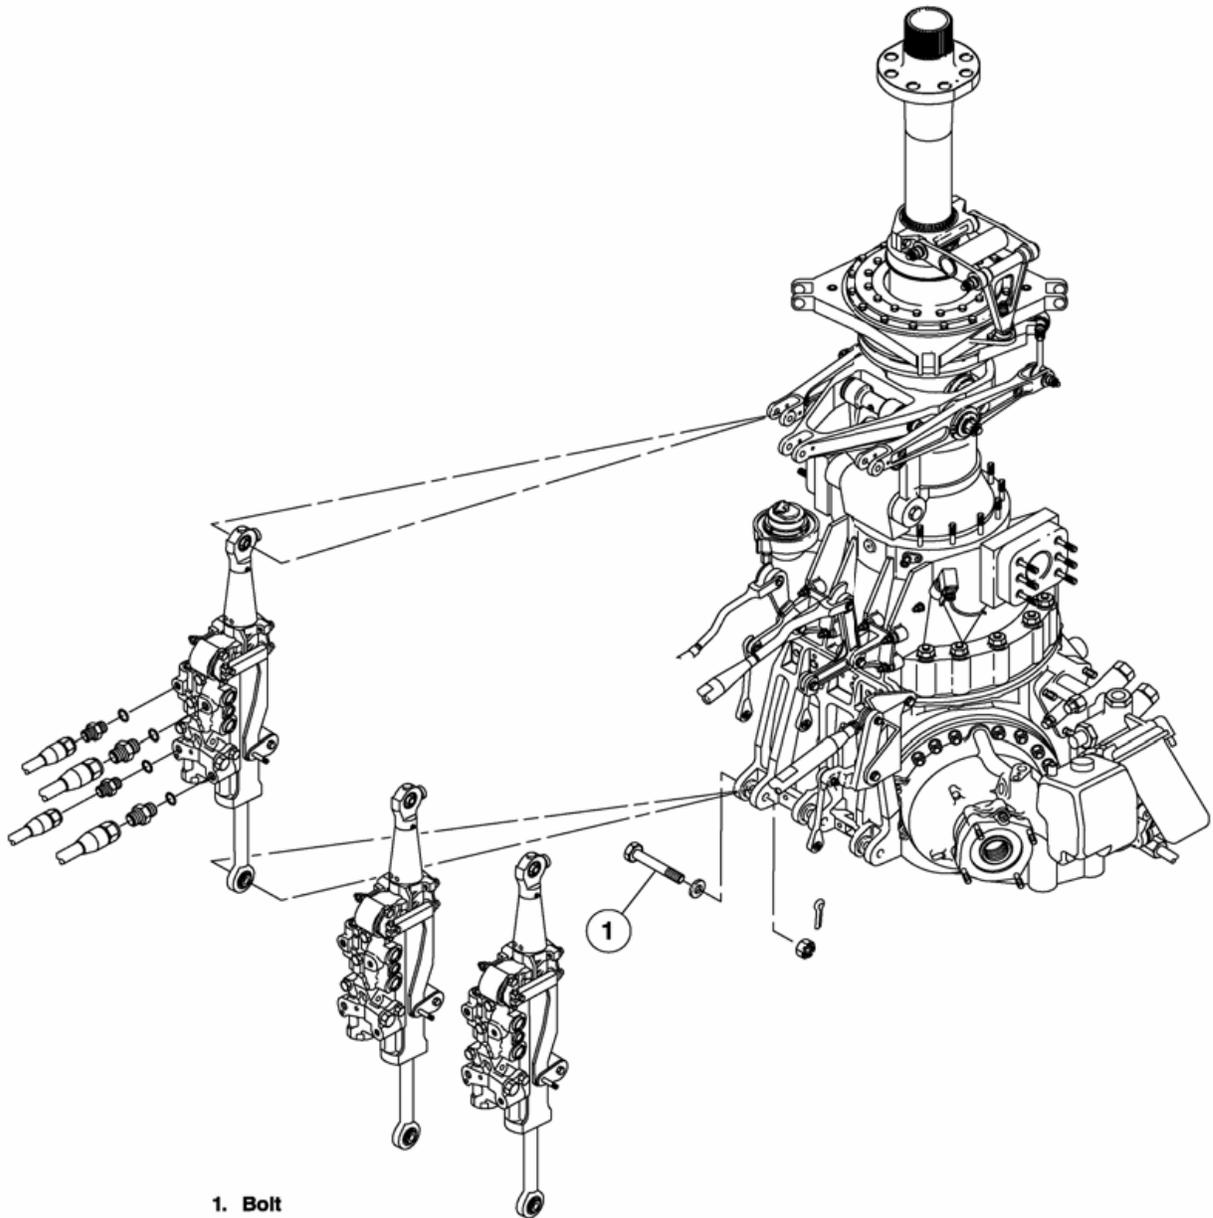
**Figure 1**

To prevent fatigue failure of the bolt and subsequent loss of control of the helicopter, do the following:

Note 1: Only the right servo lower attach bolt (1) is shown. The collective and left cyclic servo lower attach bolts are also to be replaced. (This AD does not apply to the same part-numbered bolts at the upper end of each servo.)

(a) Within 150 hours time-in-service (TIS), replace all three affected bolts, as depicted for one of these bolts in Figure 1 of this AD, with airworthy, zero-time bolts, P/N 50-047C8-31.

(b) This AD revises the Airworthiness Limitations section of the maintenance manual by establishing a retirement life of 5000 hours TIS for each bolt.

(c) Record a 5000-hour TIS life limit for each bolt on the component history card or equivalent record.
