[Federal Register Volume 77, Number 75 (Wednesday, April 18, 2012)]
[Rules and Regulations]
[Pages 23109-23112]
From the Federal Register Online via the Government Printing Office [www.gpo.gov]
[FR Doc No: 2012-9315]

[Docket No. FAA-2012-0409; Directorate Identifier 2011-SW-055-AD; Amendment 39-17020; AD 2011-18-52]

Airworthiness Directives; Agusta S.p.A. Helicopters

2011-18-52 AGUSTA S.p.A. (AGUSTA): Amendment 39-17020; Docket No. FAA-2012-0409; Directorate Identifier 2011-SW-055-AD.

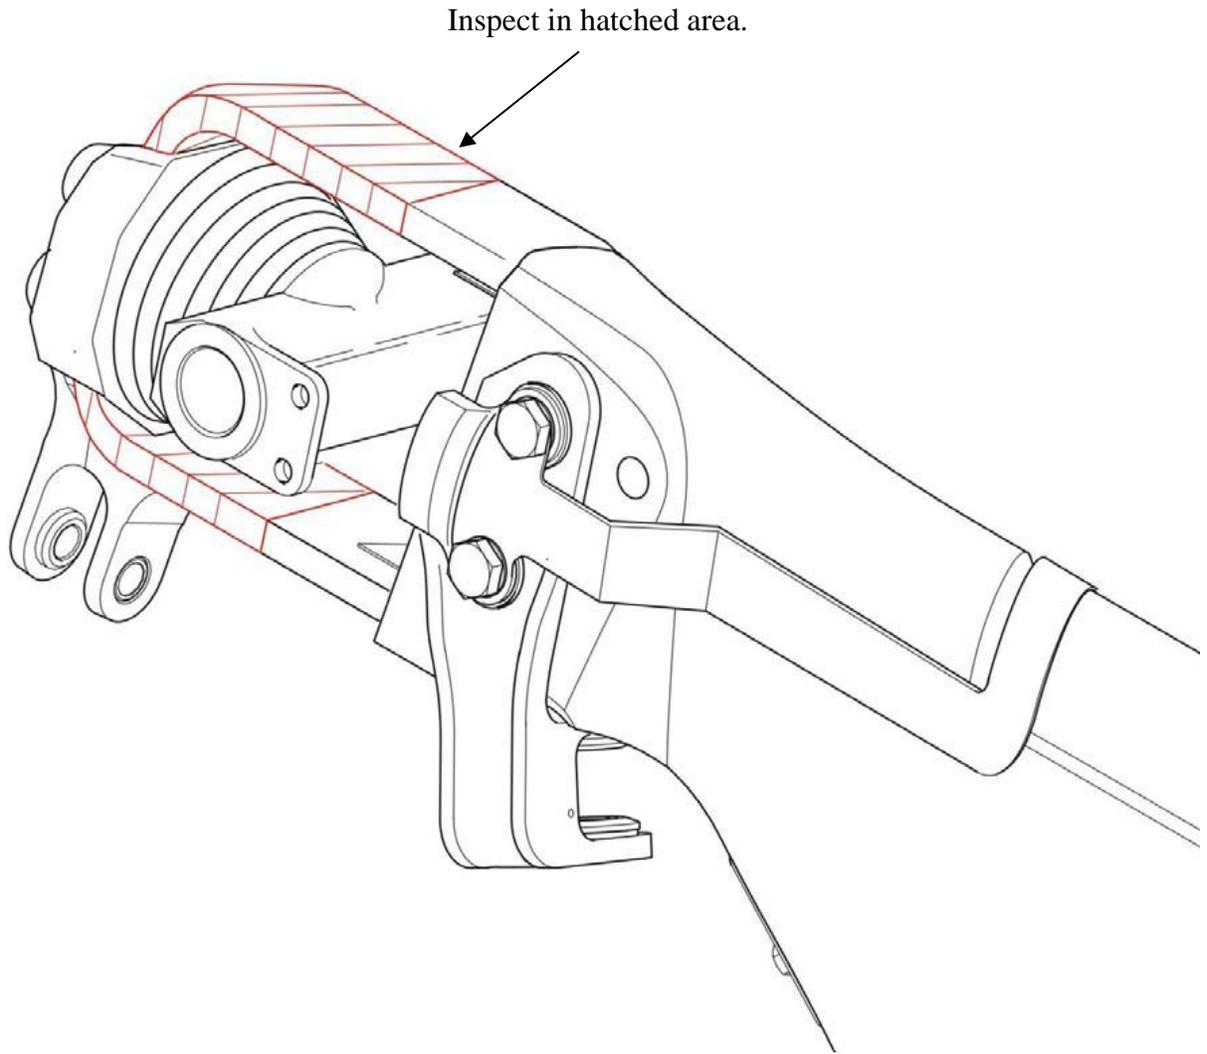
This AD defines the unsafe condition as cracks in a T/R blade. The actions in this AD are intended to detect and prevent a crack in a T/R blade which could lead to failure of a T/R blade and subsequent loss of control of the helicopter.

(3) Within 25 hours TIS, and thereafter at intervals not to exceed 25 hours TIS, visually inspect the T/R blade for a crack or damage that exceeds the limits of the applicable maintenance manual. Inspect in the area depicted in the following figure using a mirror, magnifying glass (5X or greater), and light source, or borescope.

(4) If there is a crack, or if there is damage that exceeds the limits of the applicable maintenance manual, before further flight, replace the T/R blade with an airworthy T/R blade.
