**FEDERAL AVIATION ADMINISTRATION
AIRWORTHINESS DIRECTIVES
SMALL AIRCRAFT, ROTORCRAFT, GLIDERS,
BALLOONS, & AIRSHIPS**

BIWEEKLY 2010-13

2010-10-12 Bell Helicopter Textron Canada: Amendment 39-16291. Docket No. FAA-2008-0071; Directorate Identifier 2006-SW-27-AD. Supersedes AD 2005-04-09, Amendment 39-13981, Docket No. FAA-2005-20107.

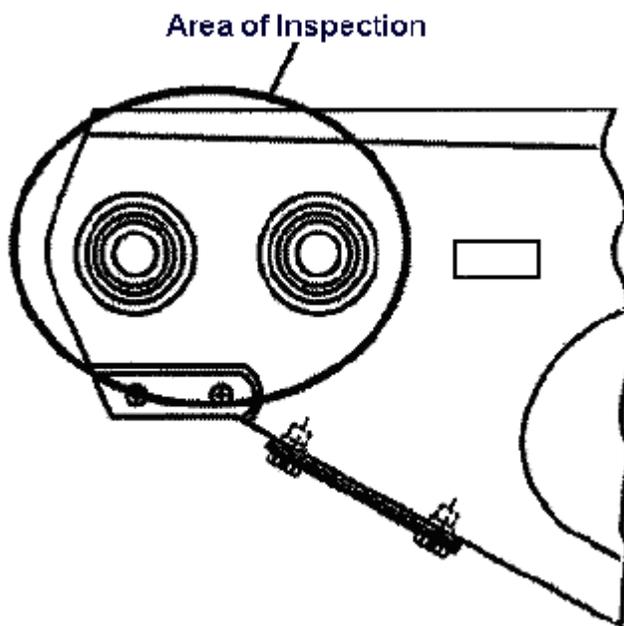
P/N 222-016-001 – all dash numbers
Figure 1
Blade Inspection Area

To detect a crack in a blade, and to prevent loss of the blade and subsequent loss of control of the helicopter, accomplish the following:

(a) Within 3 hours time-in-service (TIS), unless accomplished previously, and thereafter at intervals not to exceed 3 hours TIS, clean and visually check both sides of each blade for a crack in the paint in the areas shown in Figure 1 of this AD. An owner/operator (pilot), holding at least a private pilot certificate, may perform this visual check and must enter compliance with this paragraph into the helicopter maintenance records by following 14 CFR 43.11 and 91.417(a)(2)(v).

or an equivalent. Using a 10X or higher power magnifying glass, visually inspect both sides of the blade in the areas depicted in Figure 1 of this AD.

(1) If a crack is found, even if only in the paint, before further flight, remove the blade from the helicopter and proceed with the following:

(2) Remove the paint on the blade down to the bare metal in the area of the suspected crack by using plastic media blasting (PMB) or a nylon web abrasive pad. Abrade the blade surface in a span-wise direction only.

(3) Using a 10X or higher power magnifying glass, inspect the blade for a crack.

(i) If a crack is found, replace the blade with an airworthy blade before further flight.

(ii) If no crack is found in the blade surface, refinish the blade by applying one coat of epoxy polyamide primer, MIL-P-23377 or MIL-P-85582, so that the primer overlaps the existing coats just beyond the abraded area. Let the area dry for 30 minutes to 1 hour. Then, apply one sealer coat of polyurethane, MILC85285 TYI CL2, color number 27925 (semi-gloss white). Reinstall the blade.
