**FEDERAL AVIATION ADMINISTRATION
AIRWORTHINESS DIRECTIVES
SMALL AIRCRAFT, ROTORCRAFT, GLIDERS,
BALLOONS, & AIRSHIPS**

BIWEEKLY 2009-16

2009-15-13 Honeywell International Inc. (Formerly AlliedSignal and Textron-Lycoming):
Amendment 39-15976. Docket No. FAA-2008-1311; Directorate Identifier 2007-NE-48-AD.

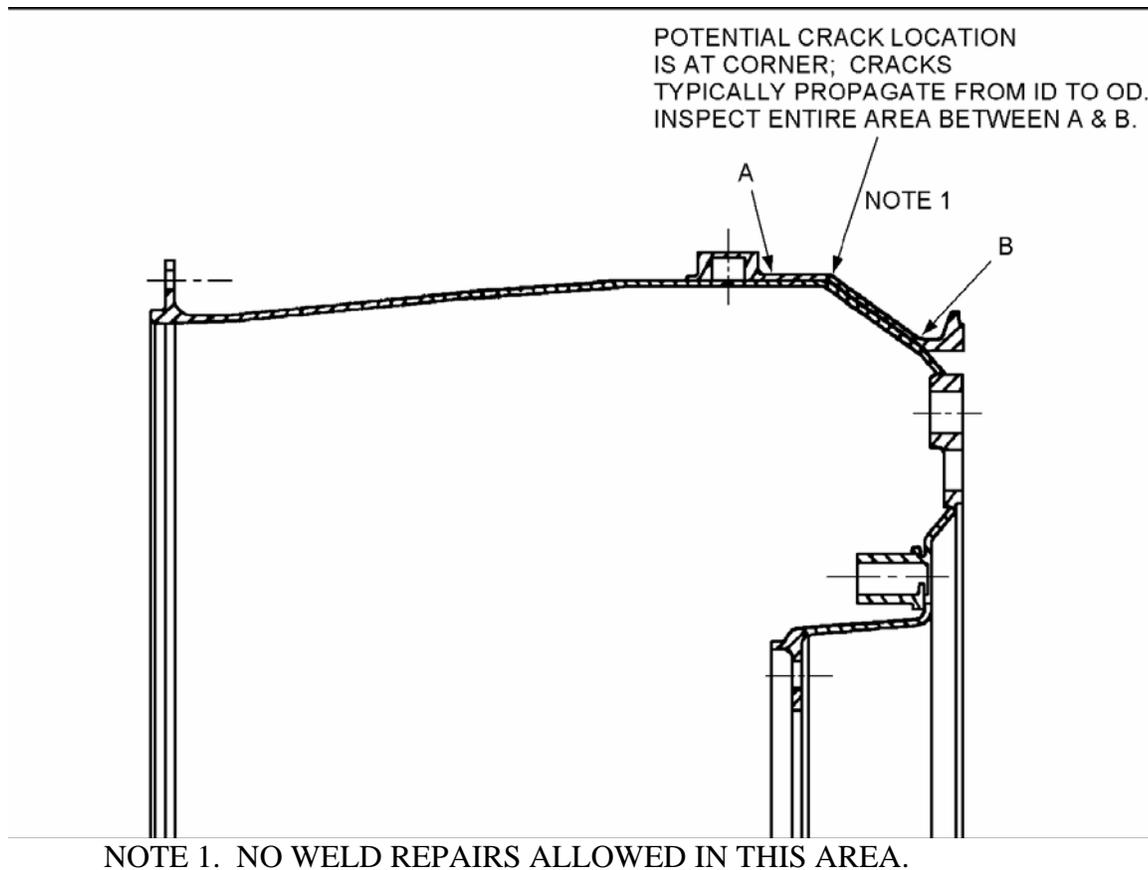
Figure 1. Visual Inspection of CCH

(d) This AD results from eight instances of cracks in CCHs. Two of the instances resulted in an engine shutdown during flight. We are issuing this AD to detect cracks in the CCH, which could result in rupture of the CCH, leading to loss of engine power and damage to the helicopter.

(f) For CCH, P/N 1-130-610-05 and 1-130-610-12, within 50 hours time-in-service (TIS) after the effective date of this AD, inspect the area between points A and B around the entire housing circumference in Figure 1 of this AD for weld repairs and cracks.

(g) For CCH, P/N 1-130-610-05 and 1-130-610-12, inspect the area between points A and B around the entire housing circumference in Figure 1 of this AD for cracks within every 50 hours time-since-last inspection. Honeywell International Inc. Standard Practices Manual 70-20-02, SP 1302, contains additional guidance on visual inspection.

(1) If you find any cracks, replace the CCH before further flight. Honeywell International Inc. Alert Service Bulletin (ASB) T53-A0142, Revision 1, dated September 14, 2006, contains additional guidance on replacing the CCH.

(2) If you find any weld repairs, replace the CCH within 100 hours TIS after the visual inspection. Honeywell International Inc. ASB T53-A0142, Revision 1, dated September 14, 2006, contains additional guidance on replacing the CCH.

(h) If you find any cracks, replace the CCH before further flight. Honeywell International Inc. ASB T53-A0142, Revision 1, dated September 14, 2006, contains additional guidance on replacing the CCH.
