**FEDERAL AVIATION ADMINISTRATION
AIRWORTHINESS DIRECTIVES
SMALL AIRCRAFT, ROTORCRAFT, GLIDERS,
BALLOONS, & AIRSHIPS**

BIWEEKLY 2011-11

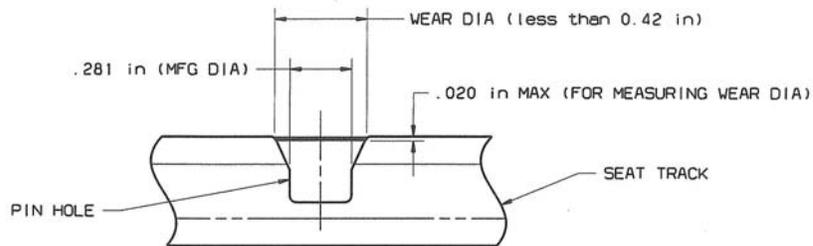
Figure 1. Diameter of seat pin locking engagement hole

(3) Inspect the diameter of each seat locking pin engagement hole in the pilot and copilot seat rails for excessive wear. Due to wear on the rail surface at the hole opening, we allow this measurement 0.020 of an inch below the surface of the rail. You must take this measurement somewhere between the surface of the rail or no more than 0.020 of an inch below the surface of the rail.

(i) If the diameter of any of the holes is 0.42 of an inch or more (see figure 1), before further flight, replace the rail.

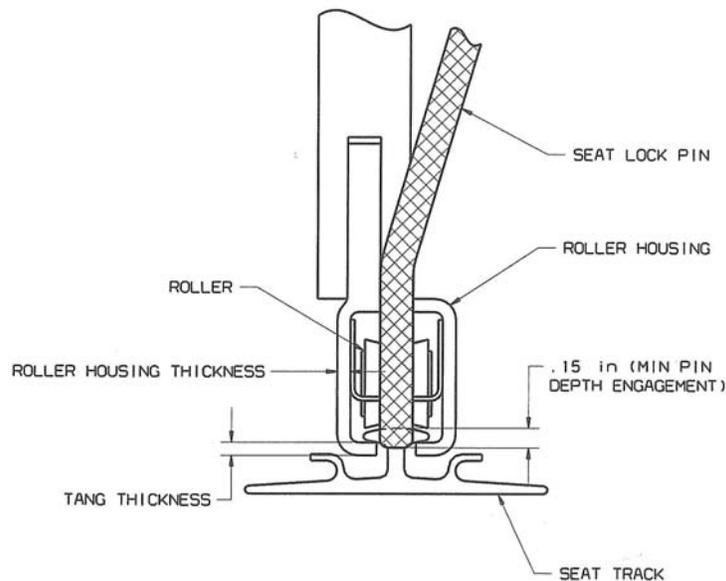
Figure 2. Seat locking pin depth engagement

(10) Lift up the forward edge of each seat to eliminate vertical play of the seat locking pin in the engagement hole, and from this position, inspect the depth of engagement of each seat locking pin (see figure 2). If the rail is worn, this depth is measured from the worn surface, not the manufactured surface.

(i) If engagement of any of the seat locking pins measures less than 0.15 of an inch, before further flight, replace or repair any seat components necessary to achieve a seat pin engagement of a minimum of 0.15 of an inch.

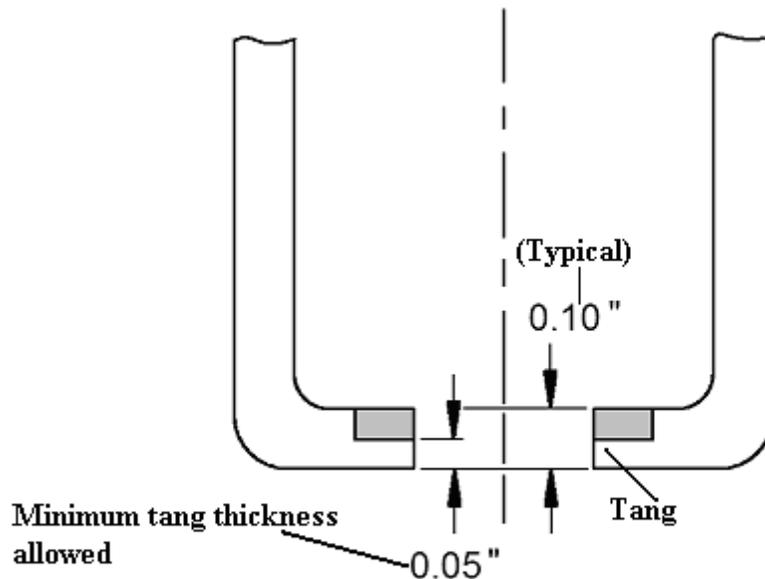
Figure 3. Closeup of seat roller housing and tang thickness

(5) Inspect the thickness of the tang (see figure 2 and figure 3). Due to wear of the tang chafing against the seat rail, measure the tang thickness where the tang inner edges contact the seat rail.

(i) If the tang thickness measures less than 0.05 of an inch, before further flight replace the roller housing.

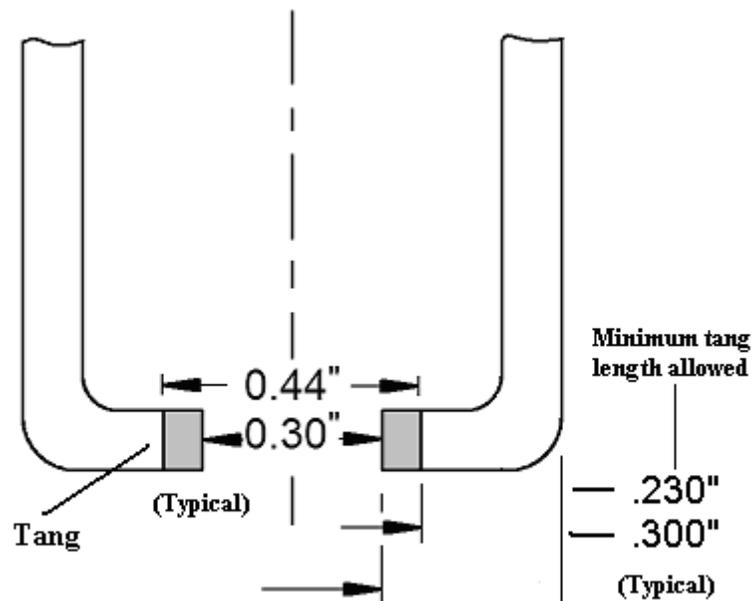
Figure 4. Closeup of seat roller housing and tang gap width

(6) Due to wear or deformation of the tangs, inspect the tang length from the inner edge of the tang to the outer edge (the bend area) of the roller housing (see figure 4).

(i) The minimum measurement allowed for the remaining tang length is 0.230 inches remaining on either of the tangs, from the inner edge of the tang to the outer edge (the bend area) of the roller housing. If the measurement is less than 0.230 inches on either of the tangs, before further flight, replace the roller housing.

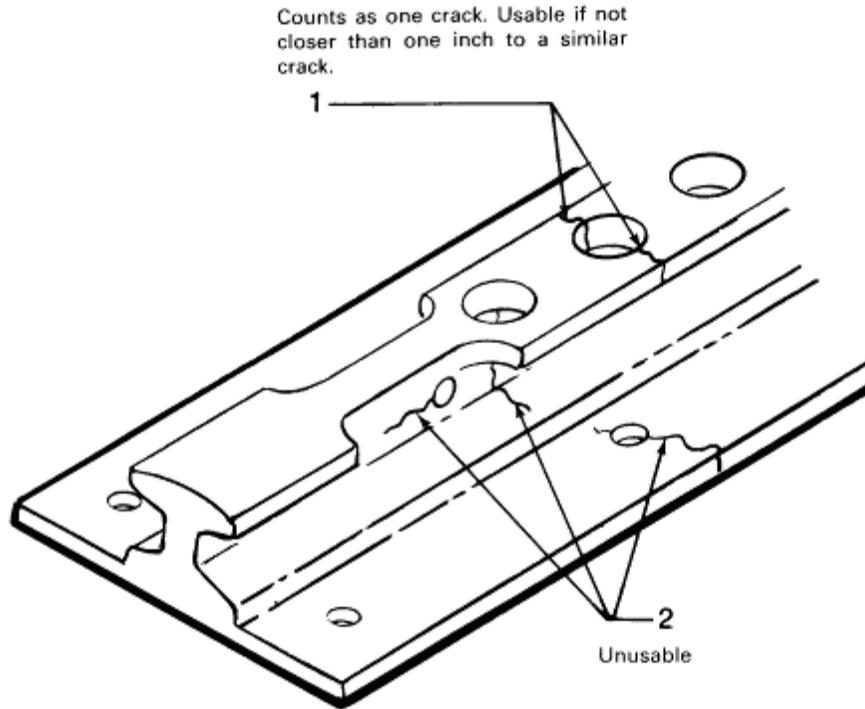
(8) Visually inspect the seat rails for cracks.

- (1) Any portion of web or lower flange is cracked (index 2).
- (2) Any crack in crown of rail is in any direction other than right angle to length of rail.
- (3) Number of cracks on any one rail exceeds four, or any two cracks (index 1) are closer than one inch.

(i) If there are seat rail cracks that exceed the crack criteria in figure 5, before further flight, replace the seat rail.
