**FEDERAL AVIATION ADMINISTRATION
AIRWORTHINESS DIRECTIVES
SMALL AIRCRAFT, ROTORCRAFT, GLIDERS,
BALLOONS, & AIRSHIPS**

BIWEEKLY 2012-10

2012-10-51 EUROCOPTER DEUTSCHLAND GMBH (ECD): Directorate Identifier 2012-SW-041-AD.

2012-10-53 EUROCOPTER DEUTSCHLAND GMBH (ECD): Directorate Identifier 2012-SW-049-AD.

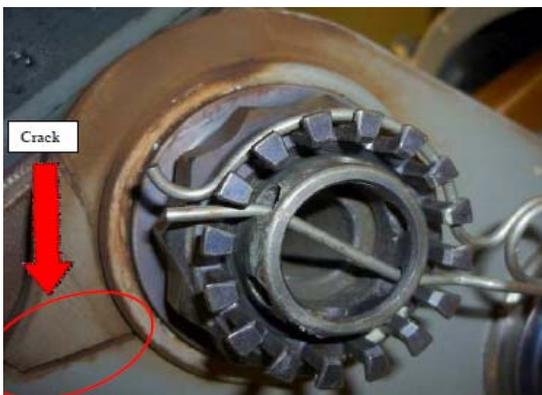
Figure 1

(1) Before further flight, and thereafter before the first flight of each day, check the lower hub-shaft flange for a crack and each blade attachment bolt for a deformed safety pin by reference to figures 1 and 2 of this EAD. The actions required by this paragraph may be performed by the owner/operator (pilot) holding at least a private pilot certificate, and must be entered into the aircraft records showing compliance with this EAD in accordance with 14 CFR §§ 43.9 (a)(1)-(4) and 14 CFR § 91.417(a)(2)(v). The record must be maintained as required by 14 CFR §§ 91.417, 121.380, or 135.439.

(iii) Inspect safety pins for deformation as shown in figure 1 of this EAD.

(4) If there is a crack in the upper or lower hub-shaft flange, before further flight, replace the main rotor hub-shaft.

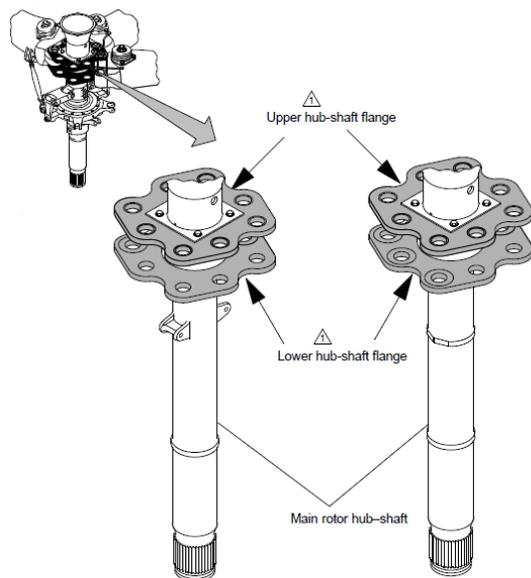
Figure 3

(ii) Clean the upper and lower hub-shaft flange as depicted in figure 3 of this EAD and visually inspect for a crack.

⚠ Check visible area of the upper and lower hub-shaft flange.

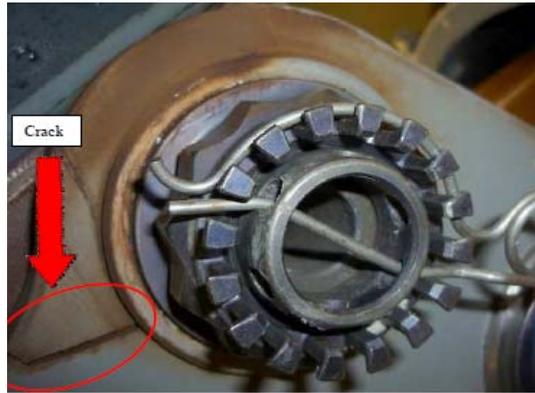
Figure 1

(1) Before further flight, and thereafter at intervals not to exceed 6 hours TIS, check the MRH shaft lower flange and the visible area of the MRH shaft upper flange for a crack. Figures 1 and 2 of this EAD are examples of cracks that have been discovered in the MRH shaft lower flange. The actions required by this paragraph may be performed by the owner/operator (pilot) holding at least a private pilot certificate, and must be entered into the aircraft records showing compliance with this EAD in accordance with 14 CFR §§ 43.9 (a)(1)-(4) and 14 CFR § 91.417(a)(2)(v). The record must be maintained as required by 14 CFR §§ 91.417, 121.380, or 135.439.

(3) If there is a crack in the upper or lower MRH shaft flange, before further flight, replace the MRH shaft.

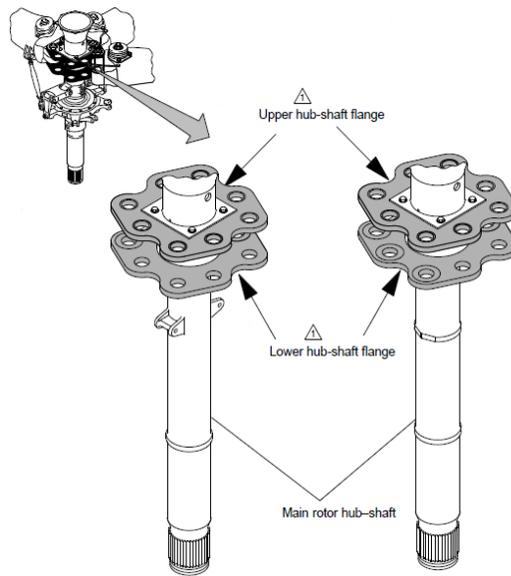
Figure 3

(ii) Clean the upper and lower MRH shaft flange as depicted in figure 3 of this EAD and visually inspect for a crack.

⚠ Check visible area of the upper and lower hub-shaft flange.

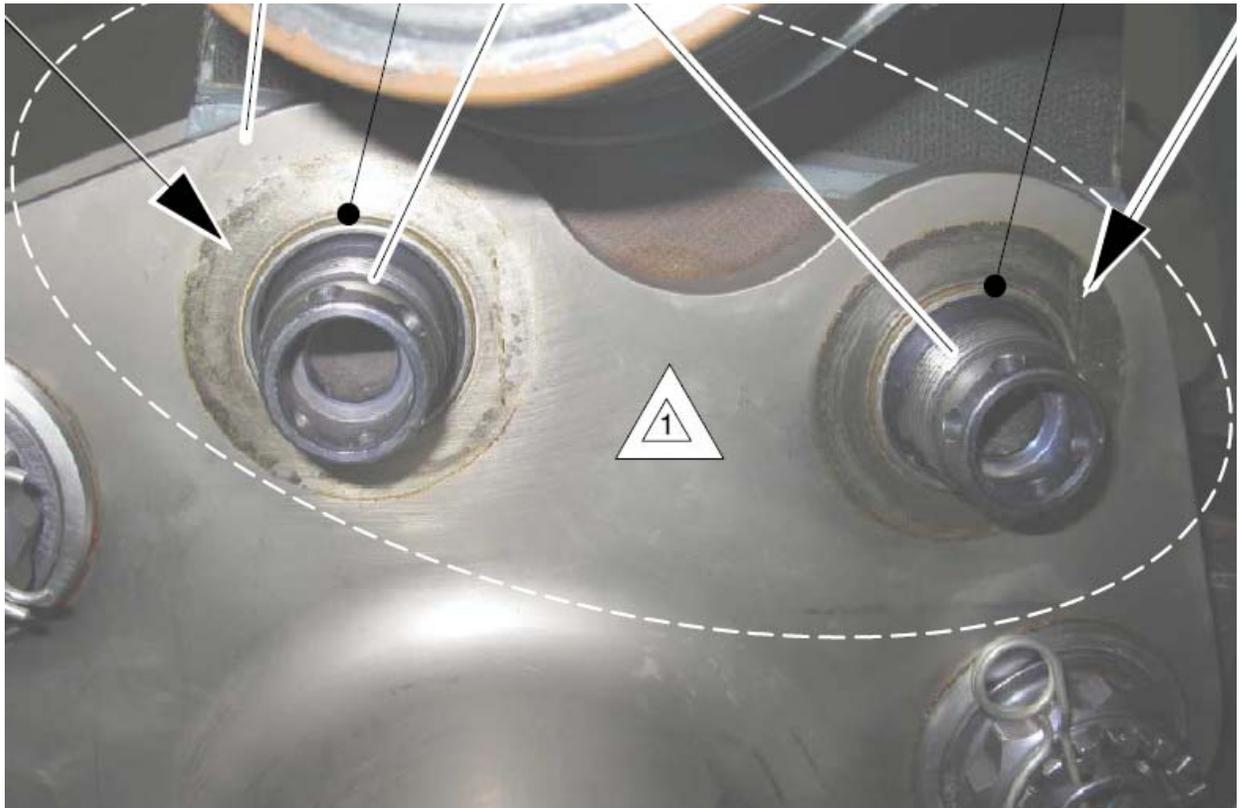
Figure 4

(v) Using a 10X or higher power magnification, inspect all lower MRH shaft flange blade bolt attachment areas for a crack as shown in figure 4 of this EAD.
