**FEDERAL AVIATION ADMINISTRATION  
AIRWORTHINESS DIRECTIVES  
SMALL AIRPLANES, ROTORCRAFT, GLIDERS,  
BALLOONS, & AIRSHIPS**

**BIWEEKLY 2012-15**

*7/16/2012 - 7/29/2012*

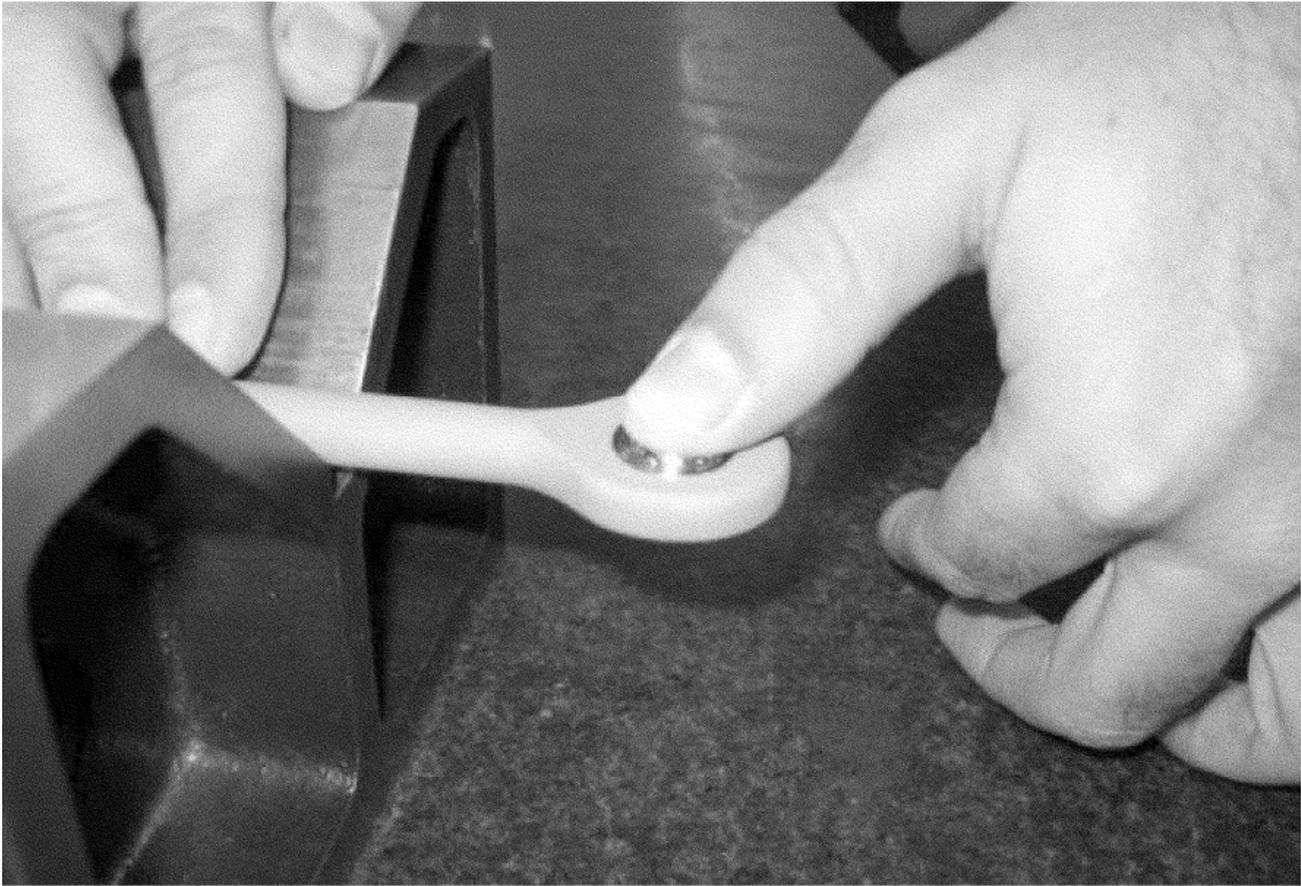
**Figure 1 to Paragraph (e)**

This AD defines the unsafe condition as an improperly swaged spherical bearing on the pitch link, which could result in loss of tail rotor control and subsequent loss of control of the helicopter.

- (1) Remove the pitch link.
- (2) Clean the area around the spherical bearings and pitch link bearing bore chamfer.
- (3) Apply axial hand pressure to the faces of both spherical bearings as shown in Figure 1 to Paragraph (e) of this AD.

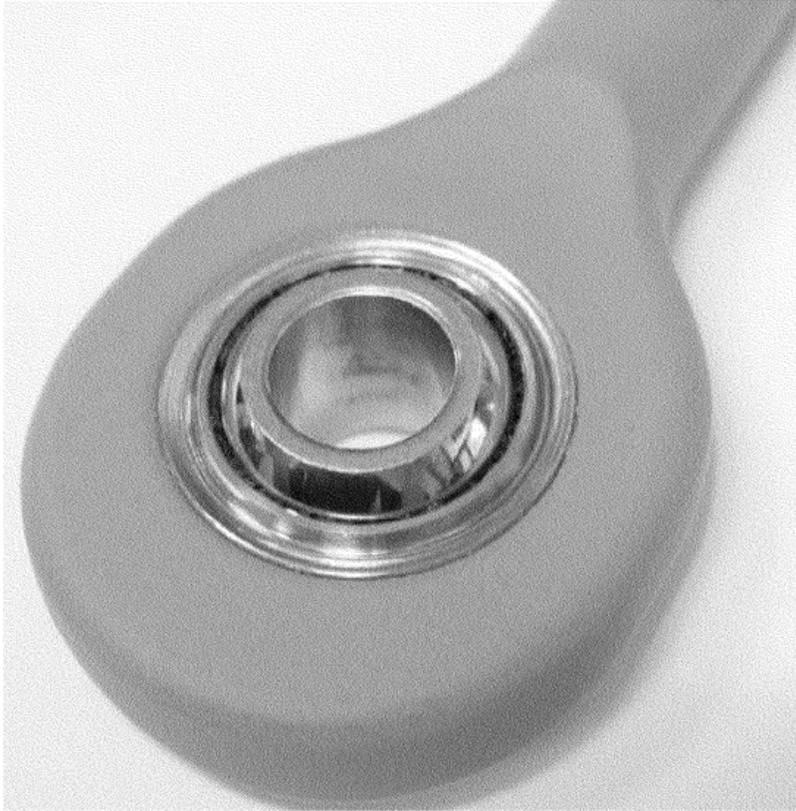
**Figure 2 to Paragraph (e)**

(4) Using an 8X or higher power magnifying glass, inspect the boundaries between the bearing and the bearing bore chamfer surface. Determine that the bearings have been completely swaged and there is no gap between the edge of the bearing and the chamfer as shown in Figure 2 to Paragraph (e) of this AD.

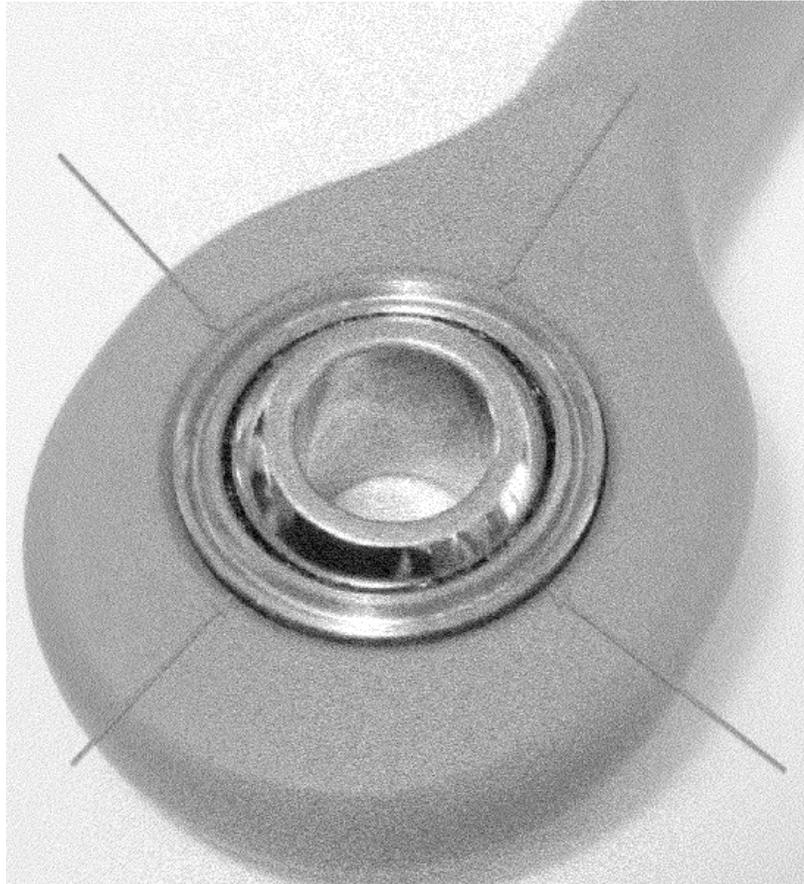
**Figure 3 to Paragraph (e)**

(5) If a bearing is not completely swaged or there is a gap between the edge of the bearing and the chamfer, as shown in Figure 3 to Paragraph (e) of this AD, replace the pitch link with an airworthy pitch link.

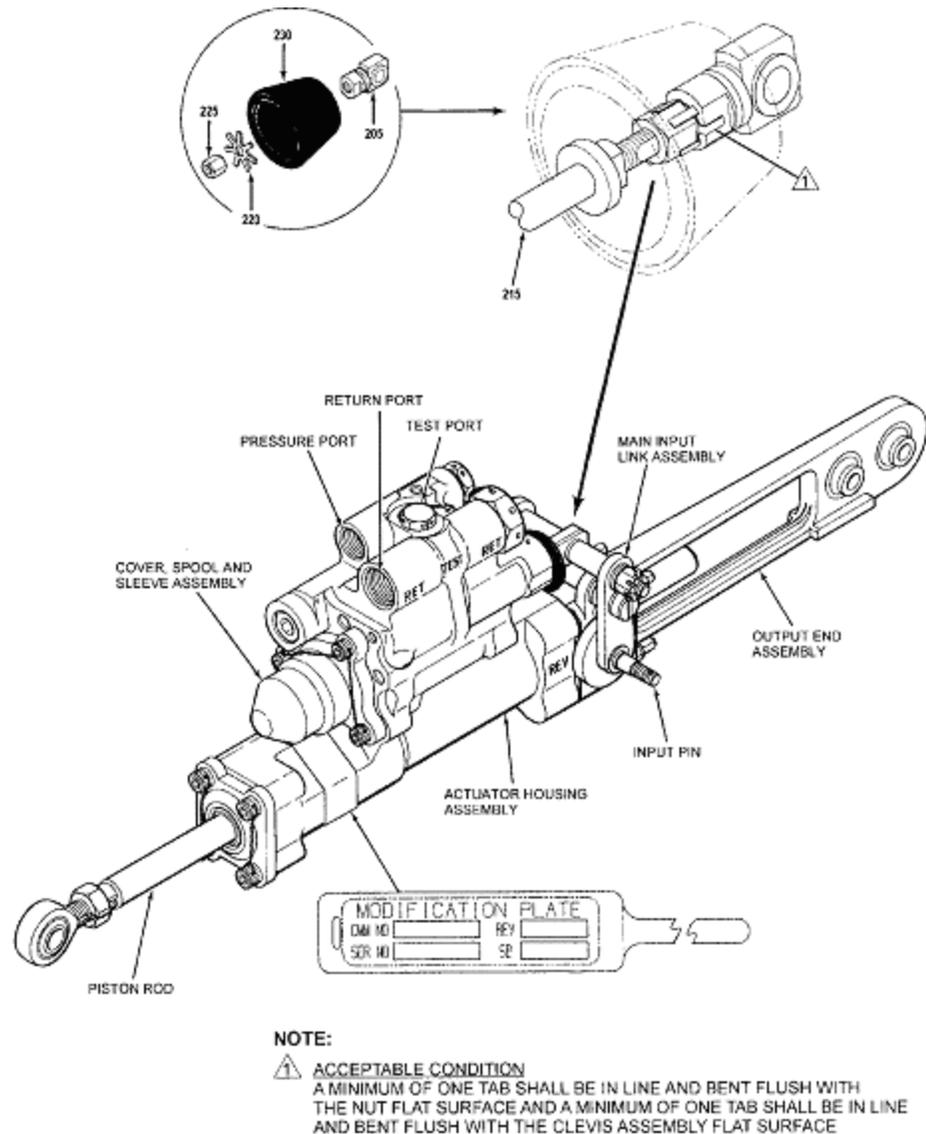
### Figure 1 to Paragraph (f)

This AD defines the unsafe condition as a loose or misaligned part in the servo that could lead to failure of the servo and subsequent loss of helicopter control.

(i) Retract the boot depicted as 230 in Figure 1 to Paragraph (f) of this AD.

(ii) Applying only hand pressure, determine whether the nut, the shaft, or the clevis assembly, depicted as items 225, 215 and 205, respectively, in Figure 1 to Paragraph (f) of this AD, turn independently. If the shaft turns independently of the nut or clevis assembly, before further flight, replace the servo with an airworthy servo.

(iii) If the shaft does not turn independently, inspect to determine if at least one tab of the lock washer is bent flush against a flat surface of the nut and if at least one tab of the lock washer is bent flush against a flat surface of the clevis assembly.

(iv) If at least one lock washer tab is not aligned and bent flush with a nut flat surface and at least one lock washer tab is not aligned and bent flush with a flat surface of the clevis assembly, before further flight, replace the servo with an airworthy servo.

(v) If any tab of the lock washer is not bent flush against either a flat surface of the nut or clevis assembly, bend the tab flush against a flat surface.

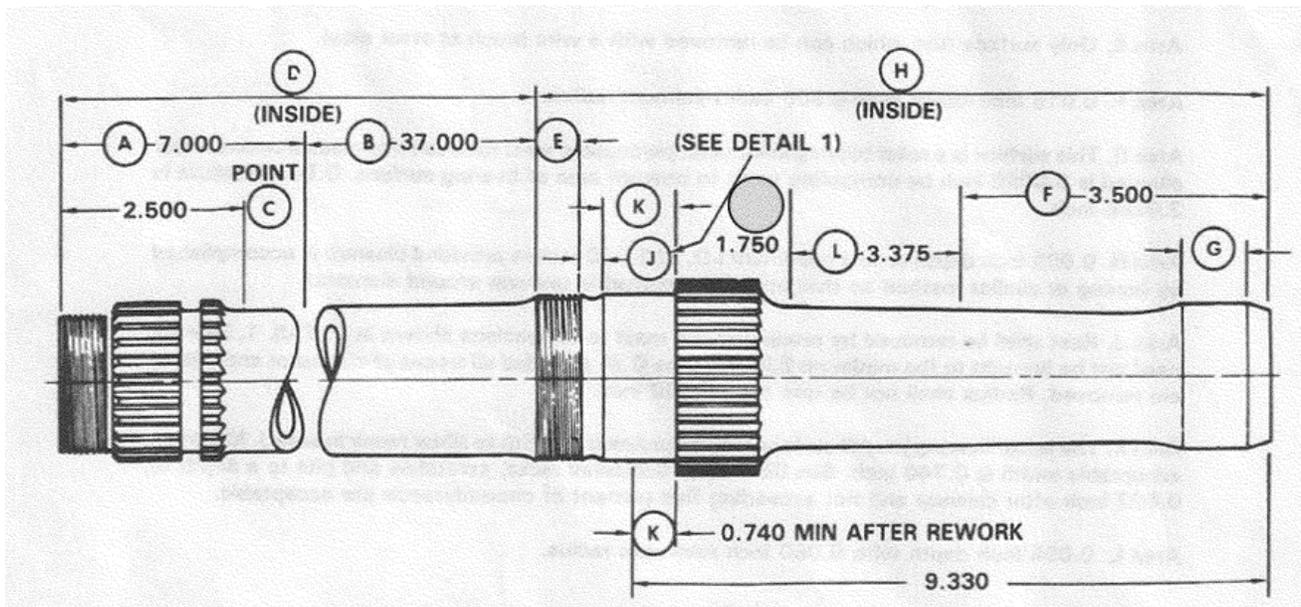
**Figure 1 to Paragraph (e)**

This AD defines the unsafe condition as a crack in the main rotor mast, which could result in failure of the mast and subsequent loss of control of the helicopter.

- (1) Within 30 days, unless accomplished previously within the last 12 months:
  - (i) Overhaul the main rotor mast assembly and magnetic particle inspect the mast; mast bearing nut; plate, mast and seal; and bearing liner for a crack.
  - (ii) Fluorescent penetrant inspect the locking plate for a crack.
  - (iii) Using a 10X or higher magnifying glass, inspect the threaded area of the mast as shown in area E of figure 1 to paragraph (e) of this AD for pitting, corrosion, or a crack. Remove any surface rust with a wire brush or steel wool.

(2) If there is a crack, pitting, or corrosion, before further flight, replace the mast with an airworthy mast.
