**FEDERAL AVIATION ADMINISTRATION
AIRWORTHINESS DIRECTIVES
SMALL AIRCRAFT, ROTORCRAFT, GLIDERS,
BALLOONS, & AIRSHIPS**

BIWEEKLY 2011-23

SMALL AIRCRAFT, ROTORCRAFT, GLIDERS, BALLOONS, & AIRSHIPS

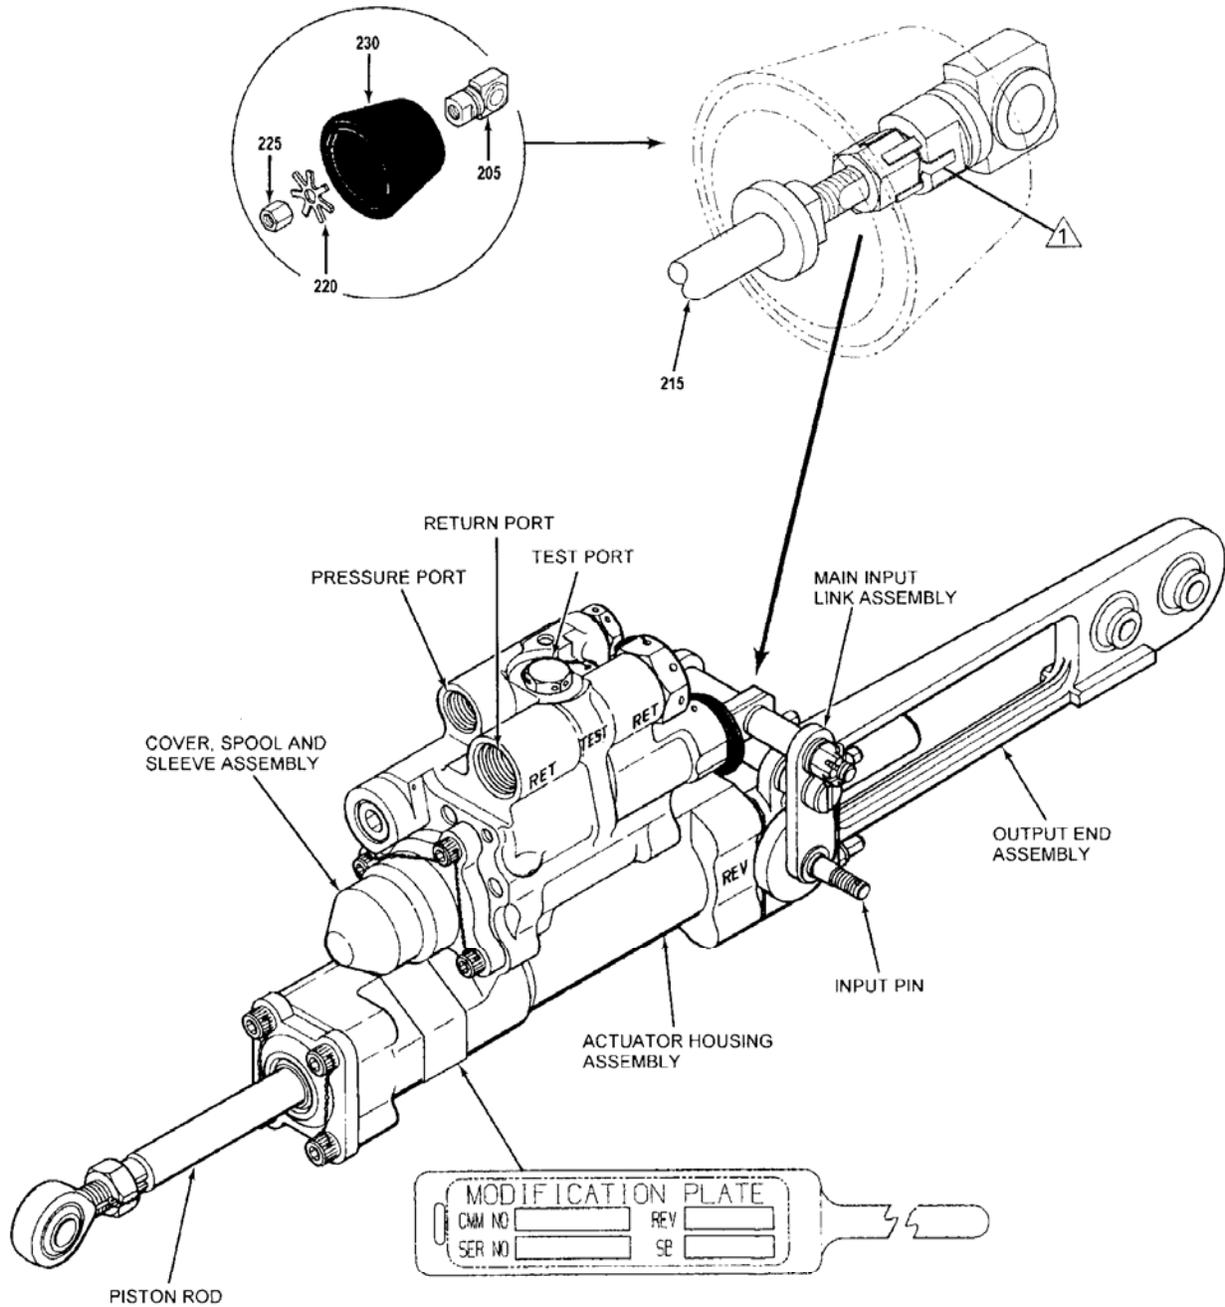
Clevis Assembly
Figure 1

1 ACCEPTABLE CONDITION
 A MINIMUM OF ONE TAB SHALL BE IN LINE AND BENT FLUSH WITH THE NUT FLAT SURFACE AND A MINIMUM OF ONE TAB SHALL BE IN LINE AND BENT FLUSH WITH THE CLEVIS ASSEMBLY FLAT SURFACE

(2) Applying only hand pressure, determine whether the nut, shaft, or clevis assembly, depicted as "225," "215," and "205," respectively, in Figure 1 of this AD, turns independently. If the shaft turns independently of the nut or the clevis assembly, before further flight, replace the servo with an airworthy servo.

(i) If at least one lock washer tab is not aligned and bent flush with a nut flat surface and at least one lock washer tab is not aligned and bent flush with a flat surface of the clevis assembly, before further flight, replace the servo with an airworthy servo.

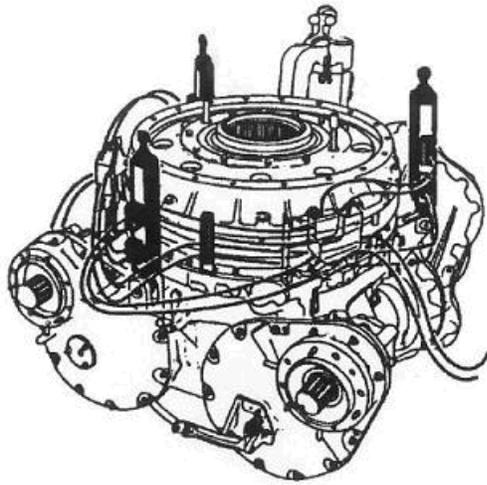
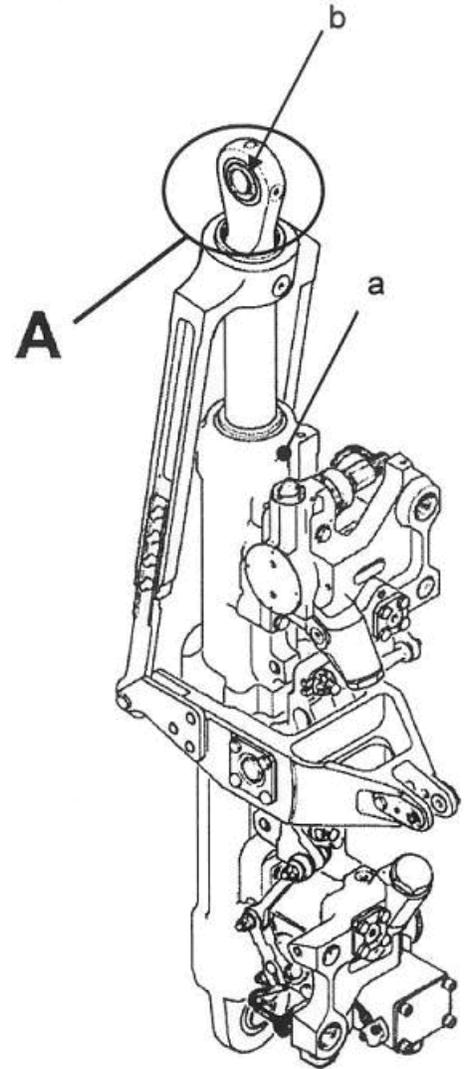
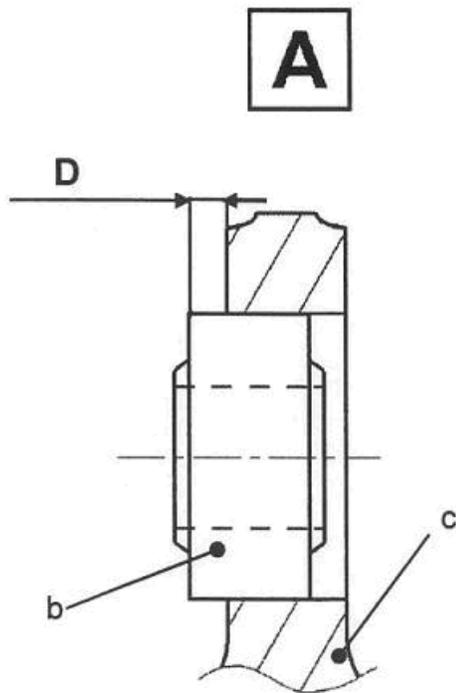
(a) Within 15 hours time-in-service (TIS), unless accomplished previously, using a feeler gage, measure the lateral play between the outer ring of the ball joint and each of the two faces of the upper end fitting as depicted in Figure 1 of this AD.

(b) If the lateral play is greater than or equal to 1 millimeter (MM) (0.04 inch) and the servocontrol has accumulated 825 or more hours TIS, before further flight, replace it with an airworthy servocontrol.

(c) If the lateral play is greater than or equal to 1 mm (0.04 inch) and the servocontrol has accumulated less than 825 hours TIS, on or before the servocontrol accumulates 825 hours TIS, replace it with an airworthy servocontrol.

(d) If the lateral play is less than 1 mm (0.04 inch), at intervals not to exceed 300 hours TIS, repeat the inspection required by paragraph (a) of this AD. At each 300 hour TIS interval inspection, if the lateral play is greater than or equal to 1 mm (0.04 inch), within 525 hours TIS, replace the servocontrol with an airworthy servocontrol.

Note 1: An acceptable method of returning the servocontrol to an airworthy condition for the purposes of this AD is by modifying the servocontrol and marking an "R" after the S/N by following Goodrich Service Bulletin (SB) No. SC7203-67-31-02, dated May 11, 2010, for servocontrol, P/N SC7203-1, or Goodrich SB No. SC72216739-02, dated May 11, 2010, for servocontrol, P/N SC7221 1. The Goodrich SBs are attached to Eurocopter Emergency Alert SB containing two numbers (67.00.40 and 67-00.27), dated June 15, 2010 as Appendix 1 and Appendix 2, respectively. None of these three SBs is incorporated by reference in this AD.
