**FEDERAL AVIATION ADMINISTRATION
AIRWORTHINESS DIRECTIVES
SMALL AIRCRAFT, ROTORCRAFT, GLIDERS,
BALLOONS, & AIRSHIPS**

BIWEEKLY 2009-13

2009-12-01 Bell Helicopter Textron, Inc.: Amendment 39-15924. Docket No. FAA-2009-15924; Directorate Identifier 2008-SW-44-AD.

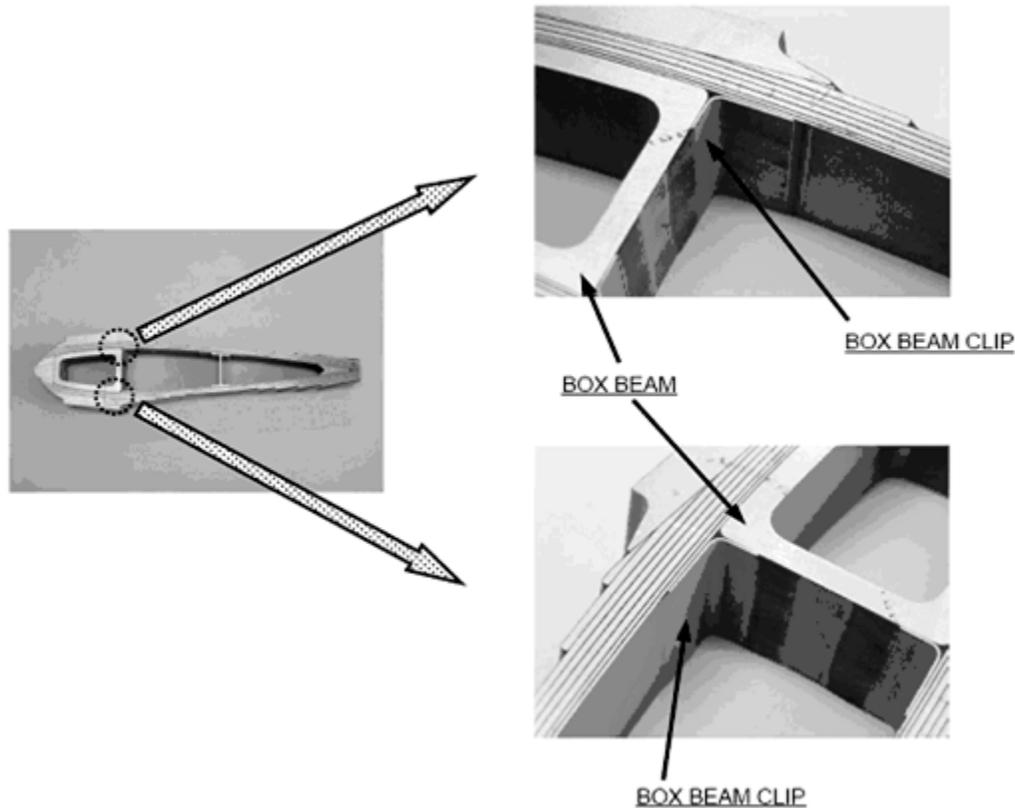
Figure 1 - Correct Installation of Clip for Box Beam

To prevent a main rotor blade spar crack as a result of an incorrectly installed main rotor blade box beam clip (clip), loss of a main rotor blade, and subsequent loss of control of the helicopter, do the following:

(a) Within 10 hours time-in-service (TIS), visually inspect the entire length of each upper and lower clip of each main rotor blade from the main rotor blade tip to the root by following Part II of the Accomplishment Instructions, paragraphs 1. through 8., of Bell Helicopter Textron, Inc. Alert Service Bulletin No. 47-08-25, dated May 26, 2008 (ASB) and referring to the depictions in Figures 1 and 2 of the ASB and Figure 1 of this AD for correct installation.

(b) Before further flight, if you find a main rotor blade with an incorrectly installed clip, replace that unairworthy main rotor blade with an airworthy main rotor blade that has a clip that is installed correctly.
