**FEDERAL AVIATION ADMINISTRATION
AIRWORTHINESS DIRECTIVES**

**SMALL AIRCRAFT
ROTORCRAFT, GLIDERS, BALLOONS, AND AIRSHIPS
BIWEEKLY 2010-22**

October 26, 2010

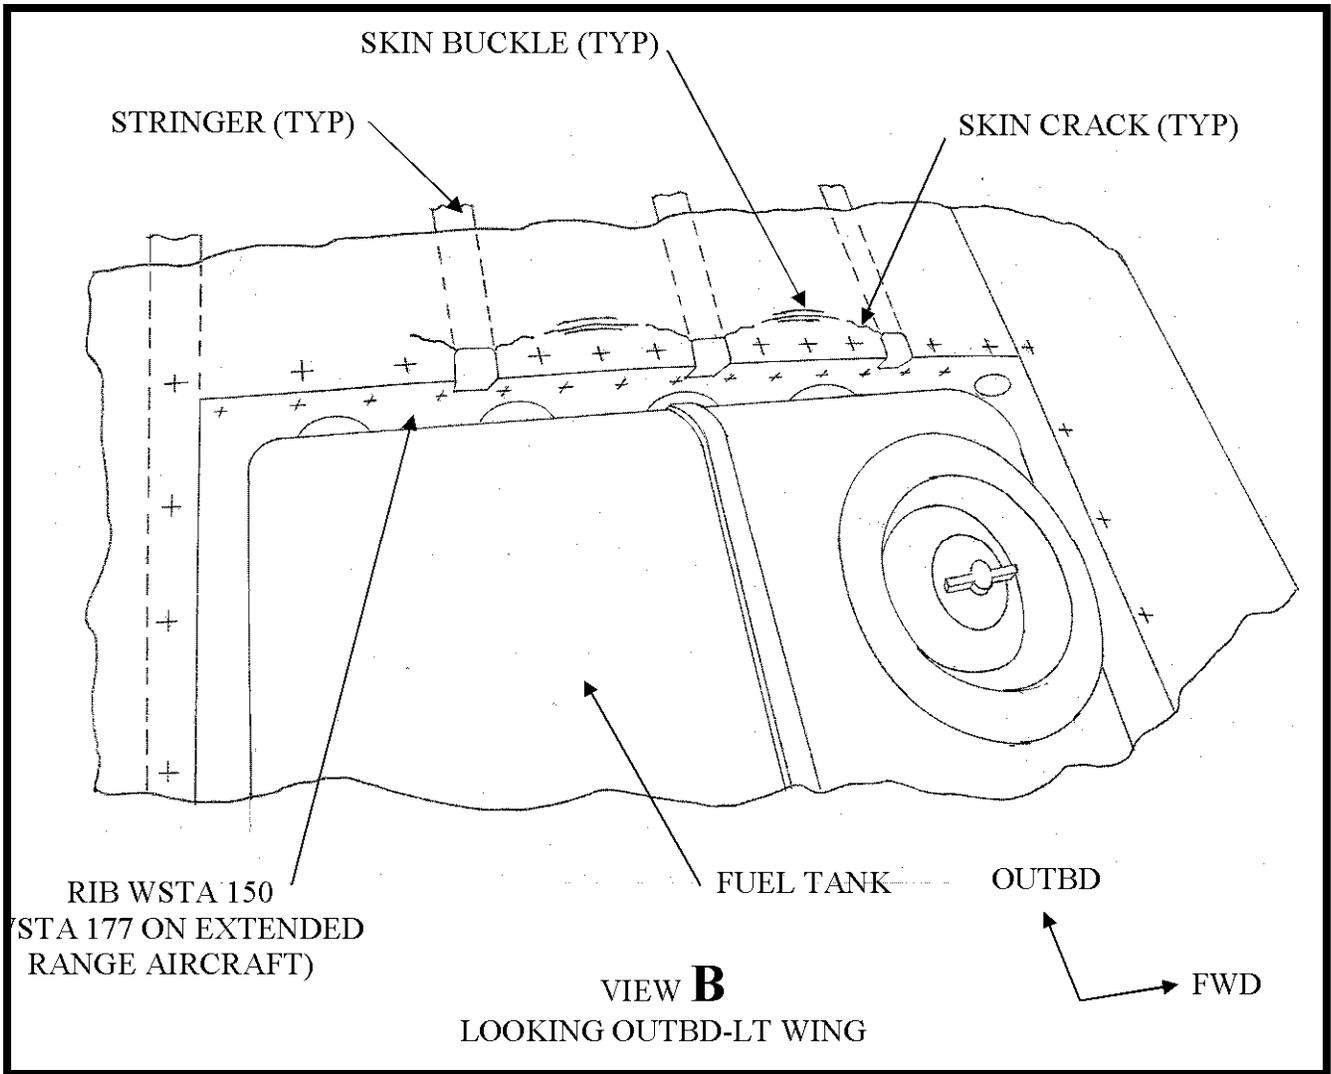
Figure 3

- (3) Cracking of the upper wing skins. Pay particular attention to any wrinkles, the radius between stiffeners at WSTA 150 (under fuel tank covers), and unreinforced access holes (See View B, Figure 3).

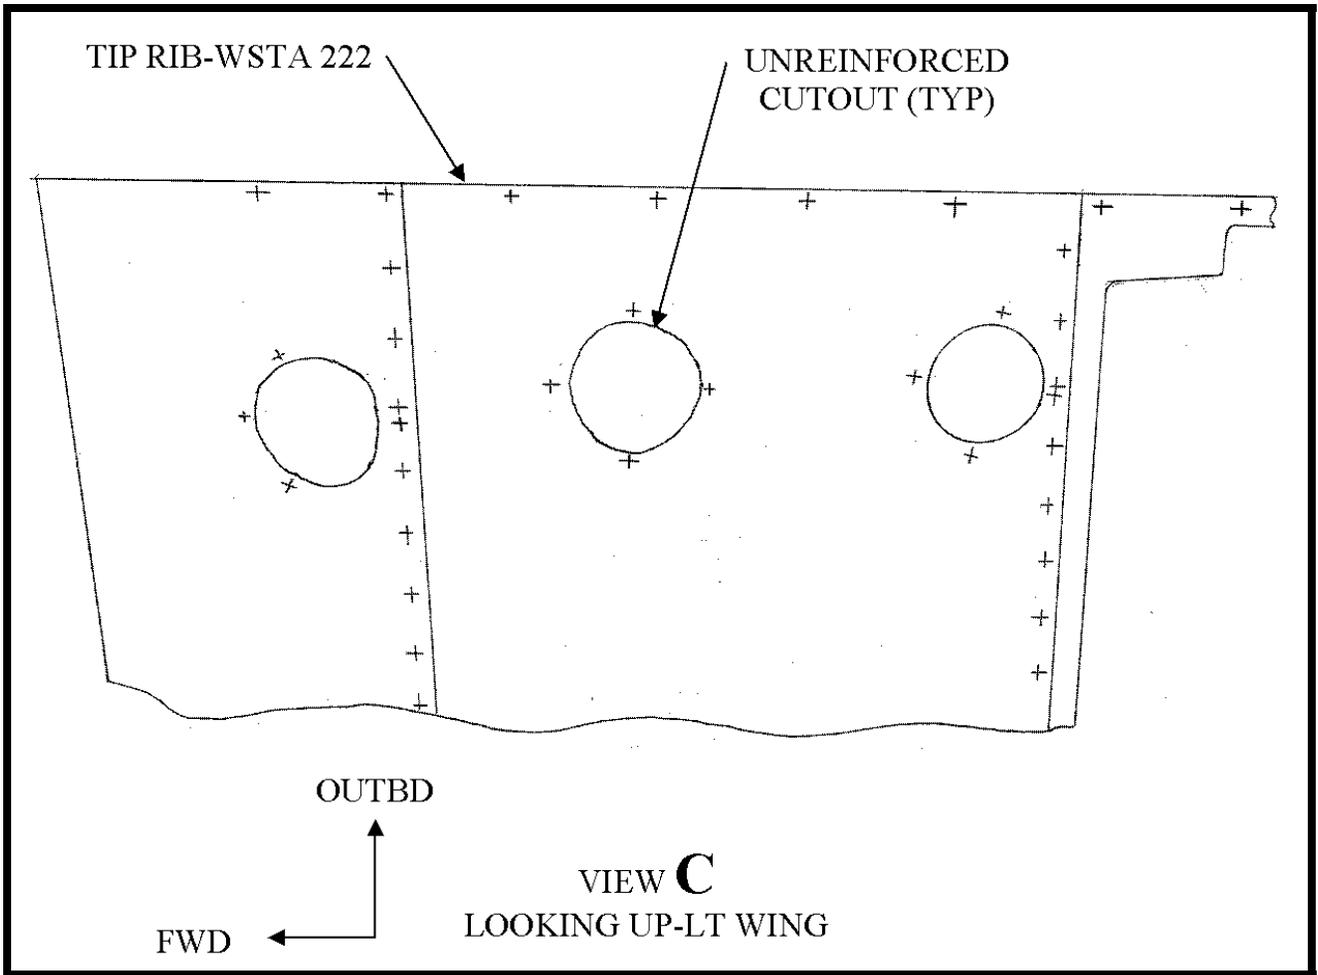
Figure 4

- (2) Inspect wing skins for unreinforced cutouts. (See View C, Figure 4).
- (3) Inspect the upper spar cap horizontal flanges for open holes (See View D, Figure 5).

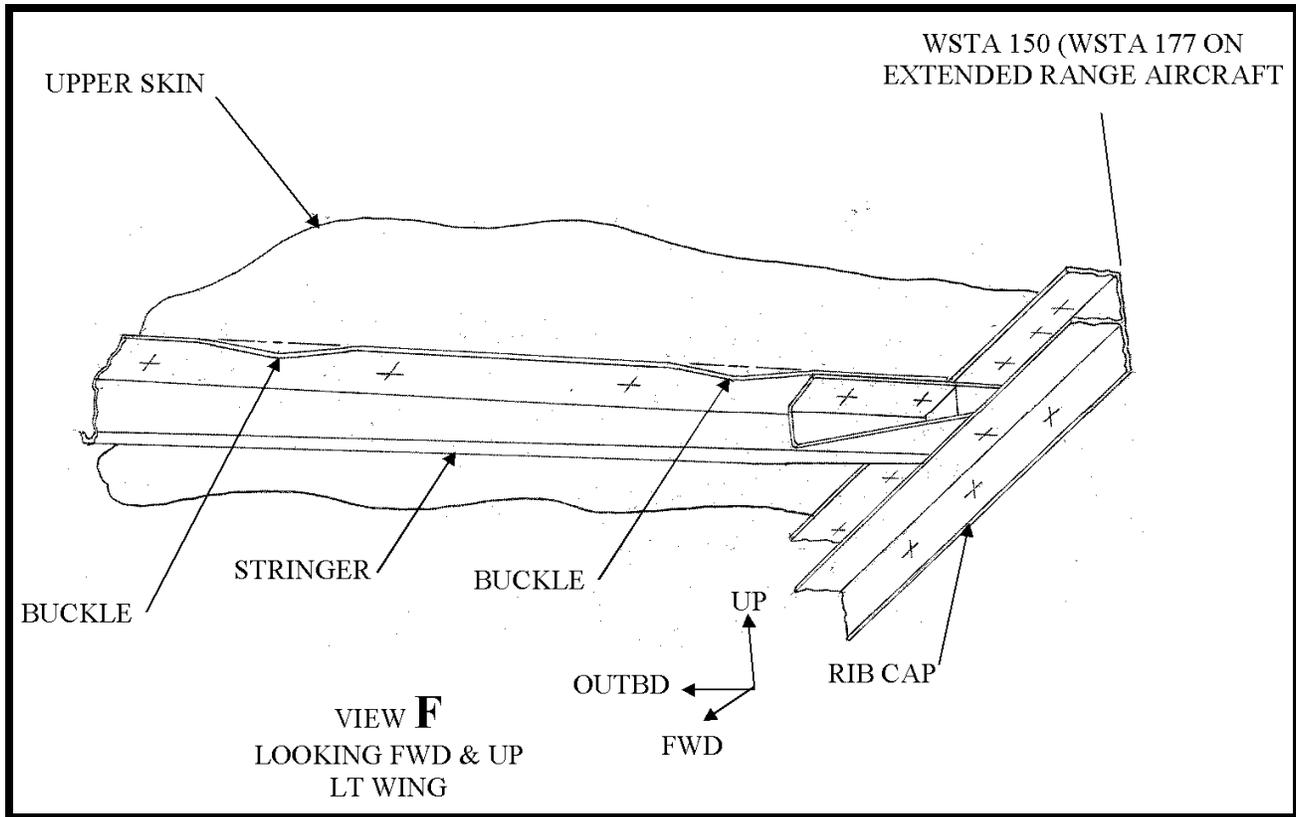
Figure 7

- (10) Inter-rivet buckling of the stringers attached to the upper surface skin, outboard of the fuel tank access covers (See View F, Figure 7).
- (11) Inspect rib at WSTA 222 for damage. Trimming of the rib may have been done to allow installation of fuel lines (See View A, Figure 2). Repair in accordance with AC 43.13-1B, Chapter 4, paragraph 4-58(g) and Figure 4-14, or by using another FAA-approved method that restores equivalent strength of the wing rib.
