**FEDERAL AVIATION ADMINISTRATION
AIRWORTHINESS DIRECTIVES
SMALL AIRCRAFT, ROTORCRAFT, GLIDERS,
BALLOONS, & AIRSHIPS**

BIWEEKLY 2010-26

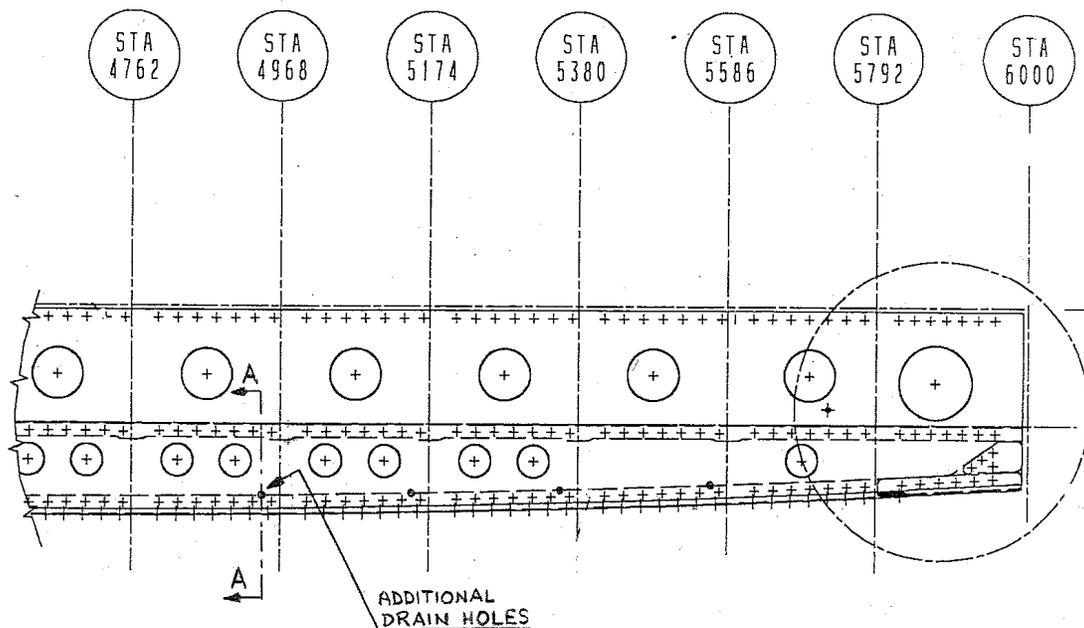
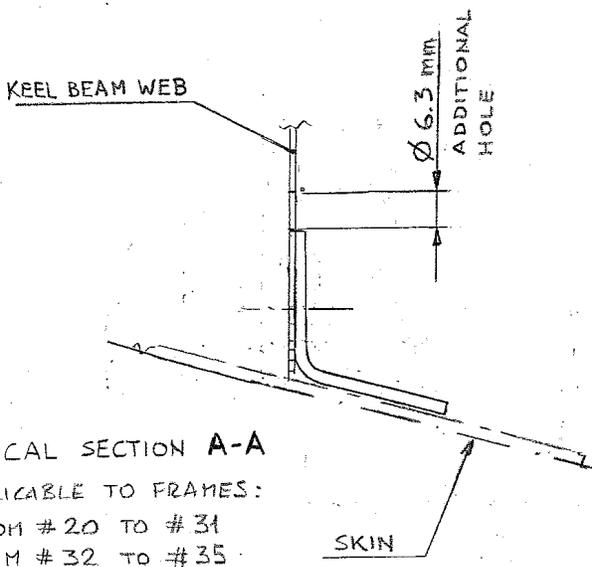
**Appendix 1 to Emergency AD 2011-01-26 (Continued)
Functional Test of the Fuselage Drain Holes**

(e) This emergency AD was prompted by three incidents of the flight controls jamming on Piaggio Model P-180 airplanes. This condition, if not corrected, could result in water or fluid accumulating and freezing when the aircraft reaches and holds altitudes where the temperature is below the freezing point. If not corrected, this may cause the flight controls to jam and result in loss of control.

Fig 1 - Additional drain holes on keel beam webs

9. Inspect the six (6) external drain holes:
 - a. Verify if they are clogged. If any drain hole is clogged, clean it.
 - b. Check for proper dimension (3.2 mm). Rework to nominal dimension any external drain hole that is found undersized. Protect the reworked drain hole by means of Alodyne. Take note of any drain hole found clogged and/or reworked, and of its position.
