DEPARTMENT OF TRANSPORTATION

Federal Aviation Administration

[Docket No. FAA-2012-1018; Directorate Identifier 2011-SW-052-AD; Amendment 39-17204; AD 2012-19-09]

Airworthiness Directives; Eurocopter France Helicopters

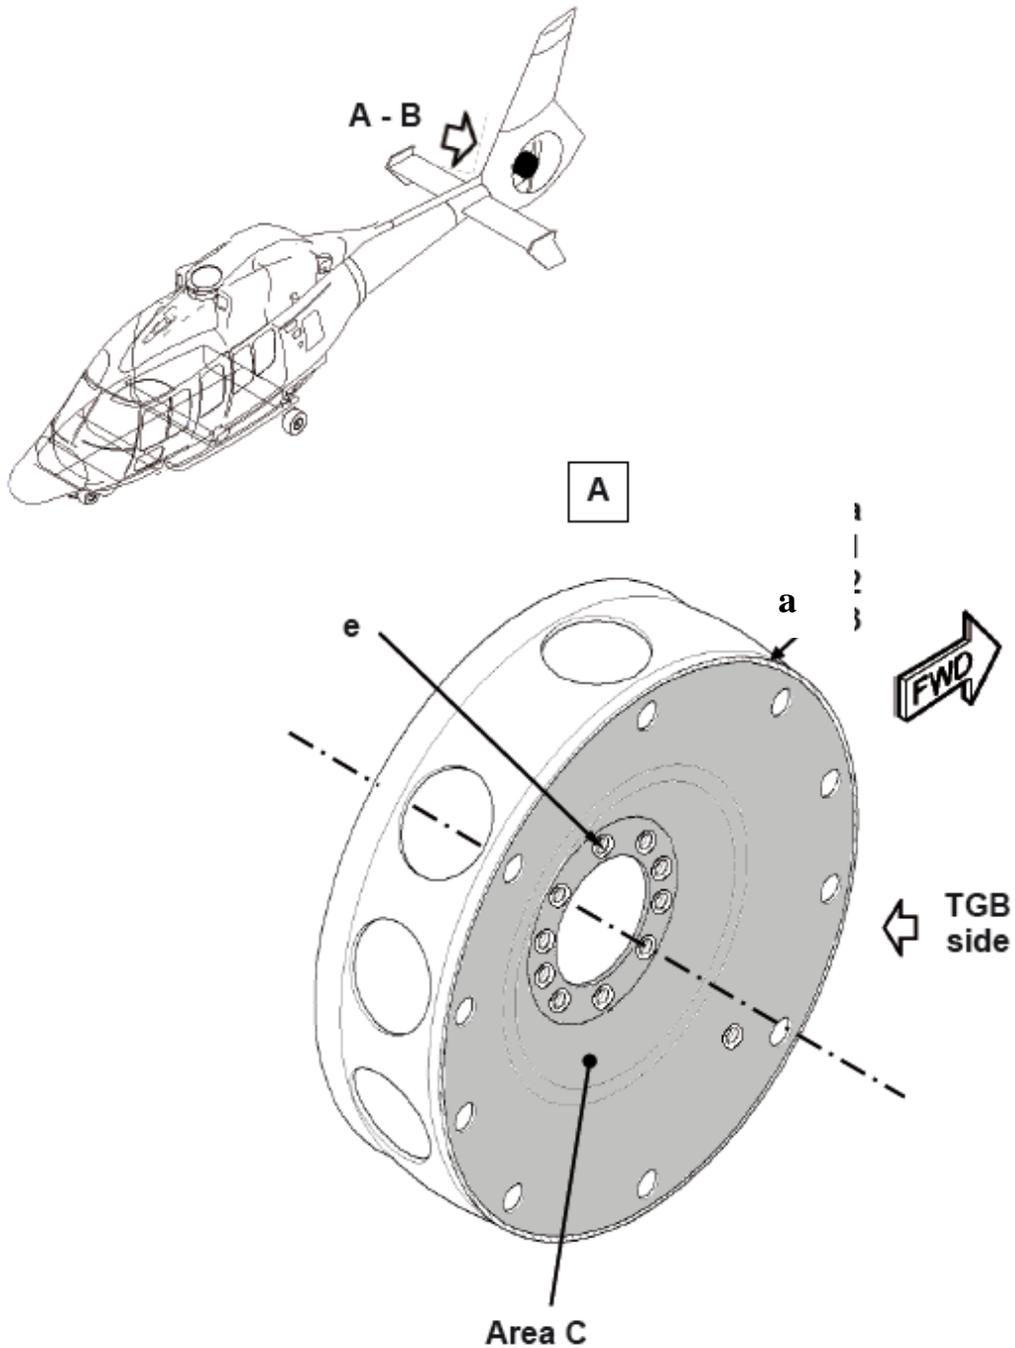
Figure 1 to Paragraph (e)(1) TRH Hub

(1) Within 55 hours time-in-service (TIS), and thereafter at intervals not to exceed 55 hours TIS, using a light, visually inspect the TRH for a crack in the entire area shown as Area C of the TRH (a) in Figure 1 to paragraph (e)(1) of this AD. The inspection area is on the tail gearbox (TGB) side of the TRH. The TGB is shown as (c) in Figures 2 and 3 to paragraph (e)(1) of this AD. You must pay particular attention to the area around the screws, shown as (e) in Figure 3 to paragraph (e)(1) of this AD, and the TRH between the lower part of the TGB and its fairing, shown as (d) in Figures 2 and 3 to paragraph (e)(1) of this AD, using details D and E of Figure 3 to paragraph (e)(1) of this AD. You must turn the tail rotor by hand to inspect the entire Area C.

(2) If there is a crack on the TRH, remove the TRH from service.
