[Docket No. FAA-2013-0146; Directorate Identifier 2012-SW-060-AD; Amendment 39-17559; AD 2013-16-21]

Airworthiness Directives; Agusta S.p.A. (Type Certificate Currently Held by Agusta Westland S.p.A) (Agusta) Helicopters

ACTION: Final rule.

2013-16-21 AGUSTA S.p.A. (Agusta): Amendment 39-17559; Docket No. FAA-2013-0146; Directorate Identifier 2012-SW-060-AD.

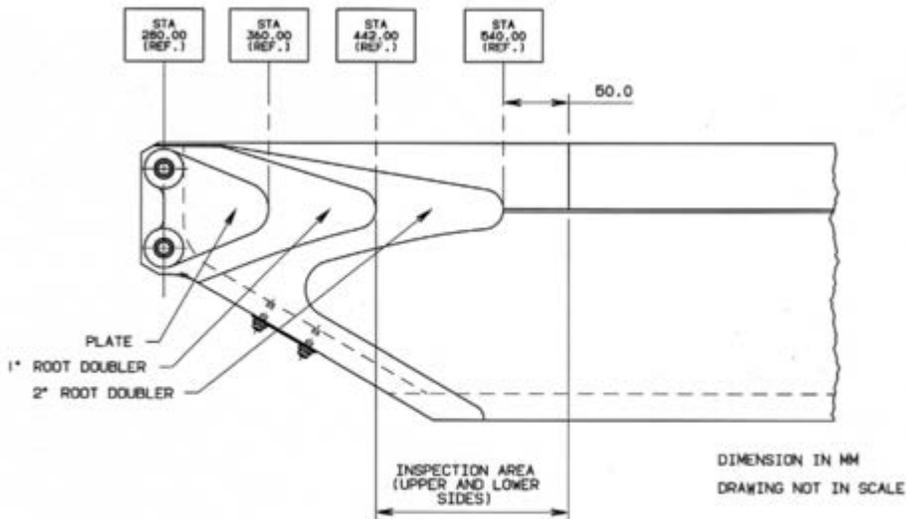
Figure 1 to Paragraph (f)(1), T/R Blade, P/N 109-8132-01-111

This AD defines the unsafe condition as a fatigue crack in a T/R blade. This condition could result in failure of the T/R blade and subsequent loss of control of the helicopter.

(1) Before each start of the helicopter engines, visually check both sides of each T/R blade for a crack in the inspection area depicted in Figure 1 to paragraph (f)(1) of this AD. This action may be performed by the owner/operator (pilot) holding at least a private pilot certificate, and must be entered into the aircraft records showing compliance with this AD in accordance with 14 CFR 43.9 (a)(1)-(4) and 14 CFR 91.417(a)(2)(v). The record must be maintained as required by 14 CFR 91.417, 121.380, or 135.439.

(5) If there is a crack in a T/R blade, before further flight, replace the cracked T/R blade.
