# **EMERGENCY**

## **AIRWORTHINESS DIRECTIVE**

**AD #:** 2012-10-51

2012-10-51 **EUROCOPTER DEUTSCHLAND GMBH (ECD)**: Directorate Identifier 2012-SW-041-AD.

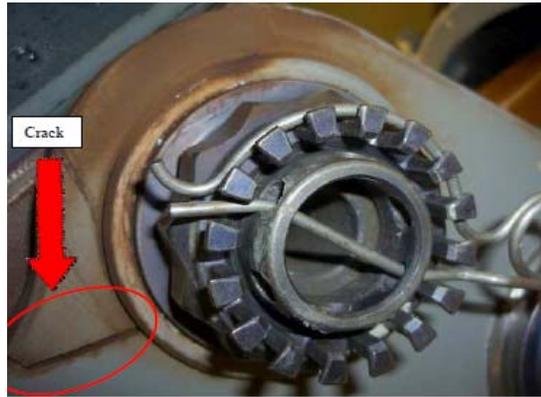
**Figure 1**

(1) Before further flight, and thereafter before the first flight of each day, check the lower hub-shaft flange for a crack and each blade attachment bolt for a deformed safety pin by reference to figures 1 and 2 of this EAD. The actions required by this paragraph may be performed by the owner/operator (pilot) holding at least a private pilot certificate, and must be entered into the aircraft records showing compliance with this EAD in accordance with 14 CFR §§ 43.9 (a)(1)-(4) and 14 CFR § 91.417(a)(2)(v). The record must be maintained as required by 14 CFR §§ 91.417, 121.380, or 135.439.

(iii) Inspect safety pins for deformation as shown in figure 1 of this EAD.

(4) If there is a crack in the upper or lower hub-shaft flange, before further flight, replace the main rotor hub-shaft.

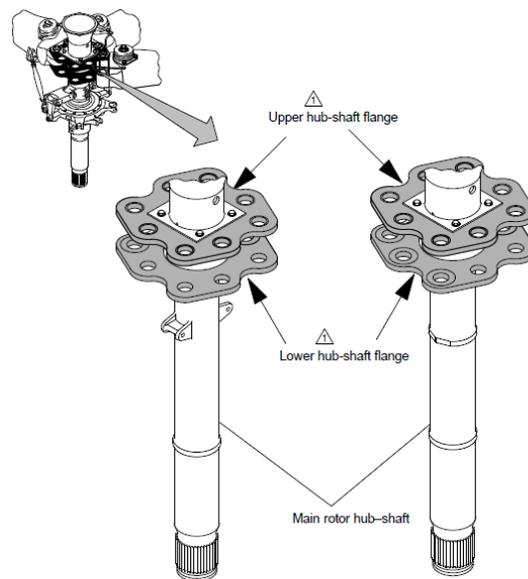
**Figure 3**

(ii) Clean the upper and lower hub-shaft flange as depicted in figure 3 of this EAD and visually inspect for a crack.

⚠ Check visible area of the upper and lower hub-shaft flange.
