Airworthiness Directives; Eurocopter France Helicopters

[Docket No. FAA-2012-1297; Directorate Identifier 2012-SW-100-AD; Amendment 39-17285; AD 2012-25-04]

2012-25-04 Eurocopter France: Amendment 39-17285; Docket No. FAA-2012-1297; Directorate Identifier 2012-SW-100-AD.

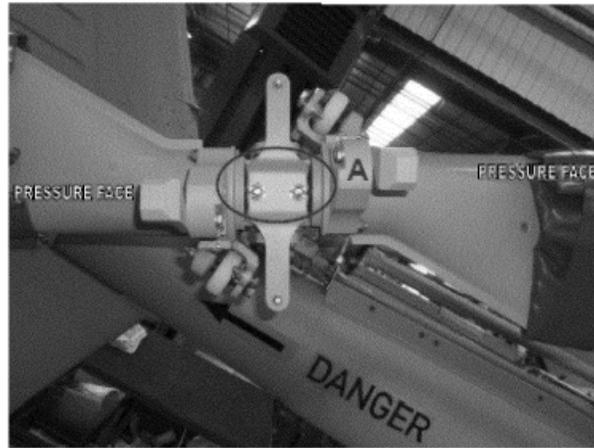
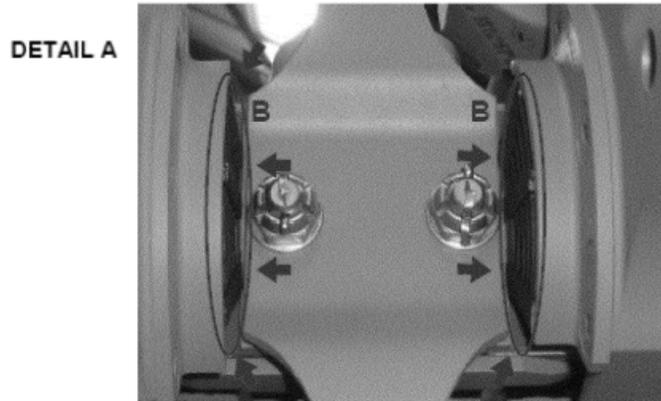
(ii) Apply load (F) by hand, perpendicular to the pressure face of one tail rotor blade (a), as shown in Figure 1 to paragraph (f) of this AD, taking care not to reach the extreme position against the tail rotor hub. The load will deflect the tail rotor blade towards the tail boom.

(iii) While maintaining the load, check all the visible faces of the bearings (front and side faces) in area B of DETAIL A of Figure 1 to paragraph (f) of this AD for separation between the elastomer and metal parts, a crack in the elastomer, or an extrusion (see example in Figure 2 to paragraph (f) of this AD). A flashlight may be used to enhance the check.

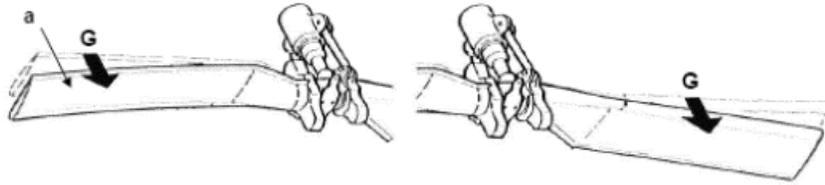
- (iv) Repeat paragraphs (f)(3)(i) through (f)(3)(iii) on the other tail rotor blade.
- (v) Apply load (G) by hand perpendicular to the suction face of one tail rotor blade as shown in Figure 3 to paragraph (f) of this AD. The load will deflect the tail rotor blade away from the tail boom.

(vi) While maintaining the load, check visible faces of Area C as shown in Figure 3 to paragraph (f) of this AD for any extrusion. A flashlight may be used to enhance the check.

(5) If there is an extrusion on any bearing, before further flight, replace the four bearings with airworthy bearings.

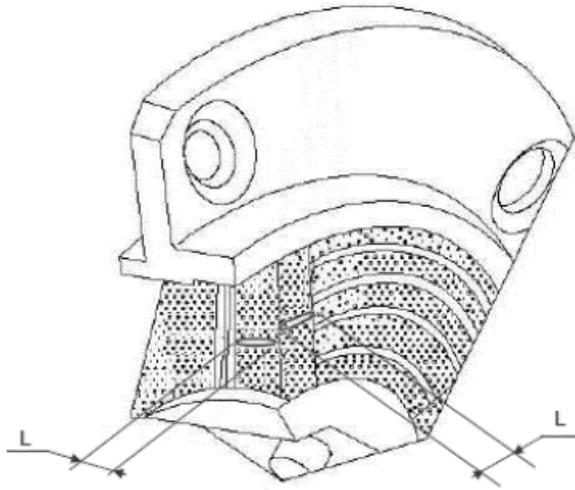
Figure 4 to paragraph (f)

(6) If there is a separation or a crack on the pressure side bearing, measure the separation or the crack. If the separation or crack is greater than 5 millimeters (.196 inches) as indicated by dimension "L" in Figure 4 to paragraph (f), before further flight, replace the four bearings with airworthy bearings.
