SAIB: NM-16-24

Date: September 15, 2016

SUBJ: Fuselage: Main Plate/Skin

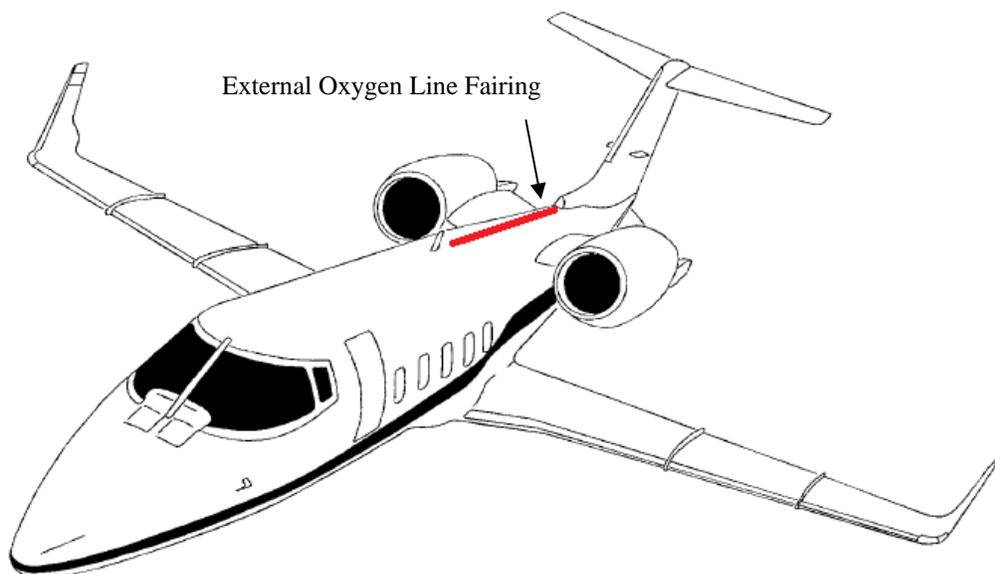
We have received reports of skin corrosion found under the external oxygen line fairing located on the top aft section of the fuselage of certain Learjet Inc. Model 35 airplanes. The external oxygen line provides oxygen from the oxygen bottle located in the dorsal fin to the occupants in the cabin. Airplanes with the oxygen tank mounted in the dorsal fin will have the external oxygen line on top of the fuselage covered by a fairing. Airplanes that retain the oxygen line fairing on top of the fuselage, even though the oxygen bottles have been removed from the dorsal fin, are also affected. Removal of the fairing, oxygen line and supporting brackets is necessary to detect the full extent of fuselage skin corrosion. The same oxygen line fairing design is installed on the other airplane models identified above.

The FAA recommends that owners/operators of the affected airplanes accomplish the following service information:

Learjet 25 Service Bulletin SB 25-53-4 dated November 23, 2015, Revision 1, dated April 4, 2016, or Revision 2, April 18, 2016 (or later approved revisions) “Fuselage – Inspection of Upper Fuselage Skin under the Aft Oxygen Line Fairing”

Learjet 28/29 Service Bulletin SB 28/29-53-4 dated November 23, 2015, Revision 1, dated April 4, 2016, or Revision 2, dated April 18, 2016 (or later approved revisions) “Fuselage – Inspection of Upper Fuselage Skin under the Aft Oxygen Line Fairing”

Learjet 31 Service Bulletin SB 31-53-12 dated November 23, 2015, Revision 1, dated April 4, 2016, or Revision 2, dated April 18, 2016 (or later approved revisions) “Fuselage – Inspection of Upper Fuselage Skin under the Aft Oxygen Line Fairing”

Learjet 35/36 Service Bulletin SB 35/36-53-15 dated November 23, 2015, Revision 1, dated April 4, 2016, or Revision 2, dated April 18, 2016 (or later approved revisions) “Fuselage – Inspection of Upper Fuselage Skin under the Aft Oxygen Line Fairing”

Learjet 55 Service Bulletin SB 55-53-13 dated November 23, 2015, Revision 1, dated April 4, 2016, or Revision 2, dated April 18, 2016 (or later approved revisions) “Fuselage – Inspection of Upper Fuselage Skin under the Aft Oxygen Line Fairing”

We also recommend that owners and operators report the results of each inspection to Learjet (even if no corrosion is found) using the Compliance Response Form in the service bulletins. In addition, if any of the skin thickness values fall below the minimum thickness table in Chapter 53 of the Learjet Structural Repair Manual, report the corrosion details to Learjet Customer Support Engineering or Customer Response Center (CRC) 1-866-538-1247 (Toll Free) / 1-514-855-2999.
