CE-05-52  
May 9, 2005

# SPECIAL AIRWORTHINESS INFORMATION BULLETIN

This Special Airworthiness Information Bulletin (SAIB) alerts you, owners and operators of **Apex Aircraft model CAP 10 B airplanes**, that the Direction Generale De L'Aviation Civile (DGAC), airworthiness authority for France, issued French Airworthiness Directive (AD) No. F-2004-144 dated August 28, 2004. This AD affects serial numbers (SN) 300 through 310, SN 312 & 313, and all SNs up to and including 299 that are changed under "CAP 10C wing" modification 000302.

APEX Aircraft Bureau de Navigabilité 1, route de Troyes 21121 DAROIS - France Tél +33 380 35 65 10 Fax +33 380 35 65 15 www.apex-aircraft.com	<h1>SERVICE BULLETIN</h1> <p>No. <b>031101</b></p>
<b>CAP10B - Flight controls - Aileron bellcrank pivot bolt replacement</b>	
Supersedes : N/A

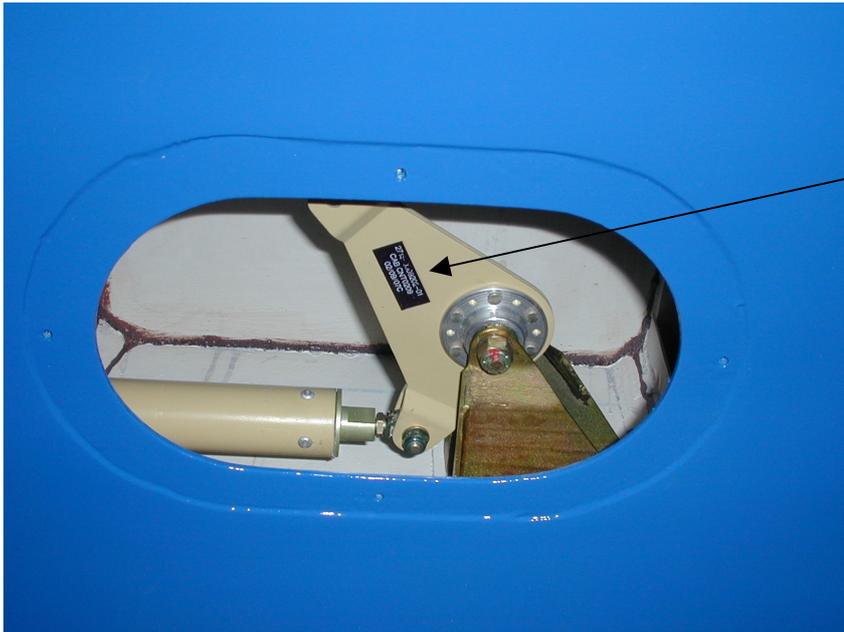
Aileron bellcrank

Remove doors to access to aileron bellcranks on both wings:

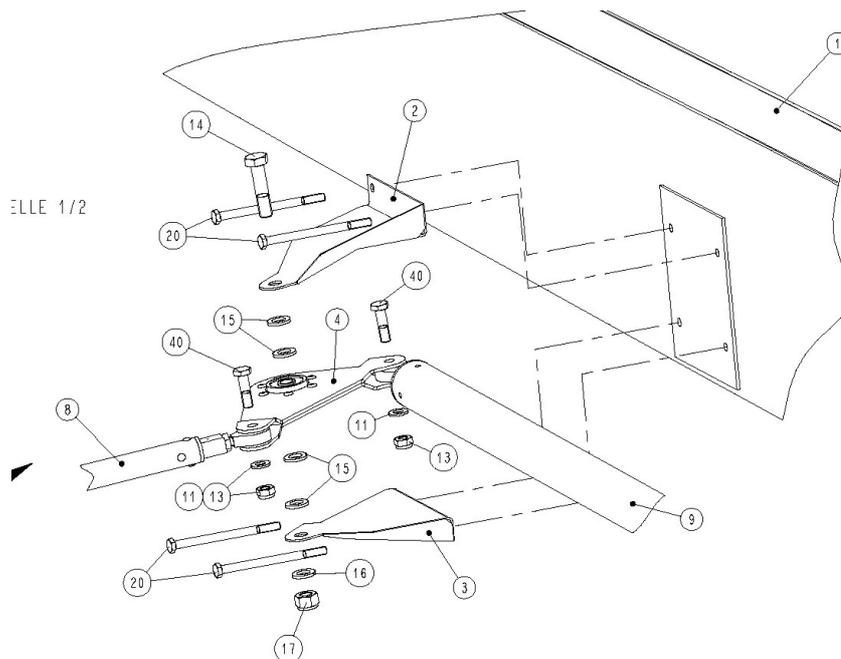
During rapid descent, vibrations have been observed in the aileron system of a CAP10C (300 flight hours). The vibrations have not led to loss of control.

The aileron bellcrank (item 4) is fixed on 2 brackets by means of an AN5-12A bolt (item 14). Two washers (AN960-516) are installed on each side of the aileron bellcrank (item 15).

- Replace the AN5-12A bolt (item 14) with an AN5-13A bolt (the latter being longer).
- Replace each set of two AN960-516 washers (item 15) with one spacer 2714-0311003 (Apex part number).
- Also replace the washer (item 16) with a spacer 2714-0311003.
- Replace the bolt and washers on left hand and right hand wings.
