SPECIAL AIRWORTHINESS INFORMATION BULLETIN

NM-05-53
May 18, 2005

RJ-SL-27-085

SUBJECT: Horizontal Stabilizer Trim Control System. Disconnect Switch Sensitivity Test

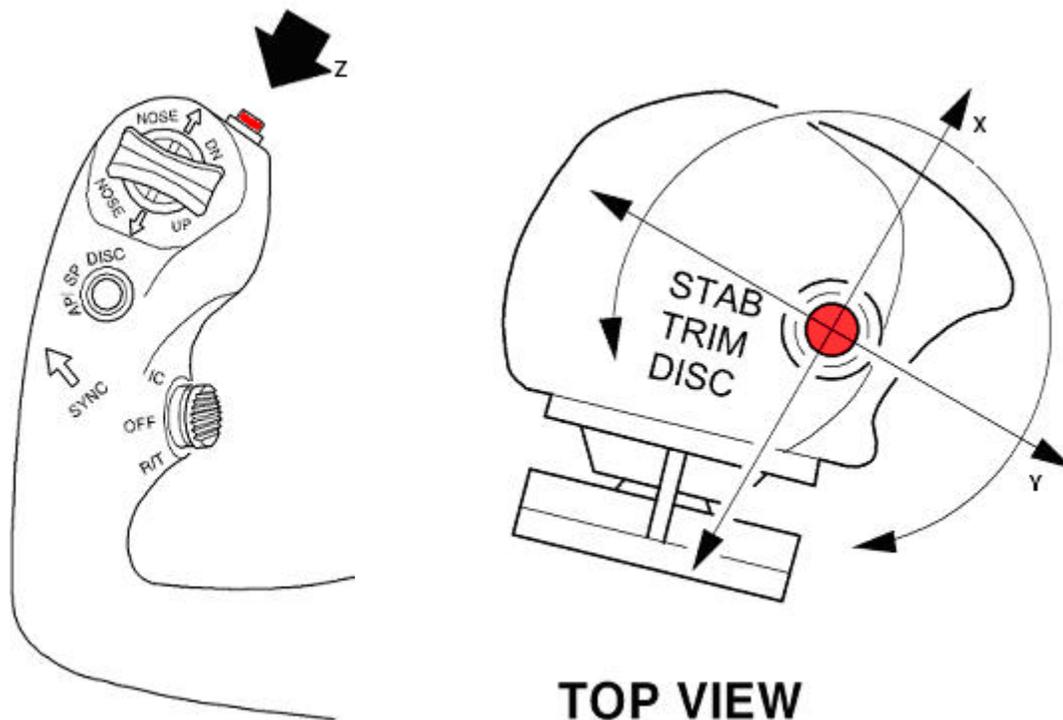
Figure 1-2: HSTCS Disconnect Switch Sensitivity Test

Pass	
		Yes	No
6.1	Without depressing the disconnect switch (no click, <u>no</u> movement in the z axis), apply lateral pressure on the side of the switch in different directions (x and y axis) as per Figure 1-2, monitoring for STAB TRIM, STAB CHAN 1 INOP or STAB CHAN 2 INOP messages on the EICAS displays.

6.2	Without depressing the disconnect switch (no click, <u>no</u> movement in the z axis), rotate the disconnect switch with a pivotal action on its axis several times in each direction as per Figure 1-2, monitor for STAB TRIM, STAB CHAN 1 INOP or STAB CHAN 2 INOP messages on the EICAS displays.

7.0	If any of the EICAS messages (STAB TRIM, STAB CHAN 1 INOP or STAB CHAN 2 INOP) are posted during the test, replace the applicable disconnect switch with a new one as per AMM TASK 27-41-30-000-802, "Removal of the Pitch Disconnect Switch", and AMM TASK 27-41-30-400-802, "Installation of the Pitch Disconnect Switch"
