SUBJ: Engine Mount Section

This Special Airworthiness Information Bulletin (SAIB) informs registered owners/operators of **M7 Aerospace LP SA226-T, SA226-AT and SA226-TC** model airplanes (under Type Certificate Data Sheets **A5SW and A8SW**) of an airworthiness concern. Specifically, this SAIB provides guidance on new procedures for inspection and modification of the left and right (LH/RH) engine mount lower truss assemblies for cracks.

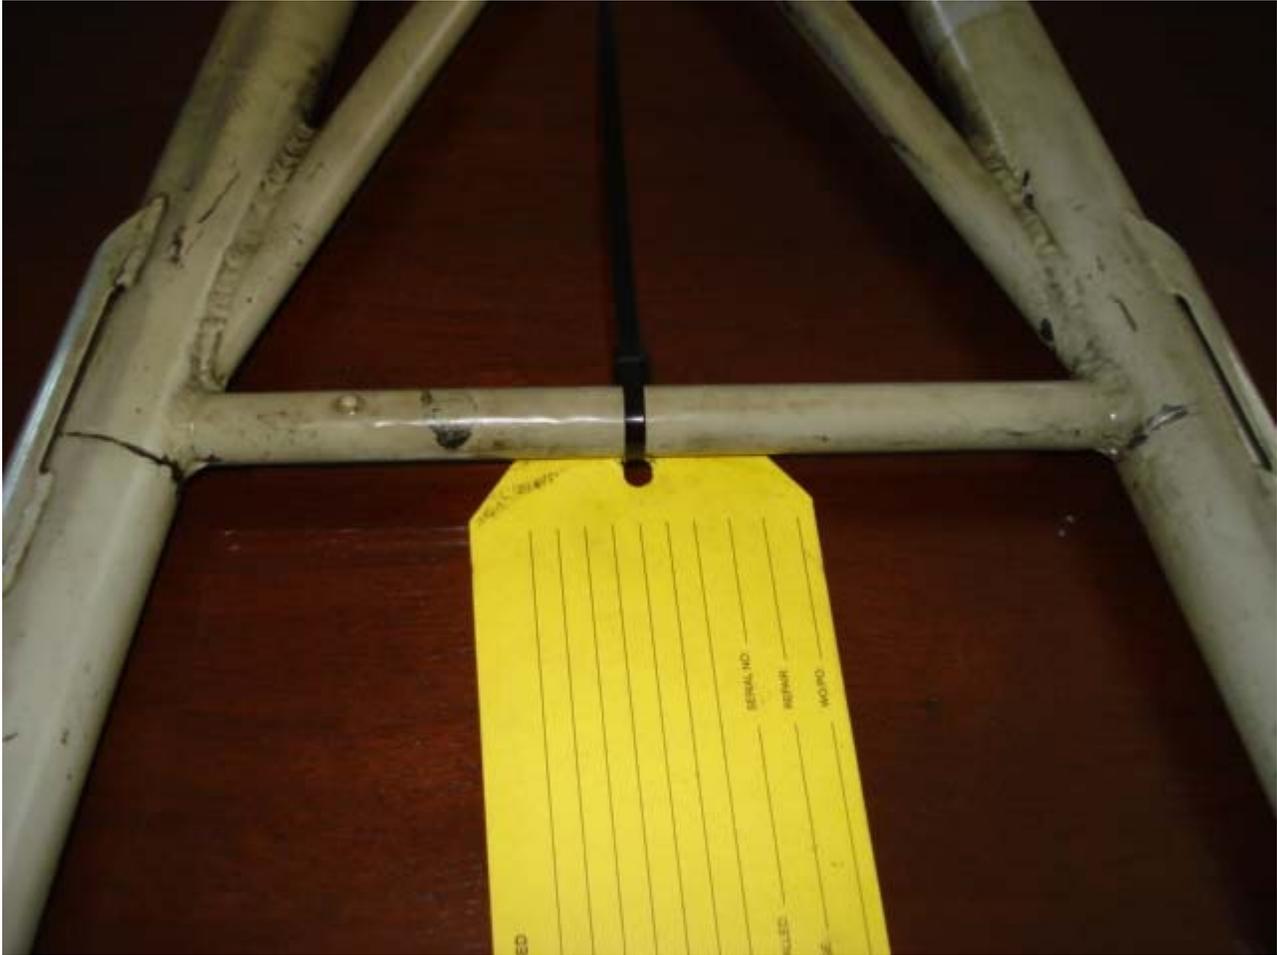
The Federal Aviation Administration (FAA) recently received reports of cracking in two engine mount lower truss assemblies P/N 27-62010 on M7 Aerospace LP model SA226 airplanes. The cracking was found adjacent to the weld affected zone where the main and lateral tubes intersect (see picture at end of this document).

The Federal Aviation Administration (FAA) recommends you inspect your M7 Aerospace LP model SA226 airplane engine mount lower truss assemblies, P/N 27-62010 at the time intervals and using the inspection procedures directed in SB 226-71-018, and to install the modification in SB 71-009 if not already accomplished. Replace any engine mount truss assembly found cracked during any inspection prior to continued flight.
