<b>SNOW ENGINEERING CO.</b> WICHITA FALLS, TEXAS	<b>ENGINEERING</b>		NUMBER #297
	<b>REPORT ORDER</b>		MODEL All
TITLE  SERVICE LETTER #297	BY Kyle Schroeder JH	CHK'D <input checked="" type="checkbox"/>	SERIAL All
	DATE 3/10/11		PAGE 1 OF 1

Engine Mount Tube Inspections

AT-400, AT-400A, AT-402, AT-402A, AT-402B  
 All serial numbers

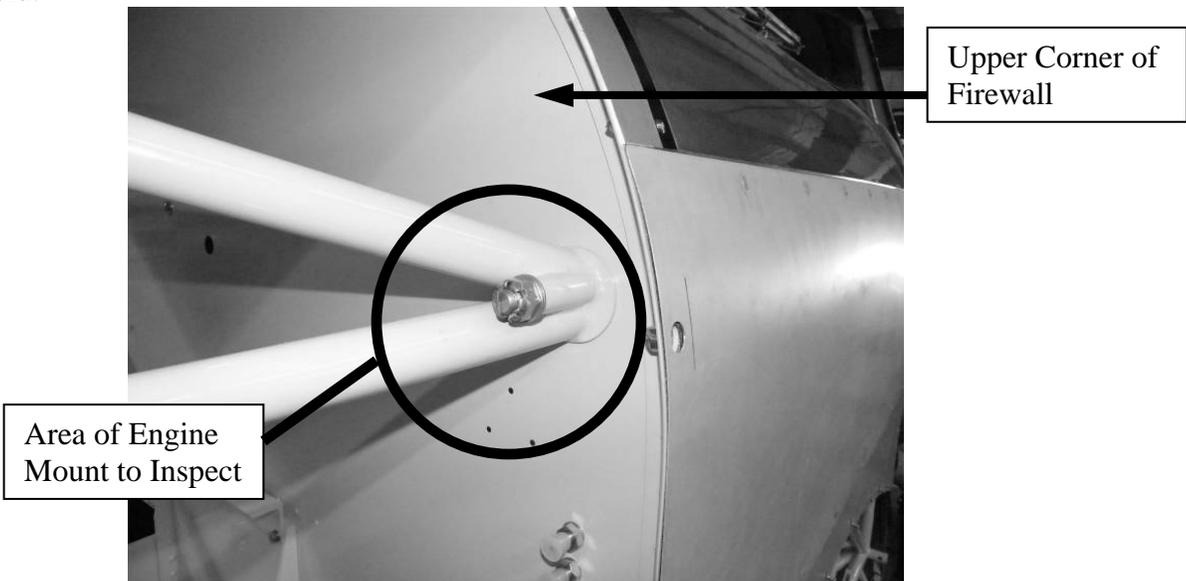
A crack has been reported in an engine mount tube on an AT-402 aircraft. The crack was located near the upper left firewall attachment of the engine mount and was found to be cracked approximately 75% of the way around the diagonal tube. This crack started at the tip of the weld for the mount bushing.

Remove the side cowl skins on both sides of the aircraft and thoroughly check the area shown below (on both sides of the aircraft) for any cracks or serious corrosion. The likely place for cracks to start is at the tip of the weld.

Perform all visual inspections per FAA Advisory Circular 43.13, Chapter 5, Section 2 “Visual Inspection”. If a crack or serious corrosion is found, please contact Air Tractor customer service at (940)564-5616 to have the issue evaluated.
