**SAIB: CE-07-18**

**Date:** March 14, 2007

This Special Airworthiness Information Bulletin (SAIB) informs you, a registered owner and/or operator of **Raytheon Aircraft Company Models, T-34A, T-34B, L-23B, 45, 35, 95, A95, B95, B95-A, 95-55, and 95B55 airplanes** with production parts that may have escaped the Raytheon Aircraft Company Quality Control System with potential problems as noted.

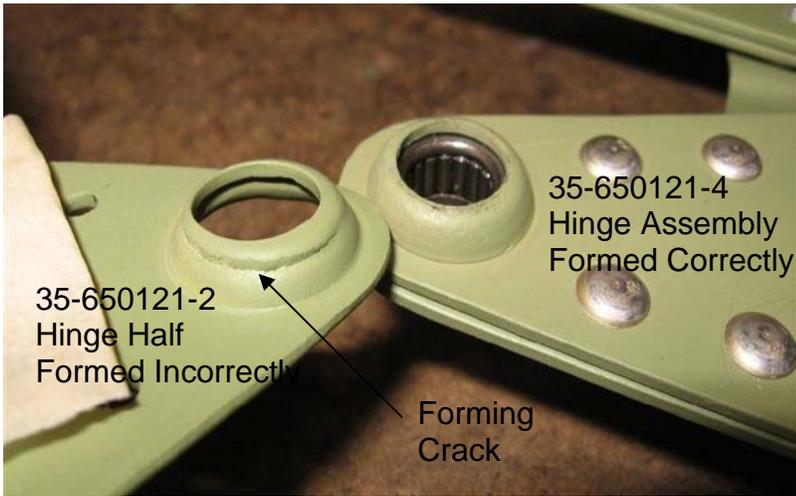
Figure 1. Hinge Half and Hinge Assembly

The parts are typically hinge halves for various control surfaces. Figures 1, 2, and 3 show the typical parts and assemblies and where the forming thinning, necking, and cracking are occurring. Parts, other than those shown in the figures, which may exhibit these production flaws are:

The FAA recommends that owners and operators inspect the elevator and rudder control surface hinge halves for proper part forming if parts were replaced after February of 2001. Figures 1, 2, & 3 show examples of incorrectly formed hinge halves. These examples exhibit thinning, necking, and possible cracking. If hinge halves are found with these forming deformities, then the hinge halve or hinge assembly needs to be replaced. The manufacture has not issued any service information on this condition.

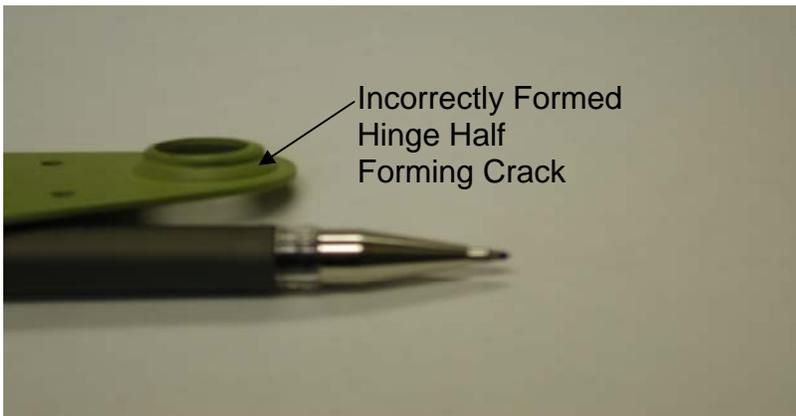
Figure 3. Hinge Half with forming crack
