SPECIAL AIRWORTHINESS INFORMATION BULLETIN

CE-05-54
May 24, 2005

This Special Airworthiness Information Bulletin (SAIB) alerts you, owners and operators of **Apex Aircraft model CAP 10 B airplanes** that the airworthiness authority for France, issued French Airworthiness Directive (AD) No. F-2004-108, dated July 7, 2004. This AD concerns CAP 10B aircraft from serial number 300 (included) or modified in accordance with modification 000302 "CAP 10C Wing".

APEX Aircraft Bureau de Navigabilité 1, route de Troyes 21121 DAROIS - France Tél +33 380 35 65 10 Fax +33 380 35 65 15 www.apex-aircraft.com	<h1 style="margin: 0;">SERVICE BULLETIN</h1> <h2 style="margin: 0;">No. 040506</h2>
CAP10C – MAIN LANDING GEAR – Torque link attaching weld	ATA : 32
Supersedes : N/A

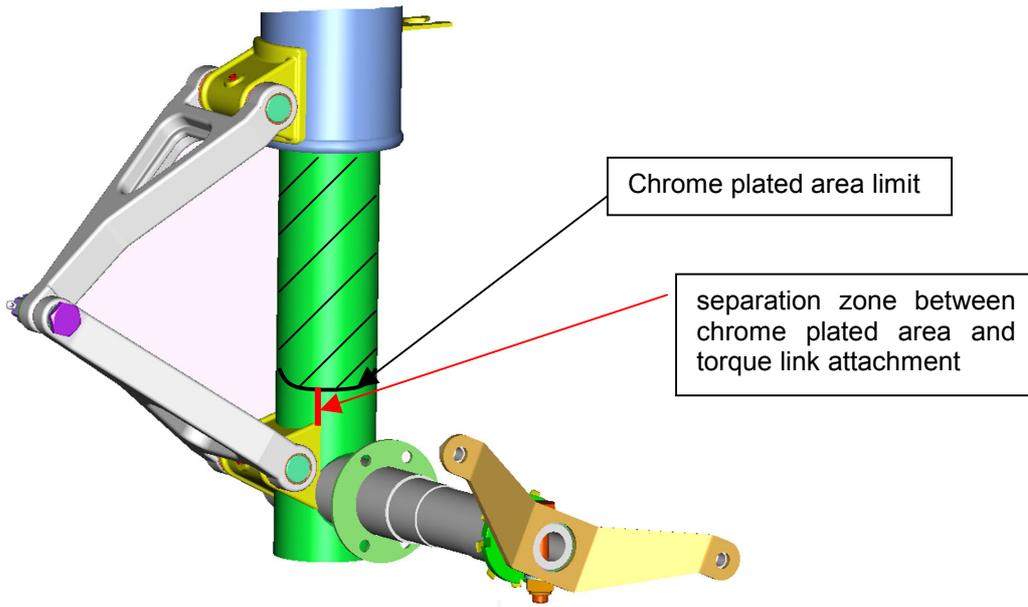
2. Determining the landing gear concerned

Main landing gears are concerned when the separation zone between the chrome plated area of the moving strut and the torque link attachment is too small.

Inspection described in § 3 following, is to be performed whenever separation zone is less than 1 mm (0.04 in).

Landing gear is not concerned when the separation zone is at least 1 mm (0.04 in).

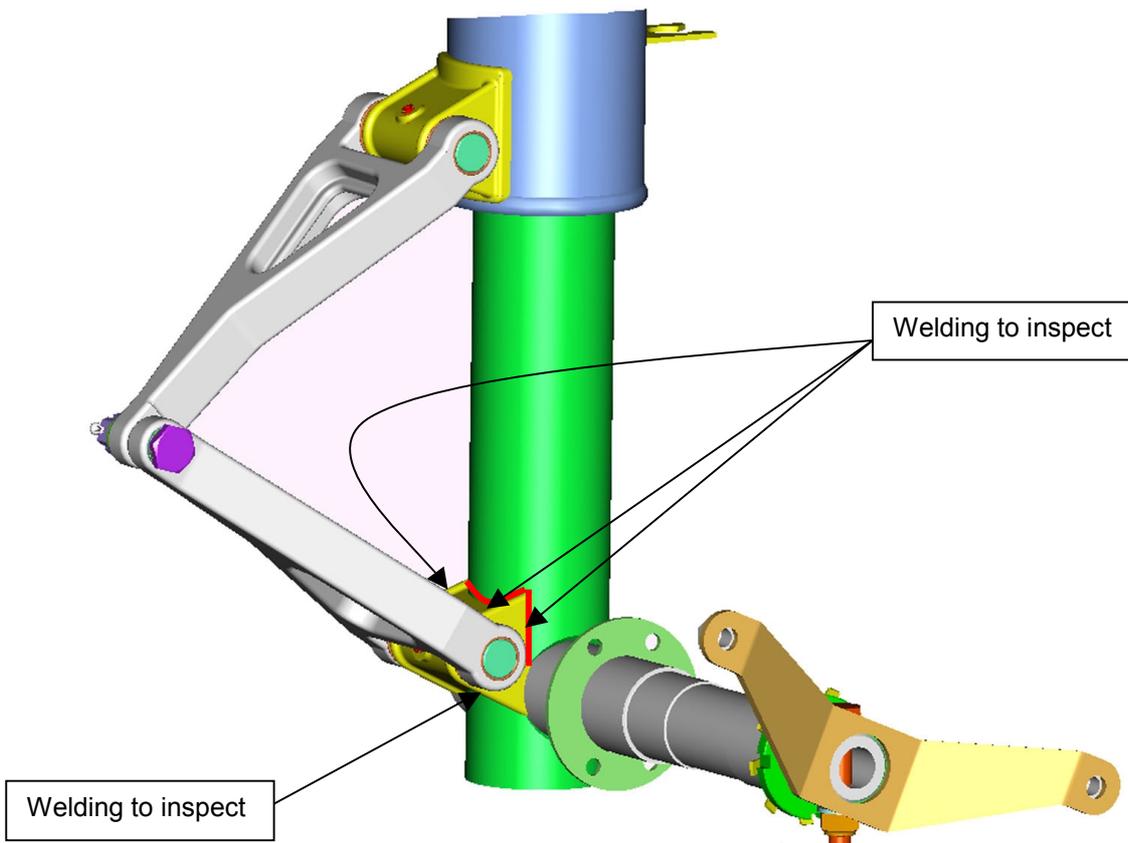
3. Inspection

The torque links attachment to the moving strut of the main landing gear has been welded for some part on the surface treatment (chrome plating). This is not complying with the welding standard and might embrittle the welding.

Do a dye penetrant check of the torque link attachment (4 sides) welding for cracks .

If cracks are found, return gear leg to APEX for repair.
