SAIB: SW-09-44
Date: July 28, 2009

SUBJ: Cabin door

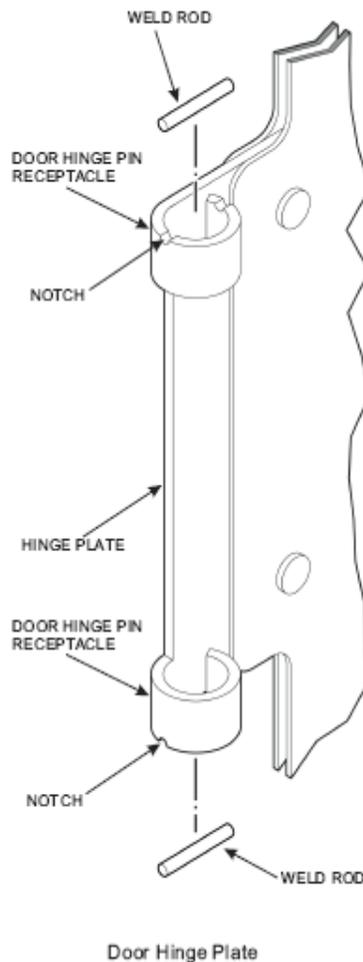
Since 2005, there have been several occurrences of the cabin door detaching from aircraft due to the serrated hinge pins coming off from the door hinge pins, allowing the door hinge pins to separate from the hinge pin receptacles on the cabin door. In December 2007, a cabin door was reported separated from an aircraft in flight as a result of separation of the serrated hinge pins from the door hinge pins. Schweizer decided a "fail safe" device was needed to preclude any future door losses, and the production hinges are now manufactured with caps to replace the open ends of the hinge pin receptacles. For those aircraft in the field, Schweizer issues service bulletins to provide an alternate method to retain the door hinge pins within the hinge pin receptacles for all affected aircraft. These service bulletins provide instructions to weld a stainless steel rod on the open ends of the hinge pin receptacles (Figure 1) to prevent the door hinge pins from falling out of the hinge pin receptacles when the serrated hinge pins are lost.

Figure1: Addition of rods to hinge pin receptacles per the service bulletin

We recommend all owners and operators comply with actions outlined in Schweizer Service Bulletins DB-026, C1B-028 and B-292 (as appropriate). It is recommended to conduct a visual check of the cabin door hinge installation before each flight until implementation of the appropriate service bulletin at the next available maintenance opportunity. The service bulletin action is not required when the new production hinge is installed.
