**SUBJ: Wings - PA-28, PA-32, PA-34, and PA-44 Rear Spar Corrosion at
Fuselage Attach Fitting**

**SAIB: CE-11-12R1
Date: December 2, 2015**

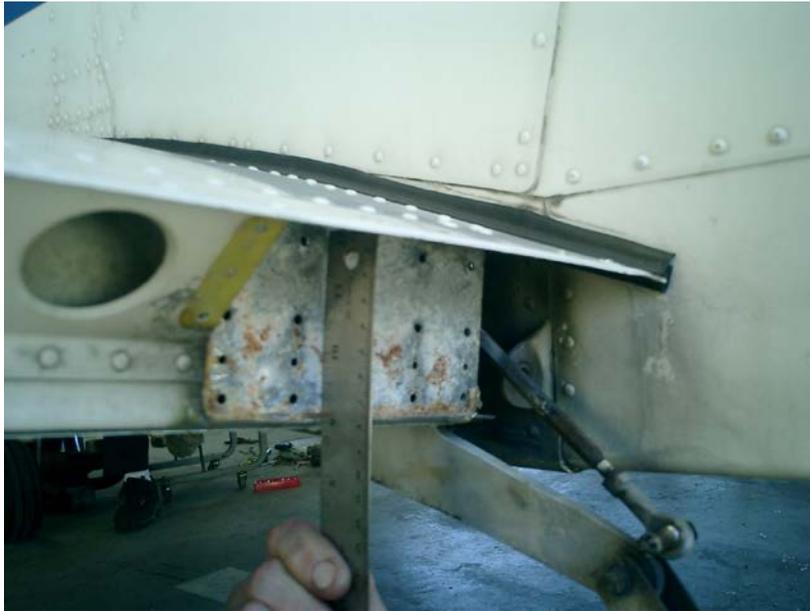
This information is presented in response to service data showing extensive corrosion on the wing rear spar at the fuselage attach fitting of Piper PA-28 and PA-32 airplanes. See Figure 1 below as an example. The example damage was found during routine maintenance affecting the part number 66762-00 plate, 62448-02/03 fitting, and 35174-04/05 aft spar. Note: The steel plate 66762-00 is common to all PA-28, PA-32, PA-34, and PA-44 airplanes, though the aluminum aft spar part number may vary.

There are other factors affecting the issue. First, we have received reports of improper paint stripping that leaves potentially corrosive chemical residue on these wing spars. All reported occurrences have included damage to only one wing on the affected airplanes. Finally, airplanes with retractable gear (e.g., PA-28R) are more difficult to inspect from the forward side of the spar due to the main landing gear wheel well.

The FAA recommends that owners and operators incorporate the actions in Piper SBs 789A, 977, and 1006 based on the applicability of the individual SB. Due to similarity of design (steel plate 66762-00 adjacent to aluminum spar) and since improper maintenance or painting procedures have been a contributing factor in past service reports, all PA-28, PA-32, PA-34, and PA-44 airplanes are susceptible to this corrosion development. Therefore, the inspections in the SBs should be implemented for all PA-28, PA-32, PA-34, and PA-44 models. We recommend that all the actions be taken within 100 hours. We further recommend inspection and incorporation as soon as feasible, but no more than 100 hours, for those airplanes at higher risk due to age, environment, lack of protective coatings, etc., as discussed above. We also recommend that owners and operators incorporate the actions in Piper SB 1244B following the compliance time in the SB.

If damage is found, a Malfunction / Defect Report or Service Difficulty Report (SDR) should be filed. The SDR system is available at <http://av-info.faa.gov/sdrx/>. There are currently no established allowable limits on the subject parts so repair or replacement will be necessary if damage is found.
