# SPECIAL AIRWORTHINESS INFORMATION BULLETIN

U.S. Department  
of Transportation  
**Federal Aviation  
Administration**

No. ANE-99-26  
July 12, 1999

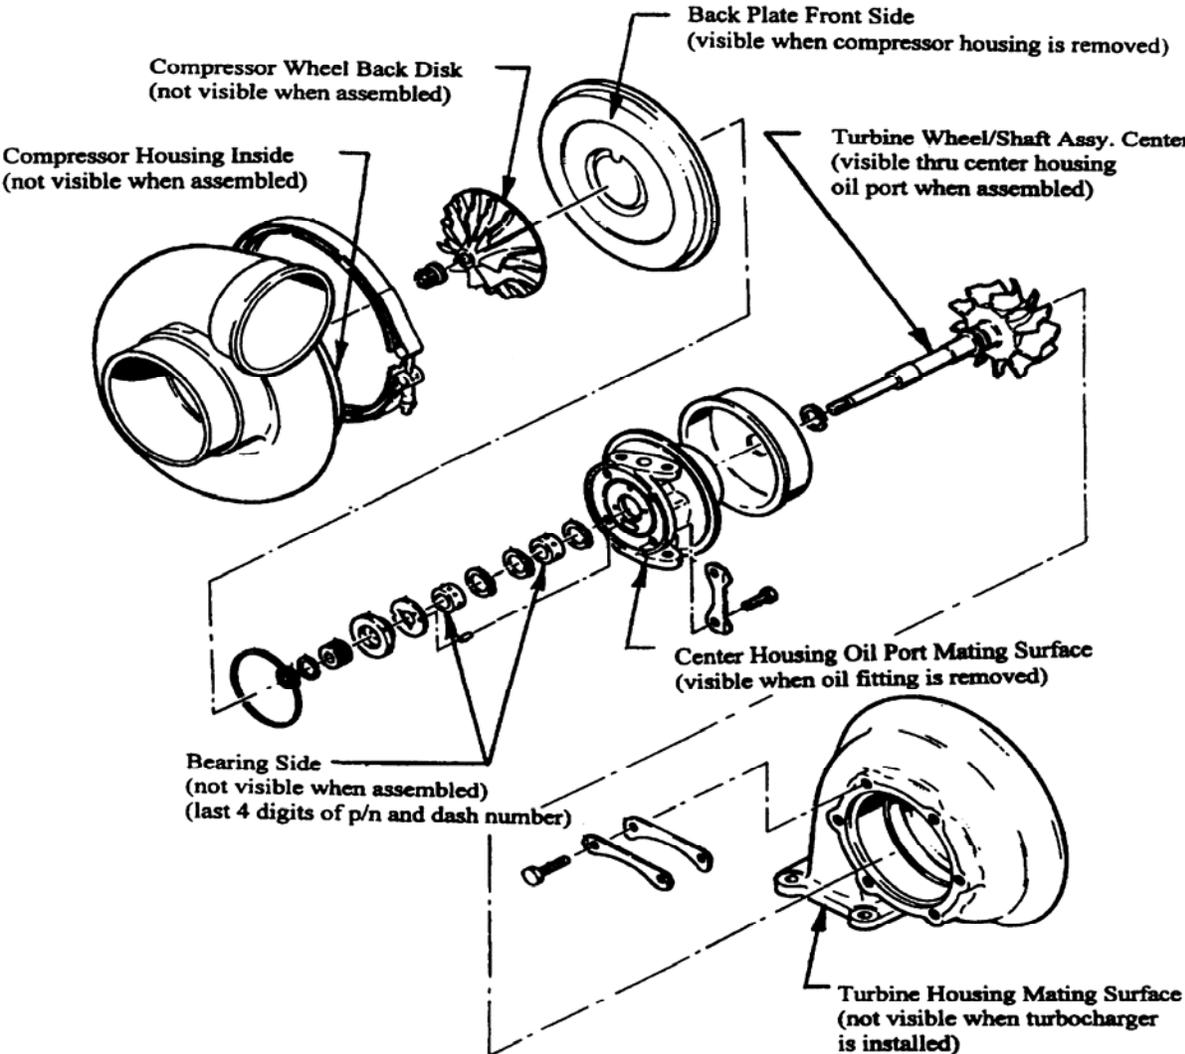
Figure 1. ANE-99-26

5. Major turbocharger components approved for aircraft and manufactured by AlliedSignal after December 1, 1997, are now permanently identified with a part number (i.e., xxxxxxAxxxx or xxxxxx-xxxxA). The part number location is depicted in the figure of this bulletin. For small components, the part number is identified on the packaging i.e., bag and tag, reference 14 CFR part 45.15.

**TURBOCHARGER COMPONENT PART NUMBER LOCATION**  
(XXXXXXXXXXXX or XXXXX-XXXXA)

2. Use only FAA approved replacement components for aircraft turbochargers. These components are now permanently identified with an AlliedSignal part number and an "A" for aircraft (see figure for marking location and AlliedSignal Overhaul Manual TP20-0128 for FAA approved part listing).

3. At turbocharger overhaul or when a turbocharger is taken apart for repair, all serviceable components should be examined on an individual basis. If their configuration or origin is questionable or if unauthorized repairs are found, the components should be replaced with FAA approved components per AlliedSignal Overhaul Manual TP20-0128 part list and with a permanent part number marking (see figure for component markings and locations).
