SAIB: CE-14-03

Date: November 15, 2013

SUBJ: Wing Spar Damage

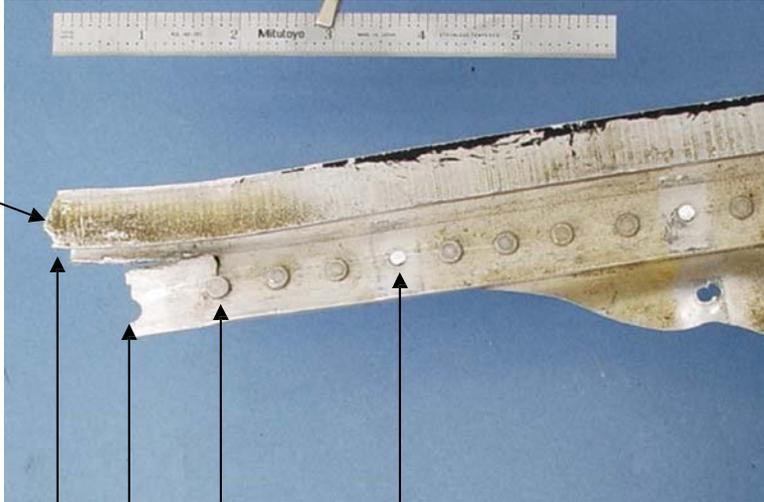
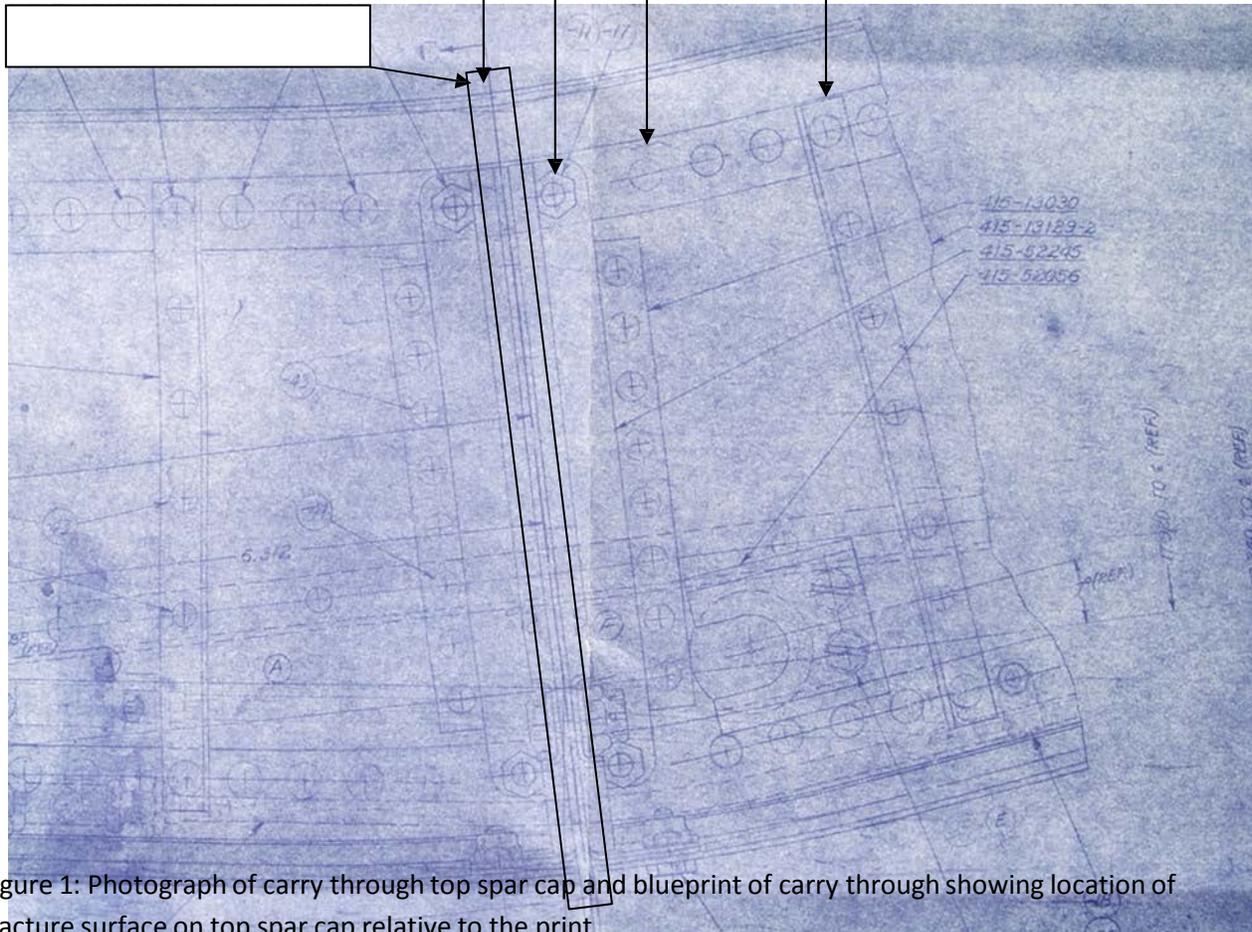
Figure 1: Photograph of carry through top spar cap and blueprint of carry through showing location of fracture surface on top spar cap relative to the print.

Note: See Figures 1 and 2 below for information of an example of an inappropriate modification performed on a spar cap. This particular spar cap most probably failed due to the pilot exceeding the design stress limitation of the airplane. A self-tapping fastener had broken off in one threaded hole and another had been threaded right into the radius of the flanged member of the spar cap (the “T” junction). The location of the hole in the spar cap T junction can lead to a reduction in structural strength of the affected structure.

Centerline of carry through. The three threaded screw holes are on this fracture surface.

Centerline of carry through.

- Use visual inspection methods to detect inappropriate modifications and/or unfilled drill holes. In addition, correct any cracking that may be a result from these modifications and/or unfilled holes.

for overall cleanliness of the area, presence of foreign objects, deformed or missing fasteners, and security of parts, corrosion, and damage. Use a 10-power magnifying glass to confirm the existence of a suspected crack. If this is not adequate, use other NDI techniques, such as liquid dye penetrant, to verify the cracks. After inspection and/or repair(s), treat the area with a corrosion preventative compound. If during any center spar area inspection, wrinkles, cracks in the spar cap or spar shear web, or inappropriate modifications, are found to exist, repair to restore structural strength before further flight. At this time, there are no approved repair instructions from the manufacturer. You may submit proposed repairs to the Denver aircraft certification office (ACO) for evaluation and approval using the contact information in this SAIB. We recommend consulting with Designated Engineering Representatives (DERs) authorized in the structural repair disciplines appropriate to this aircraft type before submitting the proposed repair to the Denver ACO. In some cases, spar replacement may be the only solution.
