# SPECIAL AIRWORTHINESS INFORMATION BULLETIN

No. ACE-99-05  
November 17, 1998

The purpose of this Special Airworthiness Information Bulletin (SAIB) is to advise registered owners of certain Cessna twin engine models of the need to determine if there is adequate alternate crankcase breather provisions.

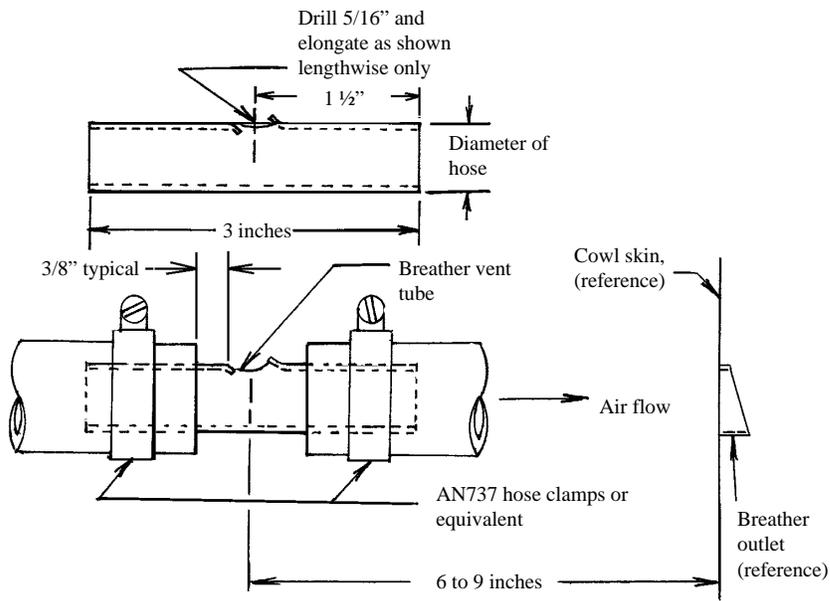
The Federal Aviation Administration (FAA) has received service difficulty reports concerning oil loss on certain Cessna twin engine airplanes. This oil loss was due to the forward crankcase oil seal being dislodged by abnormally high crankcase breather pressure. The abnormally high crankcase breather pressure was caused by icing of the crankcase breather vents. These airplanes either did not have, or had inadequate alternate crankcase venting provisions which are intended to ventilate the crankcase in the case of the icing of the primary vent. This condition may have occurred due to inadequacies in the original design or the unintentional deletion of the alternate venting provisions by field repair and/or modification. The original venting provisions were in many cases the installation of a hose section in the breather line that had a elongated hole in it.

The FAA has not mandated this modification but is strongly recommending that owners/operators of the affected airplanes examine the crankcase venting provisions installed on their airplanes for the existence of adequate alternate venting provisions, which should be a slit or hole (at least approximately one inch by .25 inches) in the breather line within a minimum of six inches inside the cowling.

If these provisions do not exist, it is recommended that alternate crankcase venting provisions be incorporated per the below figure.
