SAIB: CE-09-40  
Date: July 22, 2009

**SUBJ:** Flight Controls - Trailing Edge Flap Control System

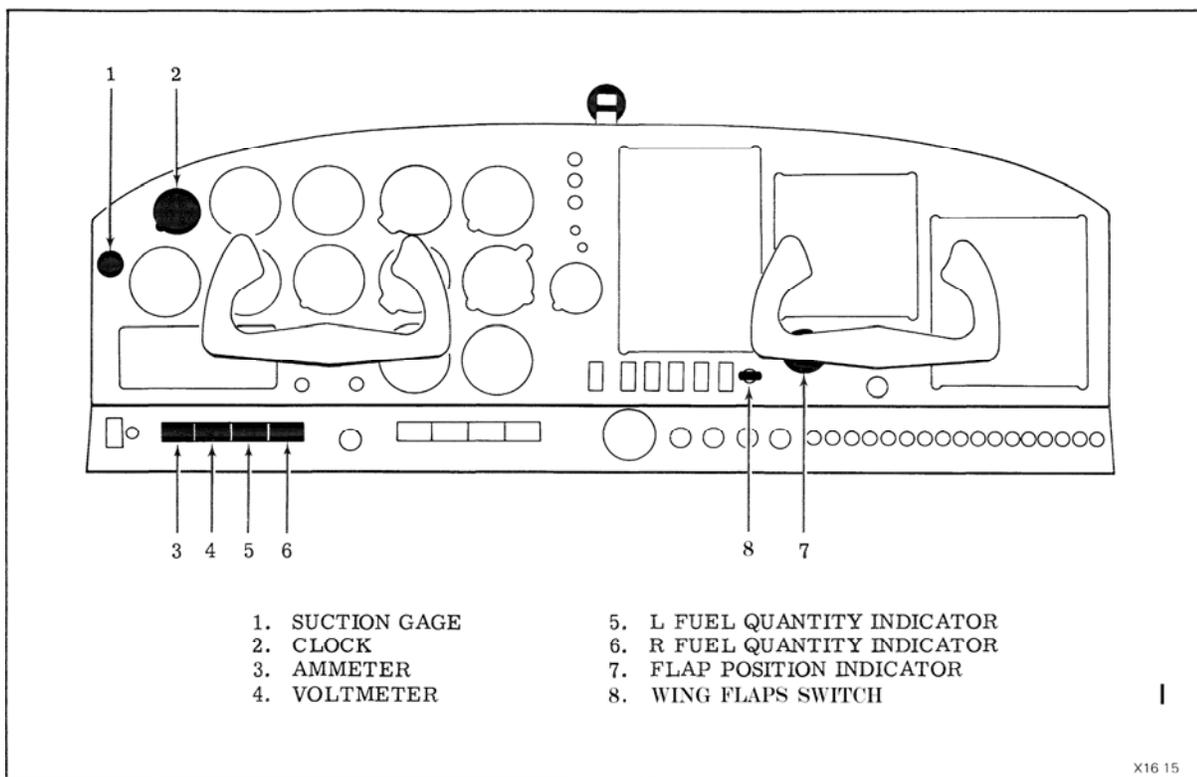
Figure 1  
(Flight Manual "Figure 3-7", modified to show flap switch.)

*The wing flaps are electrically operated... Flap position is controlled by a switch labeled "WING FLAPS" (Item 8 of Figure 1)... Flap position is electrically indicated by a gauge mounted above, and to the right of, the flap switch (Item 7 of Figure 1).*

The Aero Commander Model 112 flap switch (Commander P/N 65853 or P/NMS25201-6) as explained above is a three-position switch; Up (**not spring loaded to re-center**), Center (power off), Down (**spring loaded to re-center**).

It is possible that the flap switch spring may break, thus not allowing the switch to re-center, providing a continuous contact closure, and driving the flaps to full down within 9 seconds. The flap indicator (as shown in Item 7 of Figure 1) is located outside the pilot's normal scan and may be obstructed by the copilot's yoke. This configuration can become critical to the performance of the airplane if the following occur:

We have also become aware of incidences where a mechanic has installed the flap switch upside down, where **Up was spring loaded to center**, and **Down was not spring loaded to re-center**. Thus, while the flap switch is placed in a down position, the flap switch will stay down, and the flaps will continue down until they are fully extended. This can also become critical.

- Cycle the flaps on preflight to assure the condition of the flap system is satisfactory for flight.
- Assure that the wing flap switch operates correctly, specifically the switch springs back to neutral after the pilot releases downward pressure, and the flaps stop the travel.

- If any inoperative or improperly install switches are found, replace before the next flight.
- Report any inoperative switches and those improperly installed to the FAA point of contact listed below.
