SPECIAL AIRWORTHINESS INFORMATION BULLETIN

U.S. Department
of Transportation
**Federal Aviation
Administration**

No. ACE-97-04
May 29, 1997

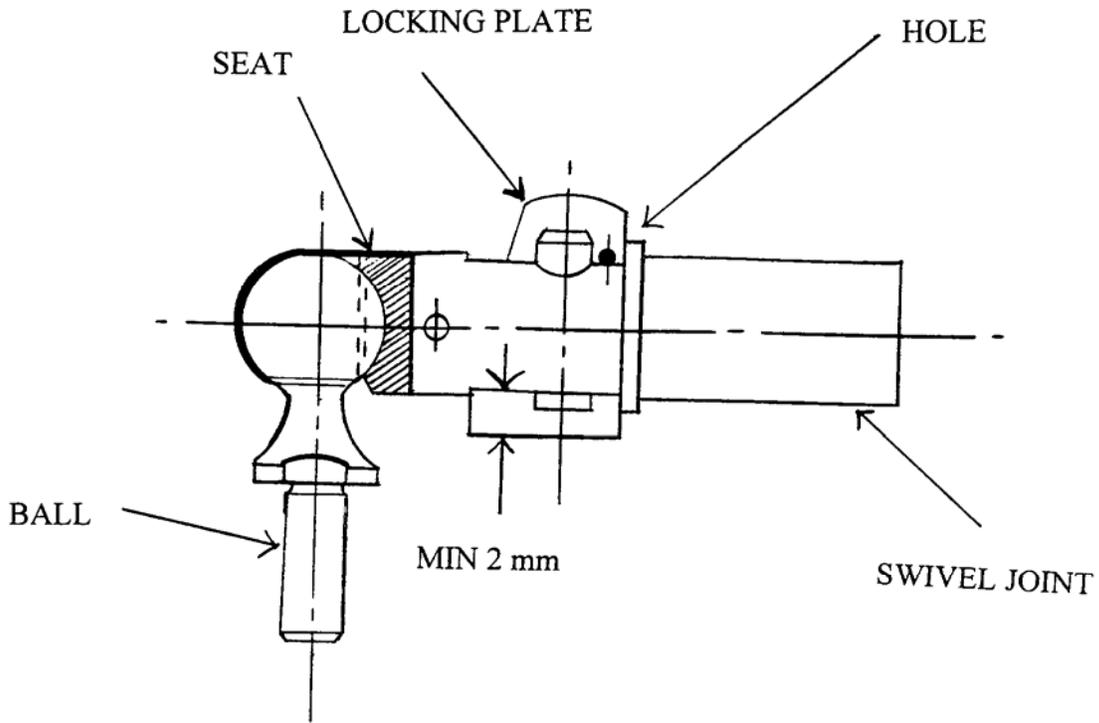
FIGURE 1

For ball and swivel joint quick connectors with lock plates:

If these connectors have a safety pin guide hole, the hole may be enlarged to a maximum of 1.2mm (0.05 in) to accommodate an appropriate aviation locking device (i.e., safety wire, pin, etc.) If the locking device already fits the guide hole, then this hole enlargement is not necessary (reference Figure 1). Because of the various locations, accessibility to the fittings, etc., the appropriate type of aviation locking device is at the discretion of the certified mechanic. However, the FAA recommends that the owner/operators use the locking devices that are supplied by their respective glider/sailplane manufacturer.

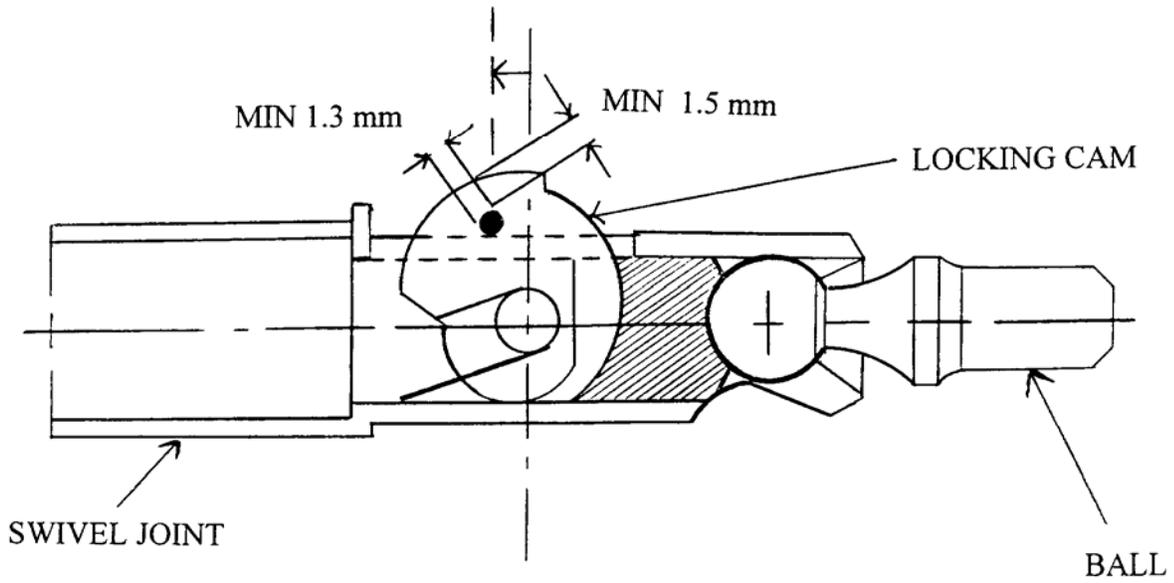
FIGURE 2

For ball and swivel joints quick connectors with locking cams:

If the locking cam does not have a safety pin guide hole, the hole may be drilled to a maximum diameter of 1.3mm with the ball correctly inserted so that one edge of the hole would be level with the main body of the joint and at least 1.5mm of material is left on the other side. When the ball is seated correctly, the hole is located aft of the centerline of the cam pivot point (as noted by the dashed line on Figure 2). It is important to have the ball seated correctly in the joint when the hole is marked and the ball and swivel connected when the hole is drilled (reference Figure 2). Suitable locking devices have been identified by the manufacturers with respect to their specific type design features. Contact the U.S. sailplane company representative or manufacturer for any technical information.
