SUBJ: Fuselage – Cracking at Aft Tail Post Weld Joint on Piper Model PA-18 (L-21) Airplanes **SAIB:** CE-13-14
Date: February 6, 2013

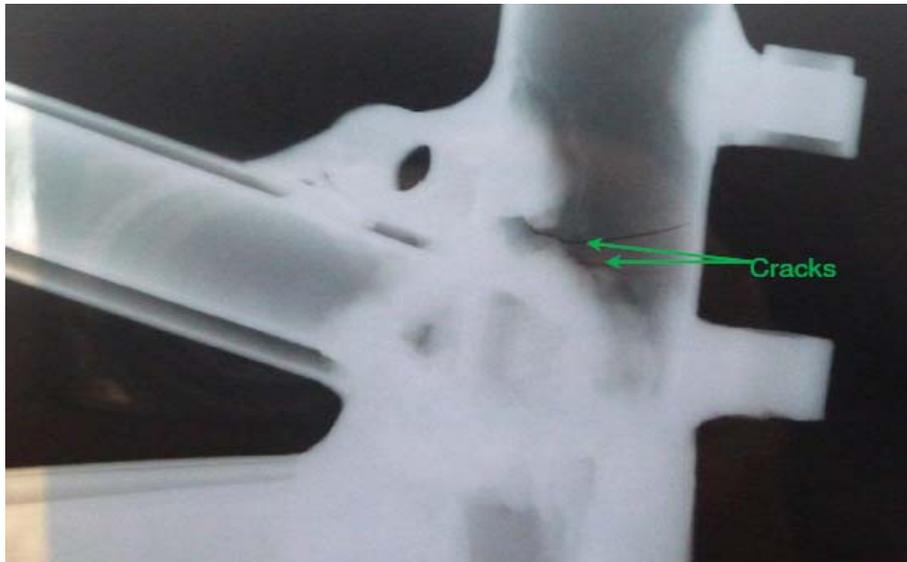
We received notice of this issue from a foreign operator. A Piper Model L-21B (PA18-135) airplane fuselage was completely disassembled to replace the worn fabric fuselage covering. After removing the fabric covering, paint was removed from the fuselage frame in areas considered susceptible to high stress and at major weld joints. A fluorescent penetrant inspection (FPI) was done on all these areas. The FPI inspection revealed two cracks in the fuselage tail section protruding into the lower rudder attachment hinge area (see Figure 1). To determine the extent of cracks into the adjacent welds and tubing, additional x-ray inspection of the area was done. The x-ray inspection revealed that the cracks did protrude into the adjacent weld areas (see Figure 2).

Figure 2 – Detail view of tail joint damage area

The FAA recommends the Piper airplane models listed below that have accumulated 1,000 hours total TIS be inspected within the next 100 hours TIS in the fuselage tail post area. We recommend use of an inspection method such as fluorescent penetrant and / or x-ray. Additionally, we recommend repeating the inspection every 1,000 hours TIS. These inspections are particularly important if the aircraft is subject to operation in severe turbulence, towing, or on rough terrain.

Repair or replace damaged components if you find cracks or corrosion
