[Docket No. 2004-SW-09-AD; Amendment 39-13651; AD 2004-06-51]

Airworthiness Directives; Boeing Defense and Space Group Model 234 Helicopters

2004-06-51 Boeing Defense and Space Group: Amendment 39-13651. Docket No. 2004-SW-09-AD.

Applicability: Model 234 helicopters, with aft vertical shaft assembly, part number (P/N) 234D3300, serial number-181 or lower with a prefix of A, installed, certificated in any category.

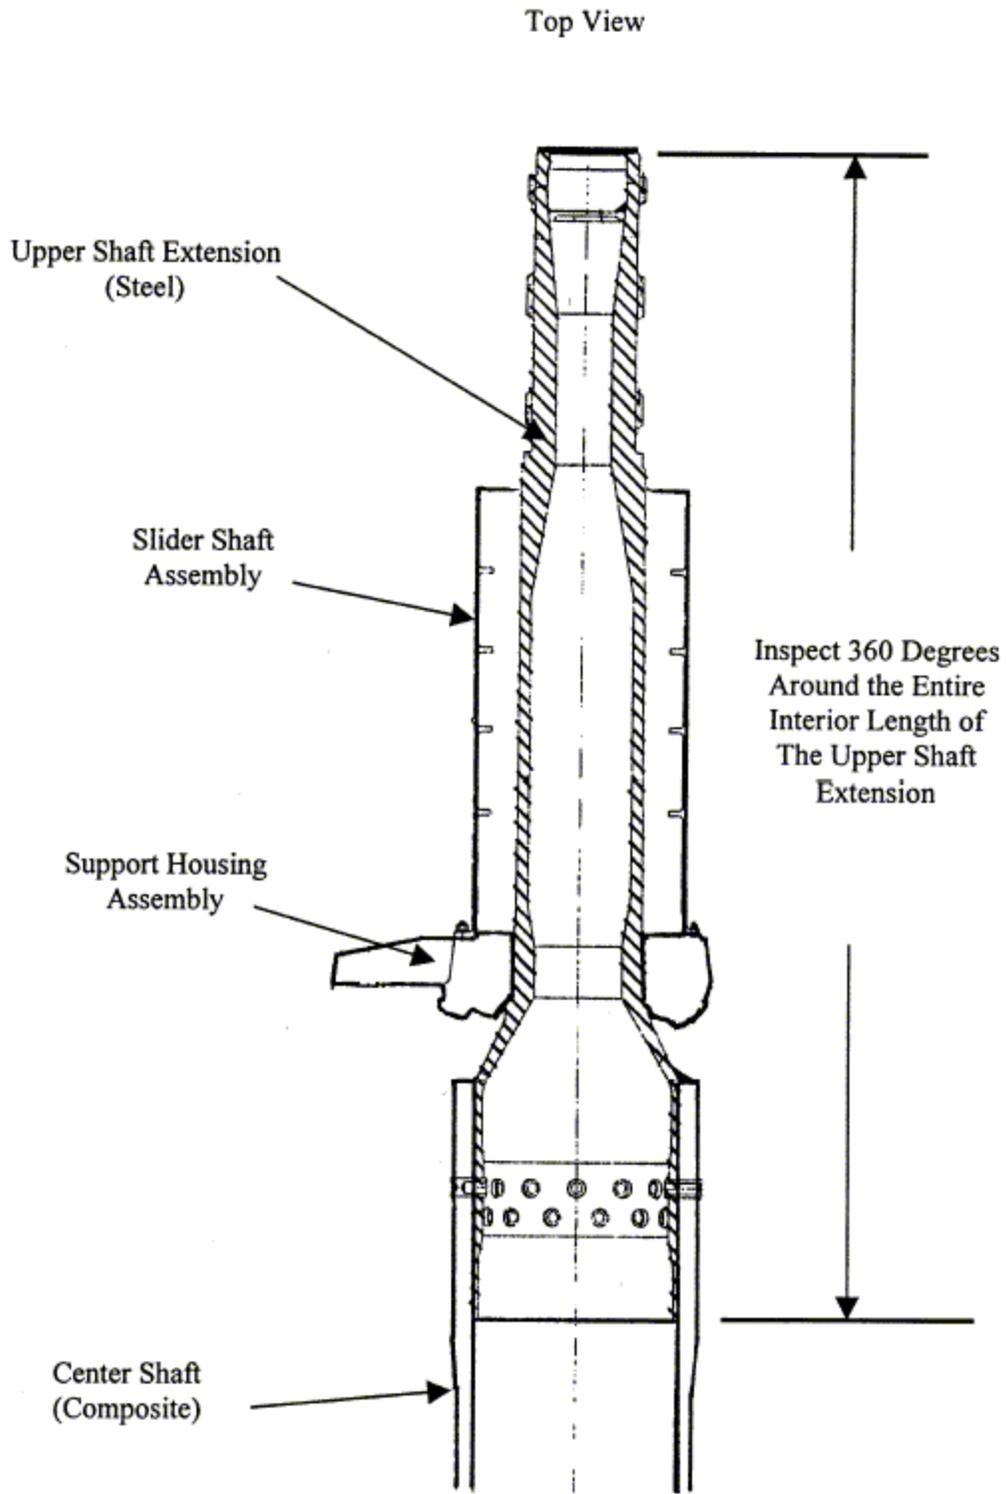
Aft Vertical Shaft
Assembly Inspection Area
Figure 1

To detect a crack in the upper shaft extension, which could result in catastrophic failure of the aft vertical shaft assembly and subsequent loss of control of the helicopter, accomplish the following:

(5) Inspect the upper shaft extension, P/N 114D3248, using a borescope or other lighted device that provides direct visual observation of the interior of the aft rotor shaft. Inspect 360 degrees around the entire interior length of the upper shaft extension. If any crack is found, replace the aft vertical shaft assembly, P/N 234D3300, with an airworthy assembly before further flight. See the following Figure 1 of this AD for the area to inspect:

(3) Inspect the upper shaft extension, P/N 114D3248, using a borescope or other lighted device that provides direct visual observation of the interior of the aft rotor shaft. Inspect 360 degrees around the entire interior length of the upper shaft extension (see Figure 1 of this AD). If any crack is found, replace the aft vertical shaft assembly, P/N 234D3300, with an airworthy assembly before further flight.
