14 CFR Part 39

[Docket No. FAA-2012-1188; Directorate Identifier 2012-SW-049-AD; Amendment 39-17254; AD 2012-10-53]

Airworthiness Directives; Eurocopter Deutschland GmbH Helicopters

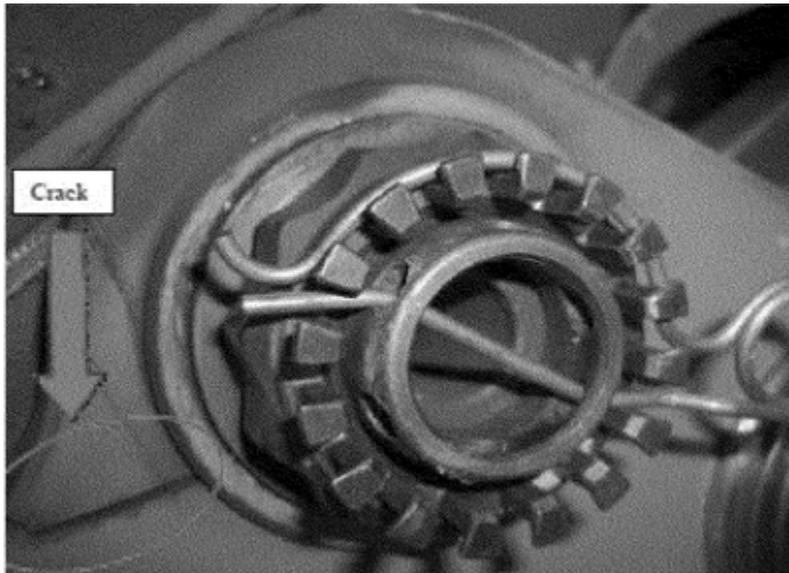
Figure 1 to Paragraph (f)(1)

This AD defines the unsafe condition as a crack in the MRH shaft flange, which could result in failure of the MRH shaft and subsequent loss of control of the helicopter.

(1) Before further flight, and thereafter at intervals not to exceed 6 hours time-in-service (TIS), check the MRH shaft lower flange and the visible area of the MRH shaft upper flange for a crack. Figures 1 and 2 to Paragraph (f)(1) of this AD are examples of cracks that have been discovered in the MRH shaft lower flange. The actions required by this paragraph may be performed by the owner/operator (pilot) holding at least a private pilot certificate, and must be entered into the aircraft records showing compliance with this AD in accordance with 14 CFR 43.9 (a)(1)-(4) and 14 CFR 91.417(a)(2)(v). The record must be maintained as required by 14 CFR 91.417, 121.380, or 135.439.

(3) If there is a crack in the upper or lower MRH shaft flange, before further flight, replace the MRH shaft. Replacing the MRH shaft with an MRH shaft having a part number listed in the applicability of this AD does not constitute terminating action for the requirements of this AD.

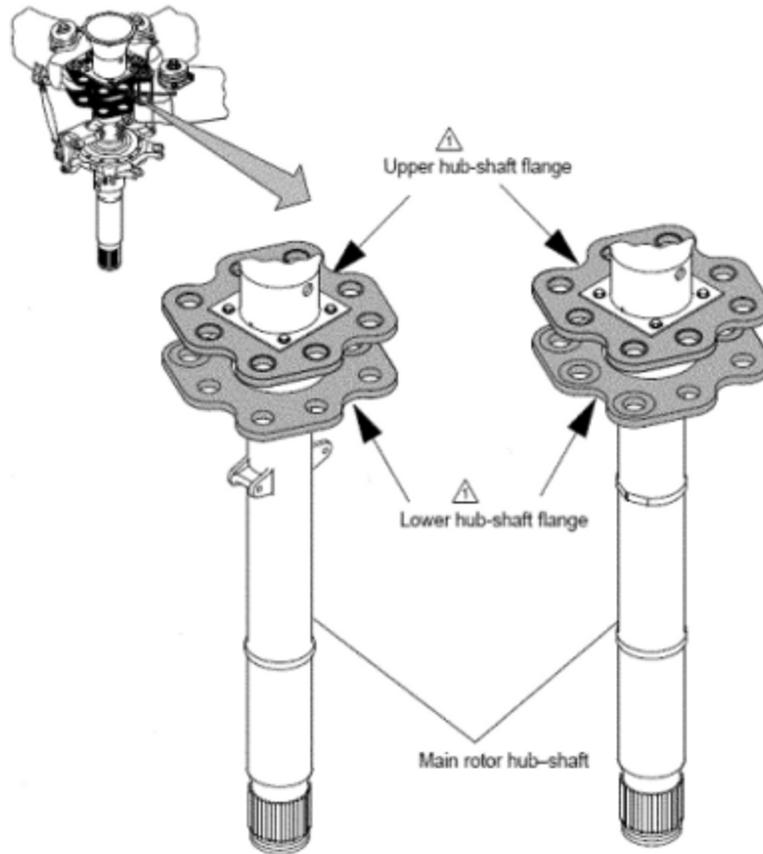
- (2) For MRH shafts with 400 or more hours TIS, within 10 hours TIS, and thereafter at intervals not to exceed 10 hours TIS:
- (i) Remove rotor-hub cap.
 - (ii) Clean the upper and lower MRH shaft flange as depicted in Figure 3 to Paragraph (f)(2)(ii) of this AD and visually inspect for a crack.

⚠ Check visible area of the upper and lower hub-shaft flange.
