**FEDERAL AVIATION ADMINISTRATION
AIRWORTHINESS DIRECTIVES
SMALL AIRCRAFT, ROTORCRAFT, GLIDERS,
BALLOONS, & AIRSHIPS**

BIWEEKLY 2011-04

2011-01-53 PIAGGIO AERO INDUSTRIES S.p.A: Amendment 39-16582; Docket No. FAA-2011-0054; Directorate Identifier 2010-CE-070-AD.

Appendix 1 to AD 2011-01-53
Functional Test of the Fuselage Drain Holes

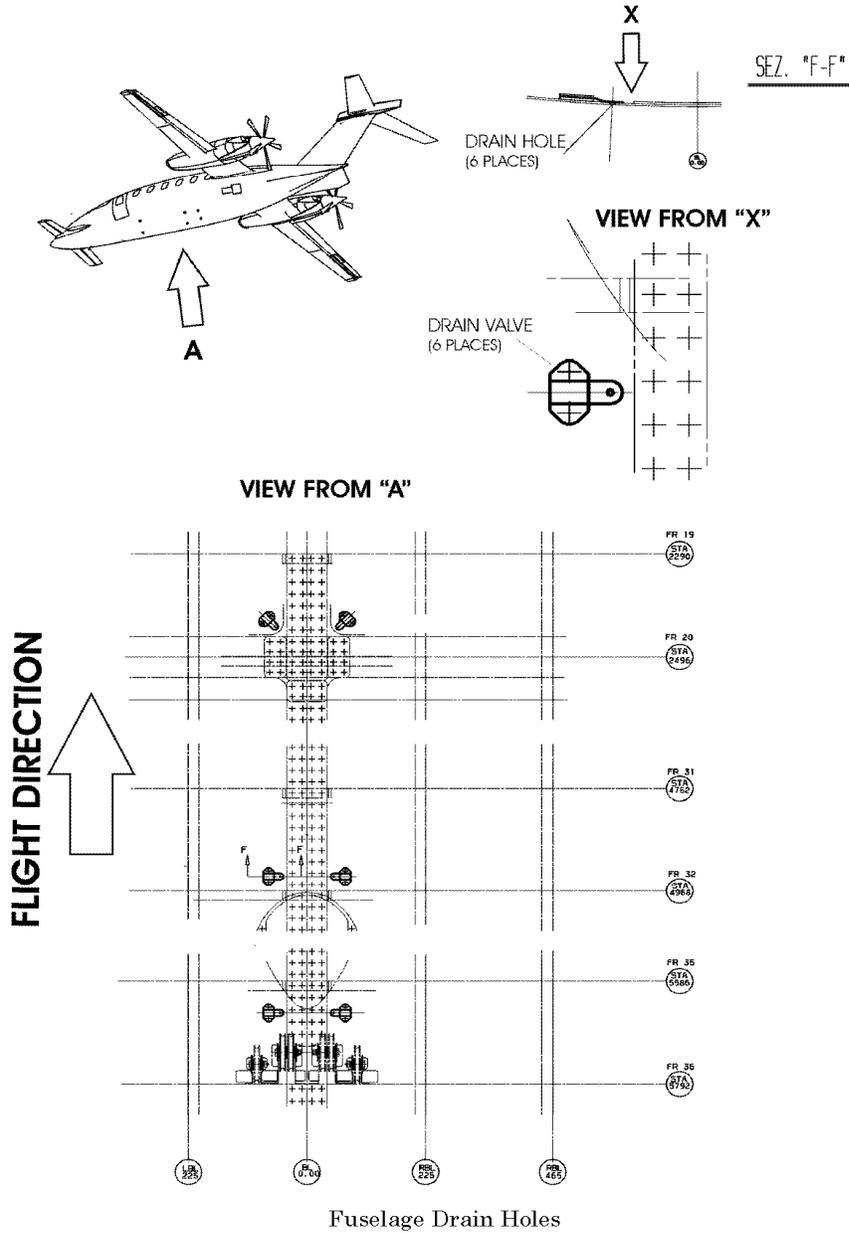
Figure 2. Fuselage Drain Holes

8. Inspect the six (6) flapper valves (two near FR 20, FR 32, and FR 36) to verify if they are clogged, stuck to the fuselage skin, or laying against the skin for their entire length.

12. Test the valves and drain holes as described:
 - a. Place an adequate amount of water in each bay between FR 19 and FR 36 (See figure 2) to verify that the water is conveyed in the central bays and that it is drained. Use at least 1/2 gallon (approximately 2 liters).

- NOTE: TAKE CARE NOT TO COME IN CONTACT WITH ELECTRICAL CONNECTORS WHILE POURING WATER.**
- b. A steady stream of water should be observed coming from the external drain holes. If not, the flapper valve does not drain properly. Cut off the rubber flap and replace the flapper valve at next A check. Take note of any cut rubber flap and its position.
