**FEDERAL AVIATION ADMINISTRATION  
AIRWORTHINESS DIRECTIVES  
SMALL AIRCRAFT, ROTORCRAFT, GLIDERS,  
BALLOONS, & AIRSHIPS**

**BIWEEKLY 2011-24**

**2011-22-05 EUROCOPTER FRANCE (EUROCOPTER):** Amendment 39-16847; Docket No. FAA-2011-1158; Directorate Identifier 2010-SW-018-AD; supersedes AD 2003-22-06, issued October 22, 2003 (68 FR 61608; October 29, 2003), Amendment 39-13354, Docket No. 2000-SW-12-AD.

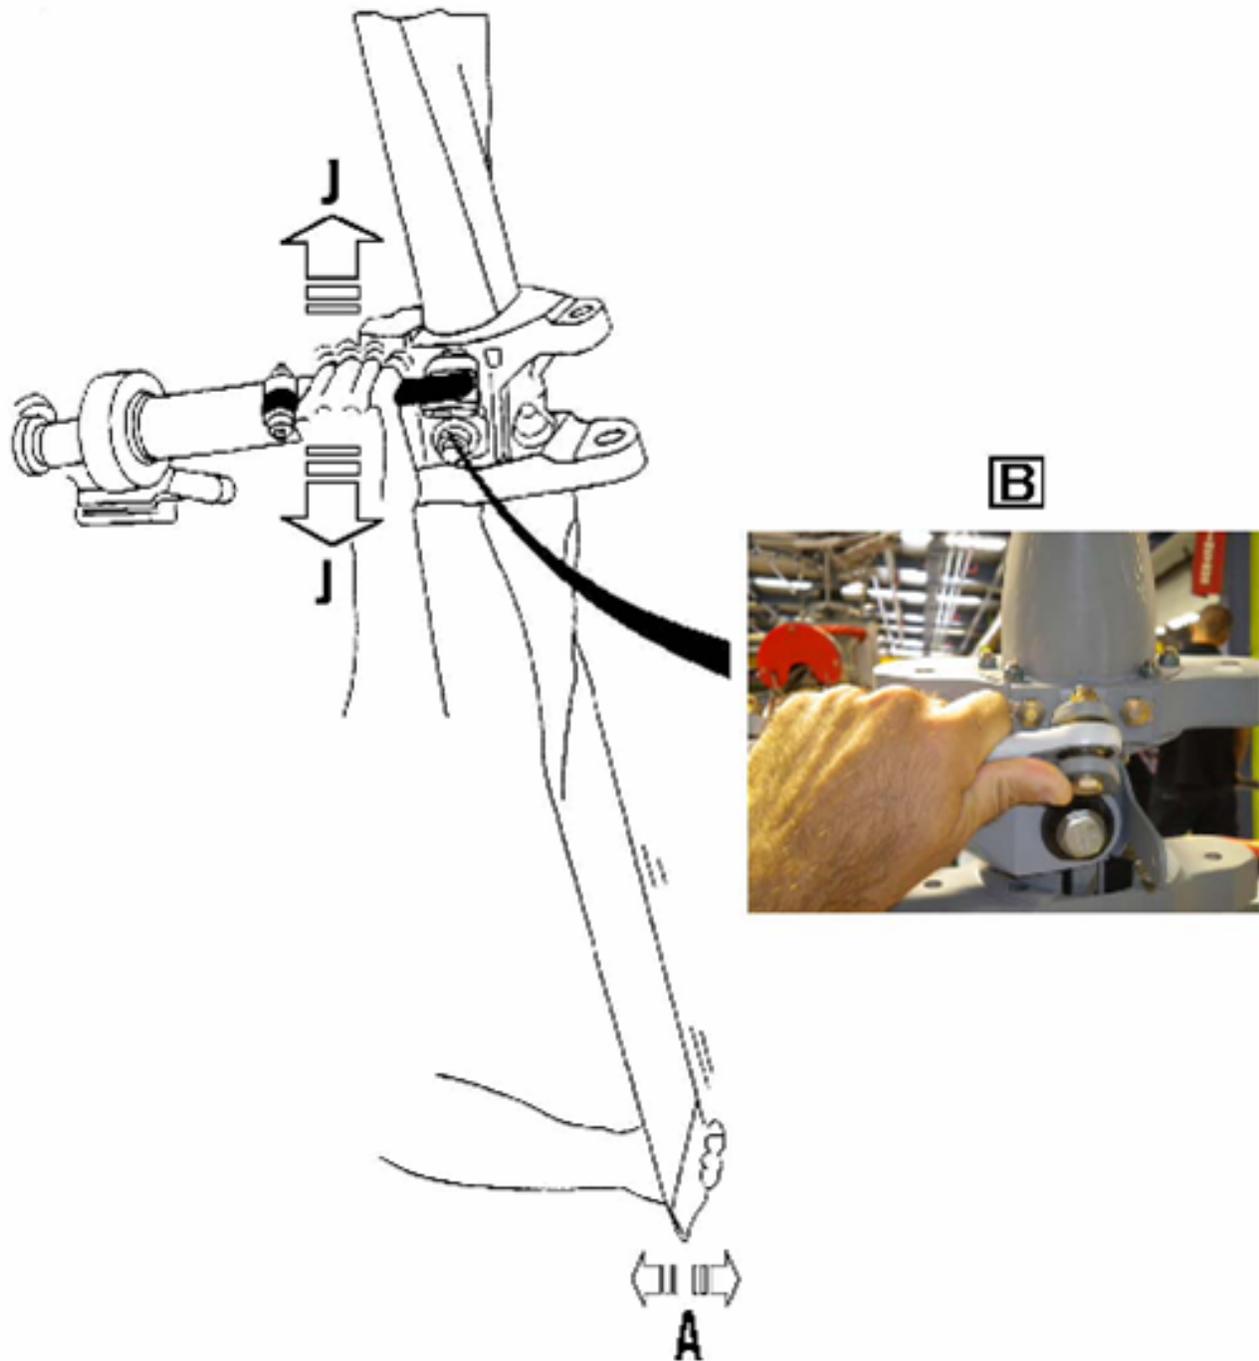
**Figure 1: Manual Check for Play of the Tail Rotor Pitch Control Rod**

To prevent failure of a T/R control rod, loss of T/R control, and subsequent loss of control of the helicopter, accomplish the following:

(b) If the Teflon cloth is coming out of its normal position within the bearing, totally or partially, or if there is discoloration or scoring on the bearing, before further flight, replace the control rod with an airworthy control rod.

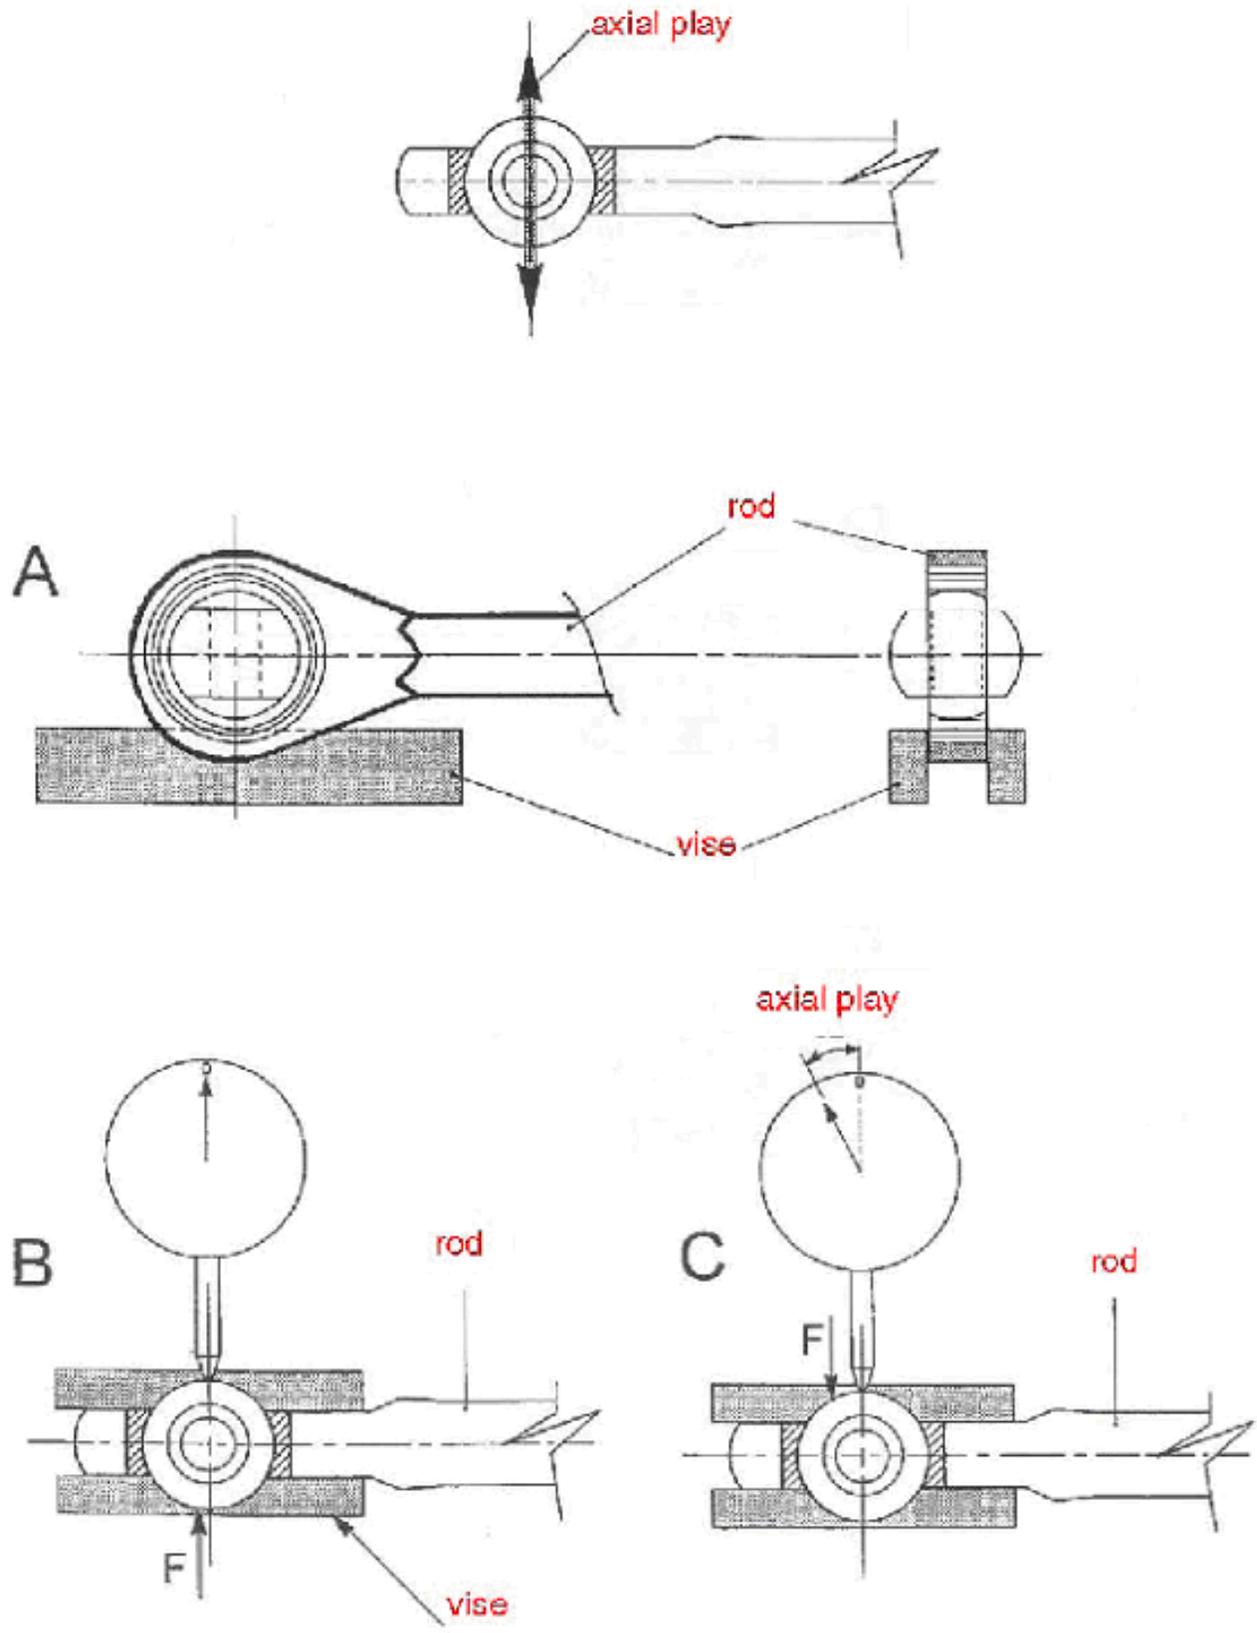
**Figure 2: Measurement of the Axial Play (A) of the Bearing**

(c) If a pilot or mechanic detects play, a mechanic must remove the control rod from the helicopter, and using a dial indicator, measure the bearing wear according to the following and as shown in Figures 2 and 3 of this AD:

- (1) Remove the control rod from the helicopter.
  - (2) Mount the control rod in a vise as shown in Figure 2 of this AD.
  - (3) Using a dial indicator, take axial play readings by moving the spherical bearing in the direction F (up and down) as shown in Figure 2 of this AD.

- (8) If the radial play exceeds 0.008 inch or axial play exceeds 0.016 inch, replace the control rod with an airworthy control rod before further flight.

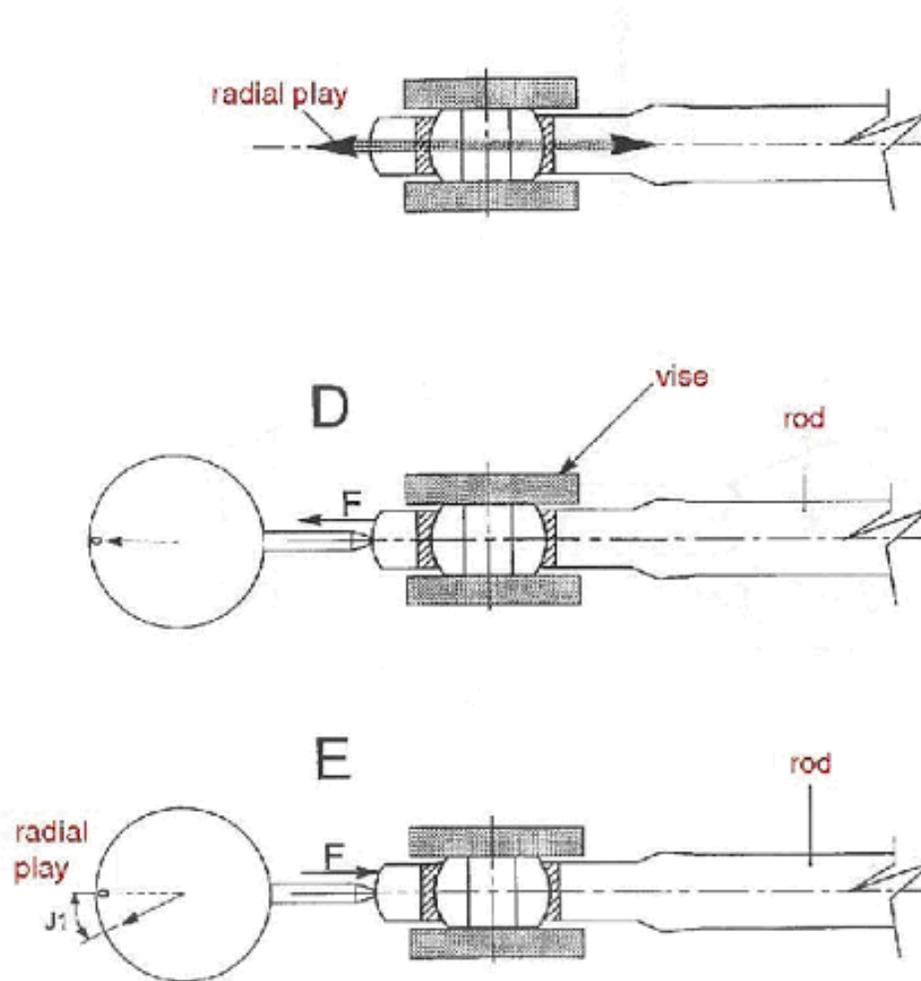
**Figure 3: Measurement of the Radial Play (R) of the Bearing**

- (4) Install a bolt through the bearing and secure it with a washer and nut to provide a clamping surface when the bearing is clamped in a vise.
  - (5) Mount the control rod and bearing in a vise as shown in Figure 3 of this AD.

- (6) Using a dial indicator, take radial play measurements by moving the control rod in the direction F as shown in Figure 3 of this AD.
  - (7) Record the hours of operation on each control rod.
