[Docket No. FAA-2012-0630; Directorate Identifier 2011-SW-010-AD; Amendment 39-17409; AD 2013-07-05]

Airworthiness Directives; Eurocopter France Helicopters

2013-07-05 Eurocopter France: Amendment 39-17409; Docket No. FAA-2012-0630; Directorate Identifier 2011-SW-010-AD.

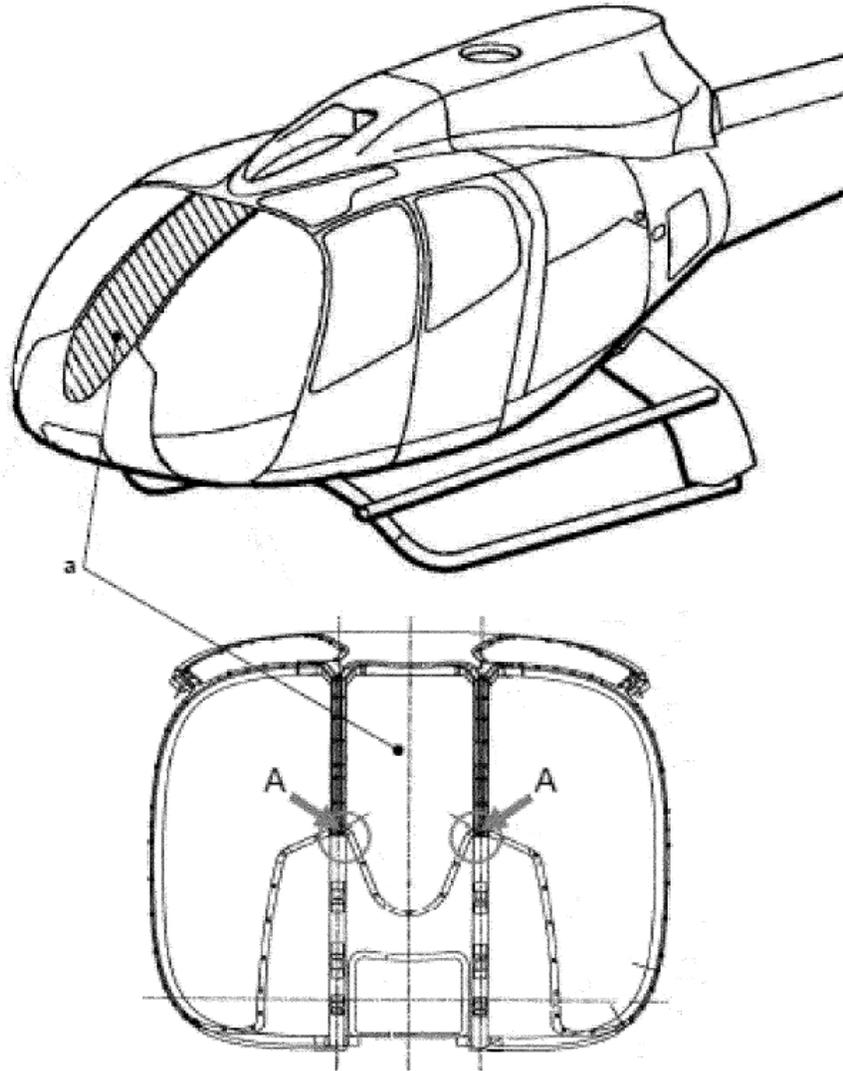
Figure 1 to Paragraph (e)(1)

This AD defines the unsafe condition as a crack in the blending radii of the center windscreen, which could lead to failure of the center windscreen, injury to the flight crew, and subsequent loss of control of the helicopter.

(1) Until the center windscreen is replaced with center windscreen P/N 350A25-9045-20, before each flight, visually check the center windscreen for a crack in the area of the blending radii where the front-lower part of the center windscreen joins the front fuselage as depicted in Figure 1 to paragraph (e)(1) of this AD. This visual check may be performed by the owner/operator (pilot) holding at least a private pilot certificate, and must be entered into the aircraft records showing compliance with this AD in accordance with Title 14 Code of Federal Regulations (14 CFR) 43.9 (a)(1)-(4) and 14 CFR 91.417(a)(2)(v). The record must be maintained as required by 14 CFR 91.417, 121.380, or 135.439.

(2) If there is a crack or if a pilot indicates that the center windscreen distorted during flight, before further flight, replace the center windscreen with an airworthy center windscreen, P/N 350A25-9045-20, in accordance with the Accomplishment Instructions, paragraphs 2.B.2.b. through 2.B.2.b.4., of Eurocopter Service Bulletin No. 56-003, Revision 0, dated November 16, 2010.

(3) Within 12 months, replace the center windscreen with an airworthy center windscreen, P/N 350A25-9045-20, in accordance with the instructions contained in paragraph (e)(2) of this AD.

(4) Replacing the center windscreen with center windscreen, P/N 350A25-9045-20, constitutes terminating action for the requirements of this AD.
