**FEDERAL AVIATION ADMINISTRATION
AIRWORTHINESS DIRECTIVES
SMALL AIRCRAFT, ROTORCRAFT, GLIDERS,
BALLOONS, & AIRSHIPS**

BIWEEKLY 2011-01

2010-17-18 R1 Air Tractor, Inc.: Amendment 39-16552; Docket No. FAA-2010-0827; Directorate Identifier 2010-CE-029-AD.

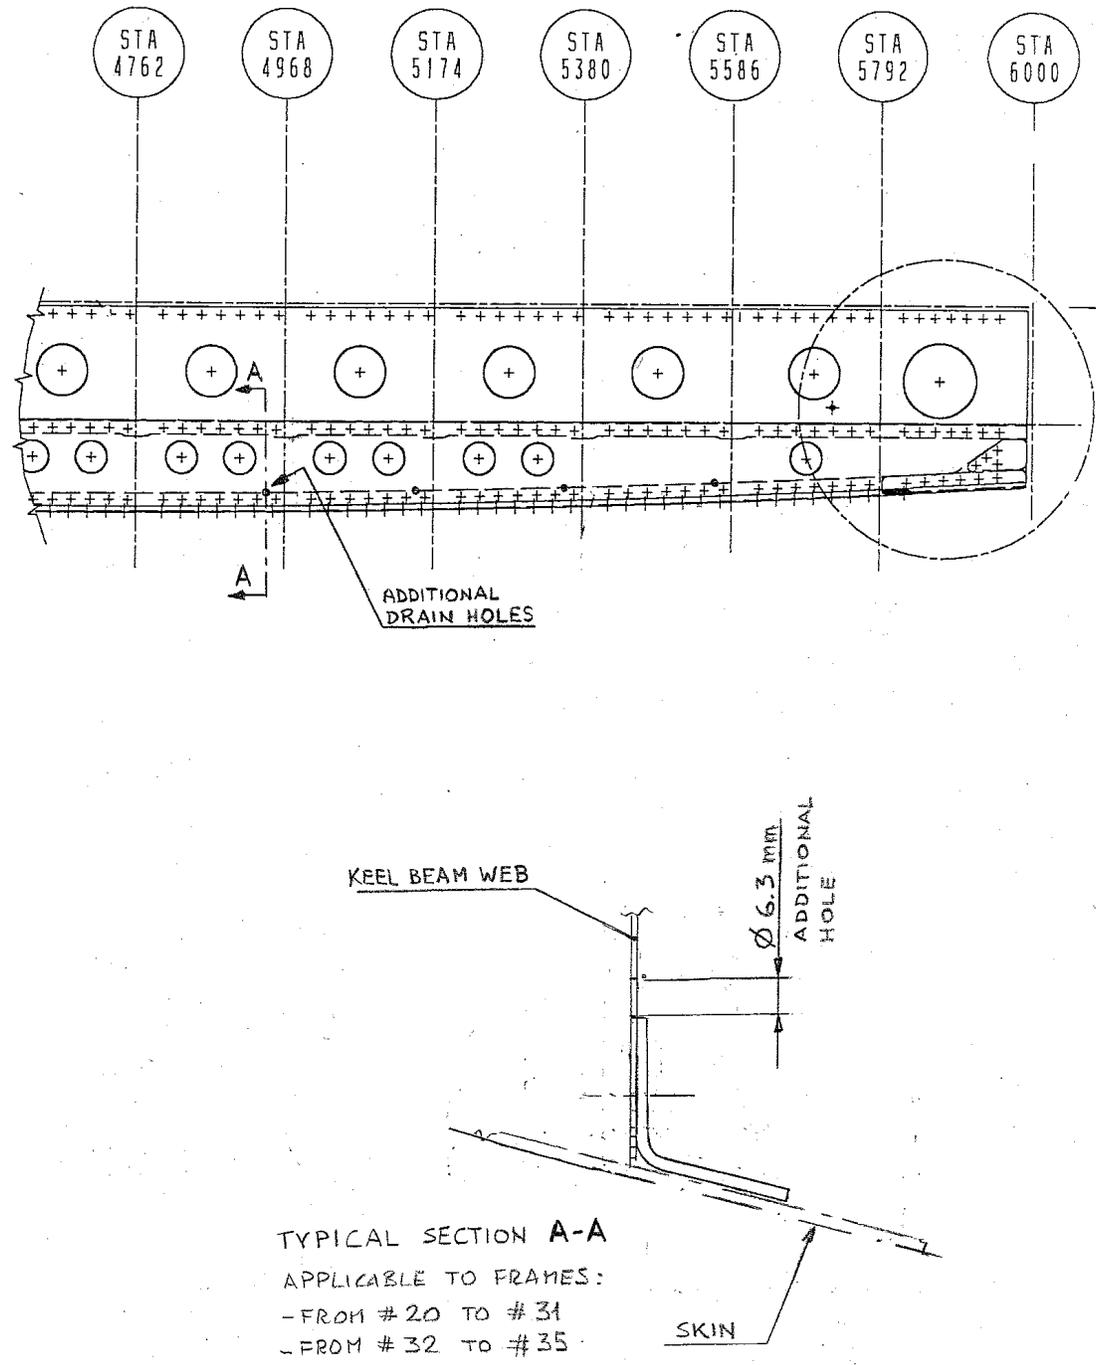
Figure 1. Additional drain holes on keel beam webs

(e) This emergency AD was prompted by three incidents of the flight controls jamming on Piaggio Model P-180 airplanes. Water or fluid accumulating and freezing when the aircraft reaches and holds altitudes where the temperature is below the freezing point may cause the flight controls to jam with consequent loss of control.

- ii. If water is found in excess of item above (4-c-i), do step 5.
5. Add 6.3 mm draining holes as per attached figure 1 (additional drain holes on keel beam webs) connecting the lateral bays to the center ones or, as alternative, apply Piaggio Aero Industries Service Bulletin 80-0291. Then proceed with step 6.
