[Docket No. FAA-2015-0497; Directorate Identifier 2012-NM-192-AD; Amendment 39-18128; AD 2015-06-10]

Airworthiness Directives; ATR-GIE Avions de Transport Régional Airplanes

2015-06-10 ATR-GIE Avions de Transport Régional: Amendment 39-18128. Docket No. FAA-2015-0497; Directorate Identifier 2012-NM-192-AD.

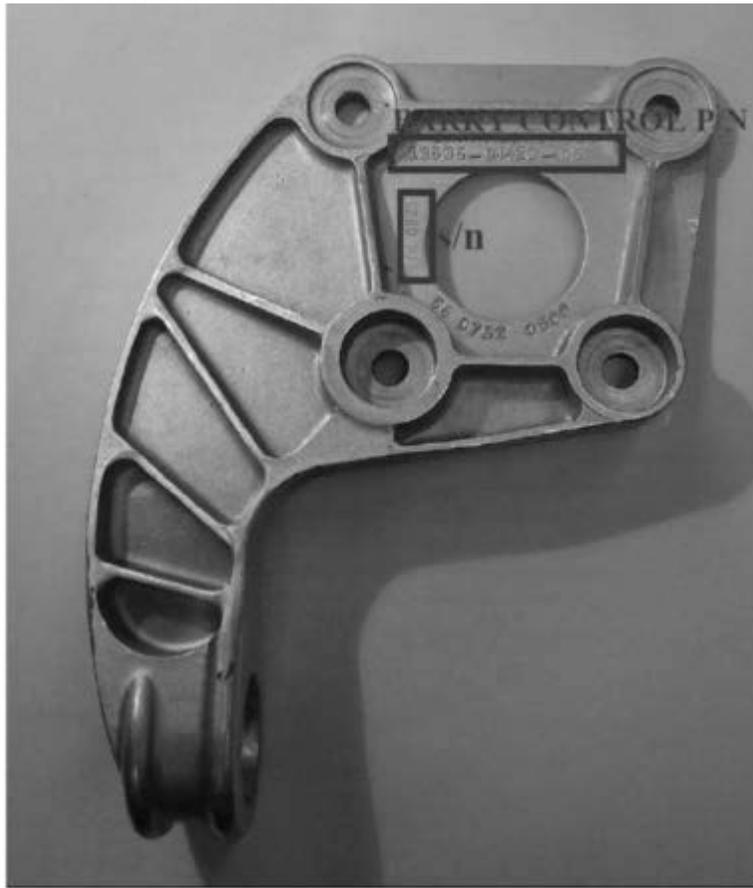
Figure 1 to paragraph (g)(1) of this AD - Location of Fitting Part Number and Serial Number

(1) Identify the serial number (S/N) of the part number (P/N) S54210394200 (Barry Control P/N 94423-05) LH and right-hand (RH) shock mount pick-up fittings installed on both engine nacelles. Figure 1 to paragraph (g)(1) of this AD identifies the fitting part number and serial number locations.

(2) If the serial number of the LH shock mount pick-up fitting, identified during any inspection required by paragraph (g)(1) of this AD, is lower than 2451 or is unreadable, and no crack has been found during any inspection required by paragraphs (g)(2) and (g)(3) of this AD: Within 6 months after the inspection required by paragraph (g)(2) of this AD, replace the LH shock mount pick-up fitting P/N S54210394200 with a serviceable LH shock mount pick-up fitting having a serial number equal to or higher than 2451, in accordance with a method approved by the Manager, International Branch, ANM-116, Transport Airplane Directorate, FAA; or EASA; or ATR-GIE Avions de Transport Régional's EASA DOA.

As of the effective date of this AD, do not install on any airplane a LH shock mount pick-up fitting P/N S54210394200, unless it is serviceable and has been determined to have an S/N equal to or higher than 2451, in accordance with the requirements of paragraph (g)(1) of this AD.

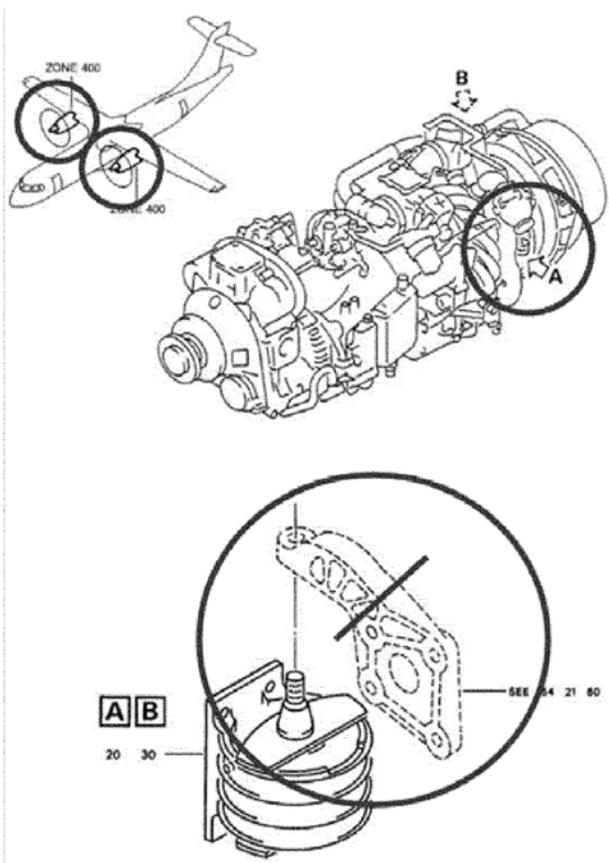
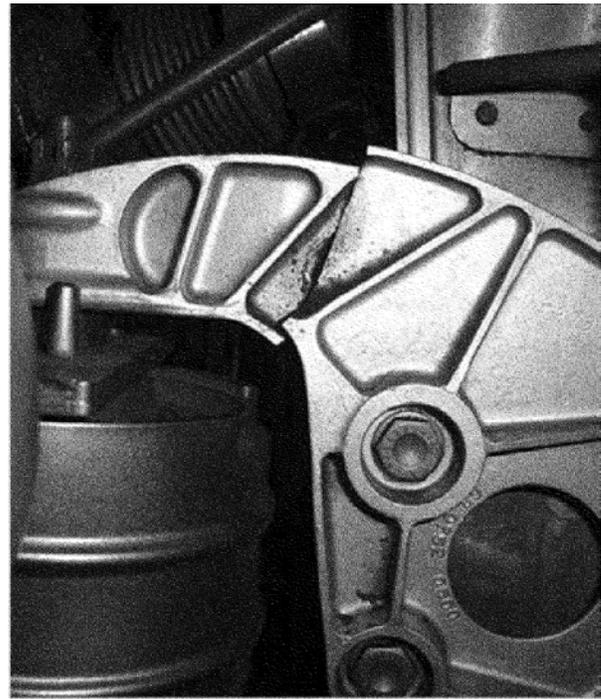
Figure 2 to Paragraph (g)(2) of this AD - Shock Mount Pick-up Fitting

Several cases of engine shock mount pick-up fitting with crack or failure have been reported, always on engine Left Hand (LH) aft side attachment. Prompted by those reports, improved Part Number (P/N) S54210394200 (Barry Control P/N 94423-05) fittings (machined radius modification) have been introduced in production, having serial number (s/n) 2451 and higher. No crack has been reported on aeroplanes equipped with those improved fittings.

(2) Do a detailed inspection of both LH and RH aft side isolator pick-up fittings on both engines to detect cracks, in accordance with paragraph 004.1 of ATR ATR72 Aircraft Maintenance Manual (AMM) Job Instruction Card (JIC) 54-11-61 DVI 10000, dated March 1, 2012. Refer to figure 2 to paragraph (g)(2) of this AD for potential crack location.

(1) If any crack is found during any inspection required by paragraphs (g)(2) and (g)(3) of this AD: Before further flight, repair in accordance with a method approved by the Manager, International

Branch, ANM-116, Transport Airplane Directorate, FAA; or EASA; or ATR's EASA Design Organization Approval (DOA).

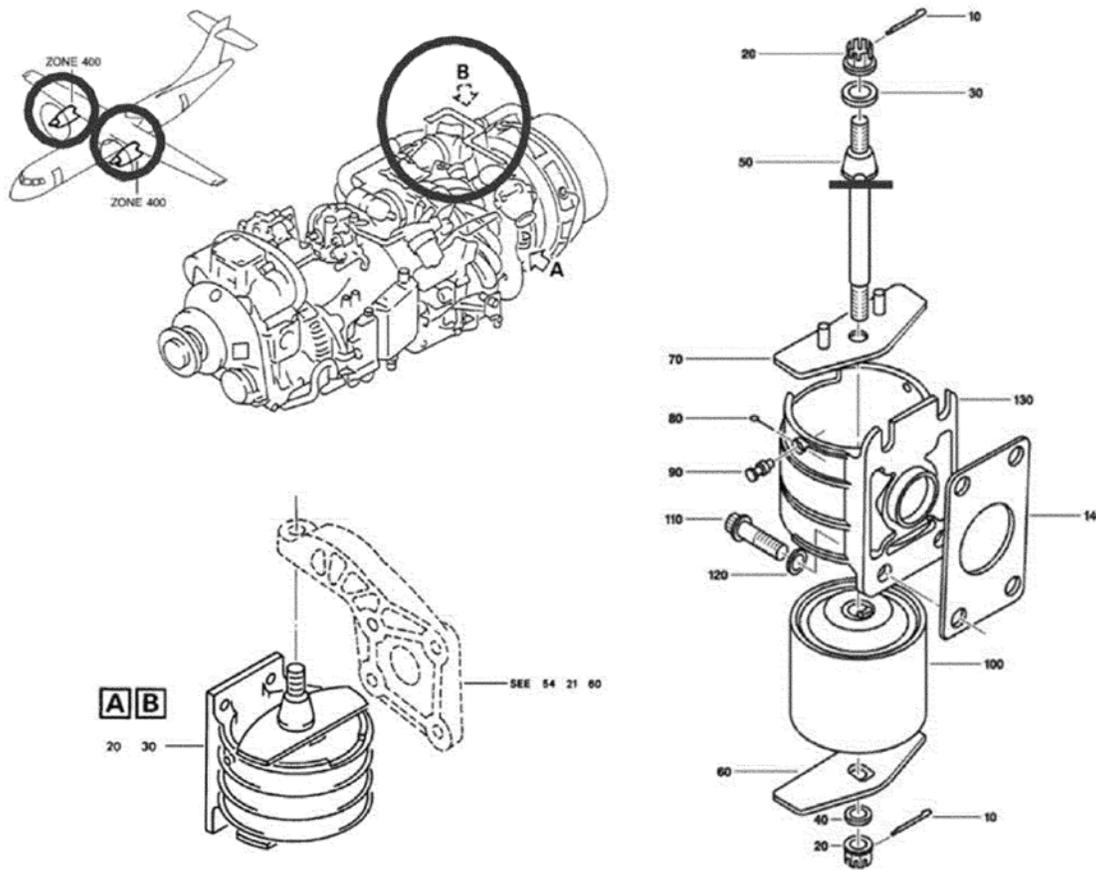
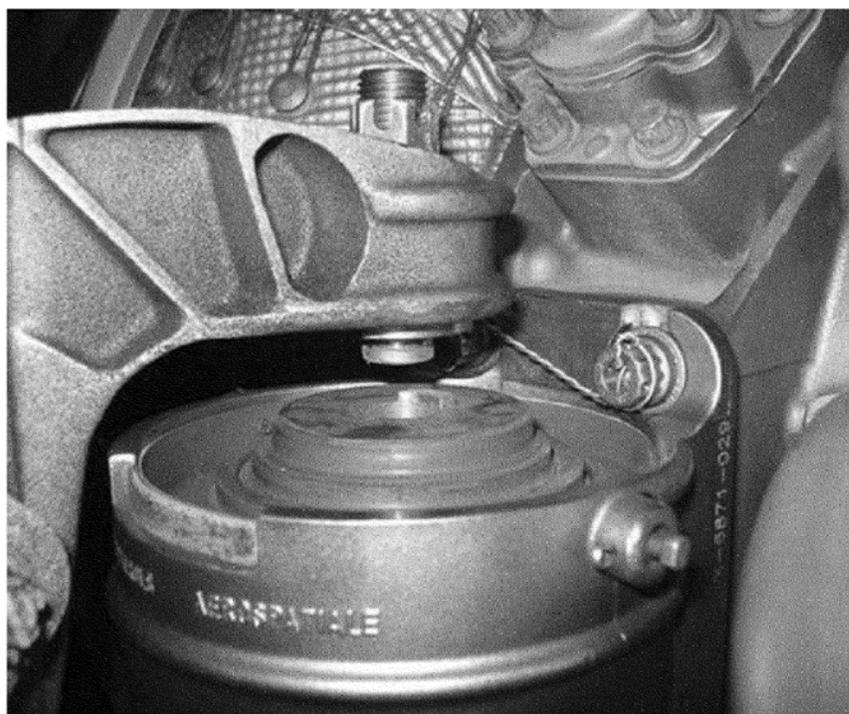
Figure 3 to paragraph (g)(3) of this AD - Shock Mount Cone Bolt

Two recent cases of failed cone bolt have been reported on ATR 72-212A aeroplanes, both on engine Right Hand (RH) aft side isolator.

(3) Do a detailed inspection of both LH and RH aft shock mount cone bolts on both engines to detect cracks, in accordance with paragraph 006.3.A. of ATR ATR72 AMM JIC 71-20-00 DVI 10000. Refer to figure 3 to paragraph (g)(3) of this AD for potential crack location.
