**FEDERAL AVIATION ADMINISTRATION  
AIRWORTHINESS DIRECTIVES  
SMALL AIRCRAFT, ROTORCRAFT, GLIDERS,  
BALLOONS, & AIRSHIPS**

**BIWEEKLY 2011-15**

**SMALL AIRCRAFT, ROTORCRAFT, GLIDERS, BALLOONS, & AIRSHIPS**

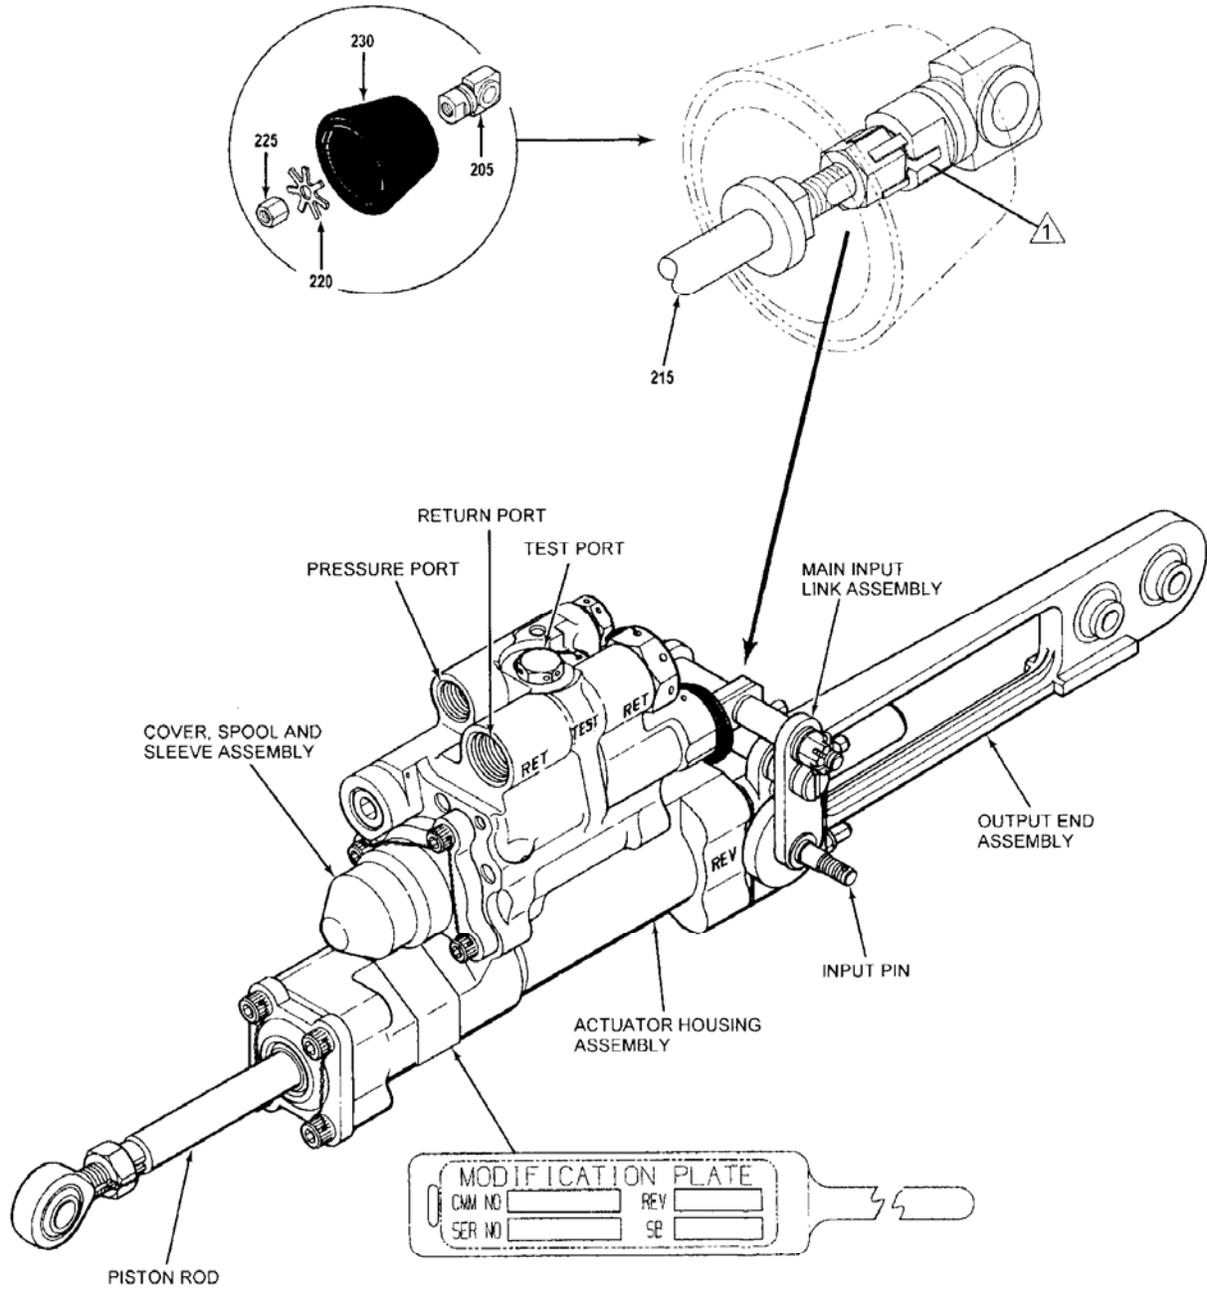
Clevis Assembly  
 Figure 1

This Emergency Airworthiness Directive (AD) is prompted by a report that a quality escape by a supplier has occurred and certain hydraulic servo actuators (servo) may have a loose nut, shaft, and clevis assembly due to improper lock-washer installation. An investigation after an accident revealed the clevis nut on the servo was loose. This condition, if not detected, could lead to a malfunction of a servo in the flight control system and subsequent loss of control of the helicopter.

(1) Retract the boot depicted as “230” in Figure 1 of this AD:

**NOTE:**  
 1 ACCEPTABLE CONDITION  
 A MINIMUM OF ONE TAB SHALL BE IN LINE AND BENT FLUSH WITH THE NUT FLAT SURFACE AND A MINIMUM OF ONE TAB SHALL BE IN LINE AND BENT FLUSH WITH THE CLEVIS ASSEMBLY FLAT SURFACE

(2) Applying only hand pressure, determine whether the nut, shaft, or clevis assembly, depicted as “225,” “215,” and “205,” respectively, in Figure 1 of this AD, turns independently. If the shaft turns independently of the nut or the clevis assembly, before further flight, replace the servo with an airworthy servo.

(i) If at least one lock washer tab is not aligned and bent flush with a nut flat surface and at least one lock washer tab is not aligned and bent flush with a flat surface of the clevis assembly, before further flight, replace the servo with an airworthy servo.
