[Docket No. FAA-2012-1135; Directorate Identifier 2012-SW-097-AD; Amendment 39-17281; AD 2012-21-52]

Airworthiness Directives; Agusta S.p.A. (Type Certificate Currently Held by AgustaWestland S.p.A.) (Agusta) Helicopters

ACTION: Final rule; request for comments.

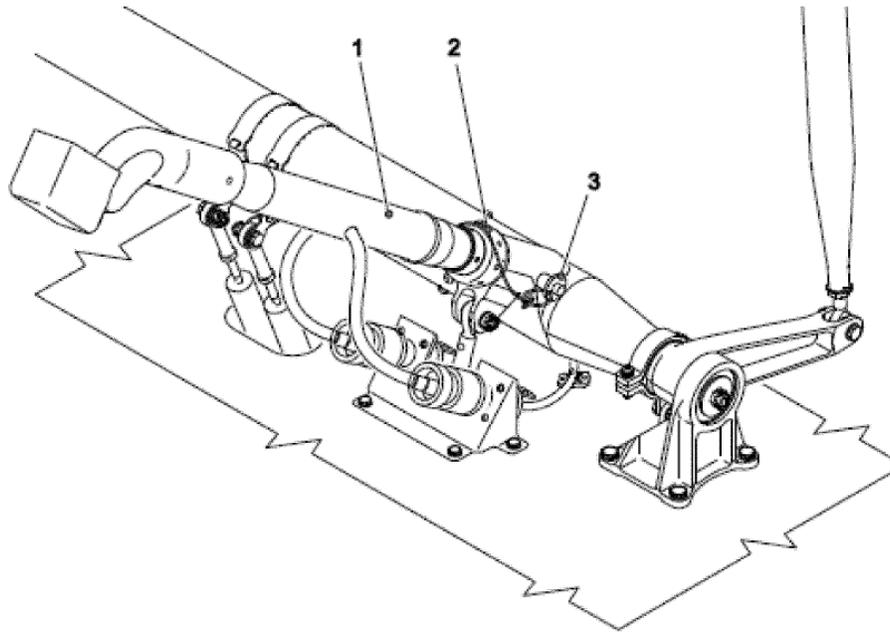
(2) Inspect the co-pilot collective stick installation to determine whether the ring nut (item 2) is loose and the quick-release pin (item 3) is installed as depicted in Figure 2 to paragraph (e) of this AD. If the ring nut is loose or the quick-release pin is not installed, before further flight, reinstall the co-pilot collective stick.

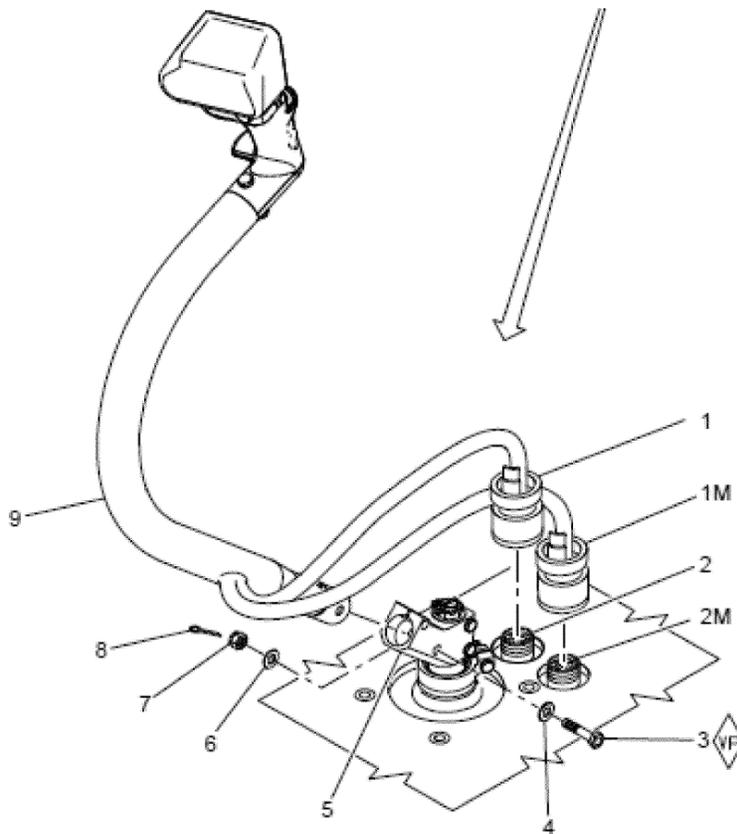
(3) Inspect the pilot cyclic stick installation for proper installation of the bolt (item 3), washer (item 4), self-locking nut (item 7), washer (item 6), and the cotter pin (item 8), as depicted in Figure 3 to paragraph (e) of this AD. If the pilot cyclic stick is not installed as depicted, before further flight, reinstall the pilot cyclic stick.
