EMERGENCY

AIRWORTHINESS DIRECTIVE

AD #: 2011-18-52

Send to all U.S. owners and operators of Agusta S.p.A. (Agusta) Model AB139 and AW139 helicopters.

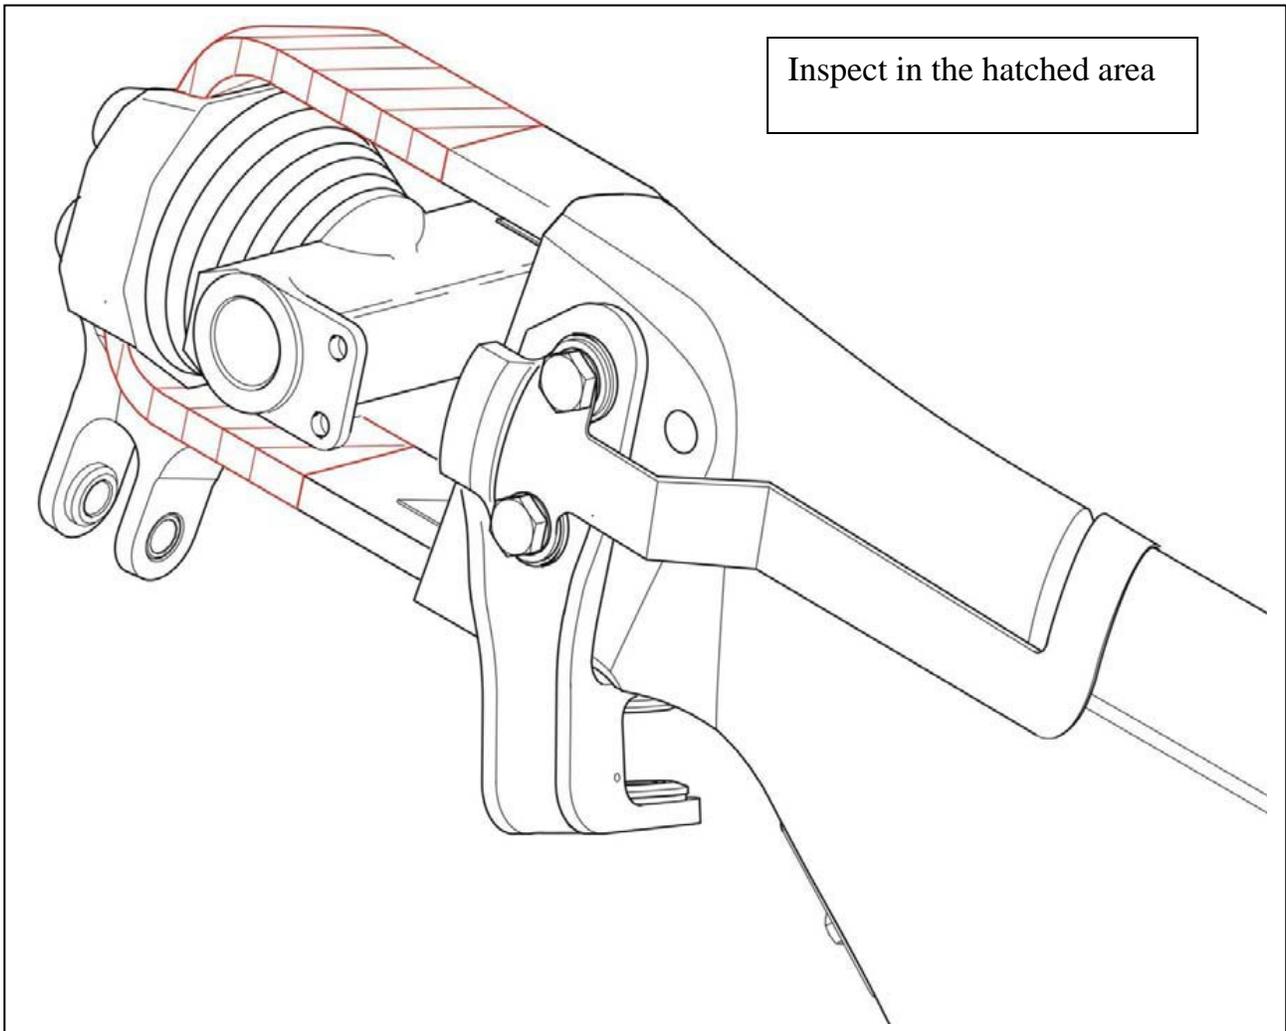
This Emergency Airworthiness Directive (AD) is prompted by a fatal accident involving an Agusta Model AW139 helicopter, which may have been caused by cracks in a tail rotor (T/R) blade. This condition, if not detected and corrected, could result in failure of a T/R blade, and subsequent loss of control of the helicopter.

- (c) Within 25 hours TIS, and thereafter at intervals not to exceed 25 hours TIS, visually inspect the T/R blade for a crack or damage that exceeds the limits of the applicable maintenance

manual. Inspect in the area depicted in the following figure using a mirror, magnifying glass (5X or greater), and light source; or borescope.

(d) If there is a crack, or if there is damage that exceeds the limits of the applicable maintenance manual, before further flight, replace the T/R blade with an airworthy T/R blade.
