**FEDERAL AVIATION ADMINISTRATION  
AIRWORTHINESS DIRECTIVES**

**SMALL AIRCRAFT  
ROTORCRAFT, GLIDERS, BALLOONS, AND AIRSHIPS  
BIWEEKLY 2011-03**

*February 1, 2011*

**2011-01-53 PIAGGIO AERO INDUSTRIES S.p.A:** Amendment 39-16582; Docket No. FAA-2011-0054; Directorate Identifier 2010-CE-070-AD.

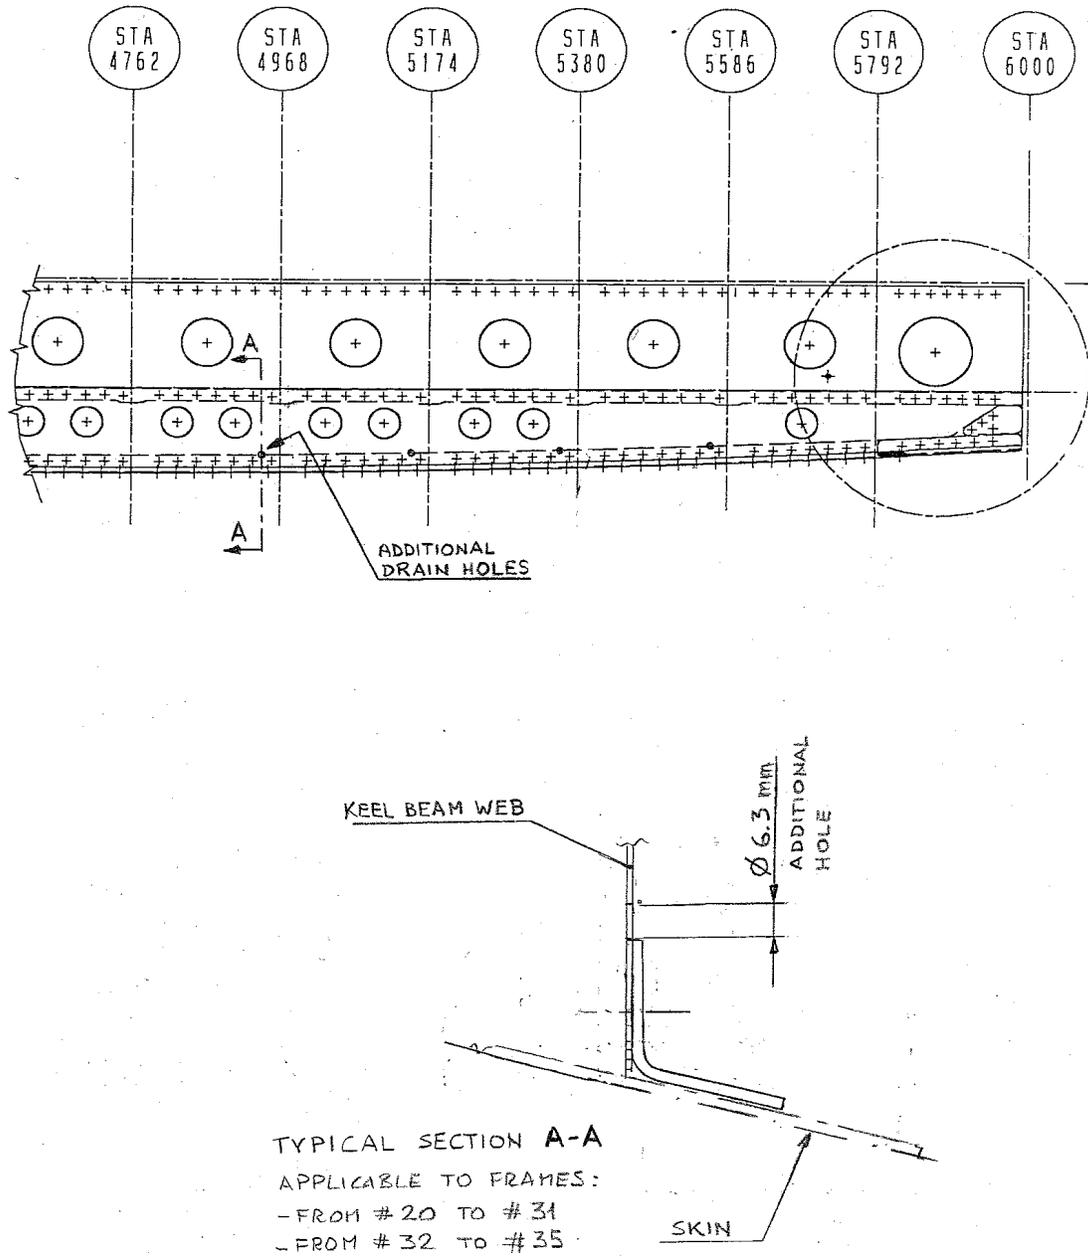
Figure 1. Additional drain holes on keel beam webs

(e) This AD was prompted by reports of water accumulation in the belly of the fuselage that froze and caused the flight controls to jam. We are issuing this AD to prevent water or fluid from accumulating in the belly of the fuselage and freezing when the aircraft reaches and holds altitudes where the temperature is below the freezing point. This condition could cause the flight controls to jam, which could result in loss of control.

- c. Evaluate the amount of fluid collected:
    - i. If water is found only in the bottom of the belly (i.e., undrainable within the keel beams), go to step 6. Step 5 does not need to be accomplished at this time.

- ii. If water is found in excess of item above (4-c-i), do step 5.
5. Add 6.3 mm draining holes as per attached figure 1 (additional drain holes on keel beam webs) connecting the lateral bays to the center ones or, as alternative, apply Piaggio Aero Industries Service Bulletin 80-0291. Then proceed with step 6.
