**FEDERAL AVIATION ADMINISTRATION
AIRWORTHINESS DIRECTIVES**

**SMALL AIRPLANES, ROTORCRAFT, GLIDERS,
BALLOONS, & AIRSHIPS**

BIWEEKLY 2012-19

9/10/2012 - 9/23/2012

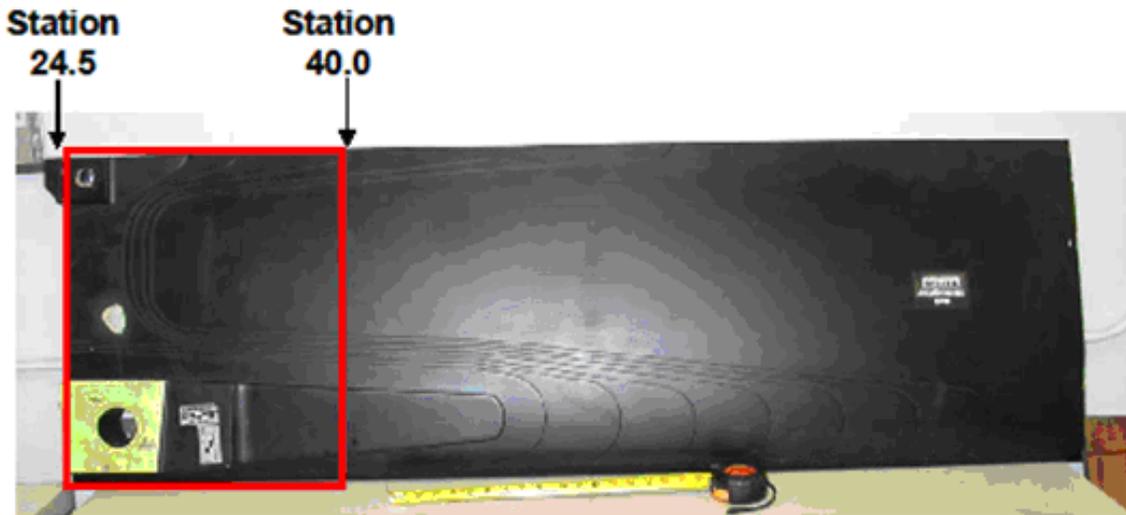
Figure 1 to paragraph (e)(1)(ii)

This AD defines the unsafe condition as an edge void, corrosion, or a crack on an M/R blade. This condition could lead to loss of the M/R blade and subsequent loss of control of the helicopter.

(A) Visually inspect the upper and lower grip plates and doublers of the M/R blade for an edge void, any corrosion, or a crack.

(B) Visually inspect the remaining upper and lower surfaces of the M/R blade for an edge void, any corrosion, or a crack.

(iii) Repair the M/R blade if the edge void is within the maximum repair damage limits or replace the M/R blade with an airworthy M/R blade.

(iv) If there is any corrosion, replace the M/R blade with an airworthy M/R blade or repair the M/R blade if the damage is within the maximum repair damage limits.

(v) If there is a crack in any grip plate or doubler, replace the M/R blade with an airworthy M/R blade.

(vi) If there is a crack in the M/R blade skin, replace the M/R blade with an airworthy M/R blade, or repair the M/R blade if the damage is within the maximum repair damage limits.

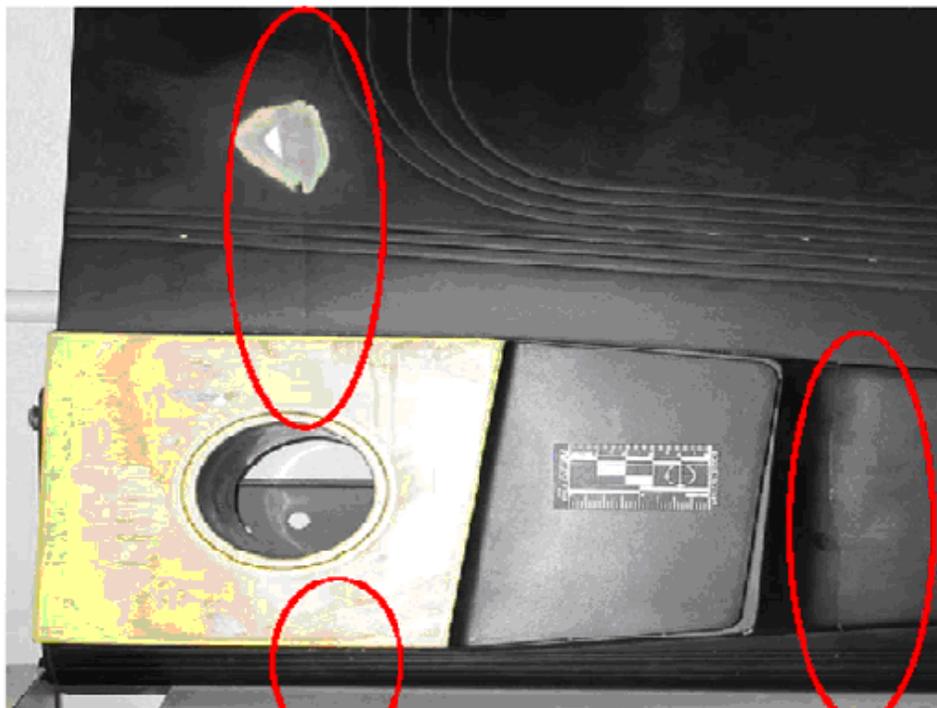
Figure 2 to paragraph (e)(1)(ii)

Note 2 to paragraph (e)(1)(ii): Crack indications on an actual M/R blade are shown in Figure 2 to Paragraph (e) of this AD.
