**FEDERAL AVIATION ADMINISTRATION  
AIRWORTHINESS DIRECTIVES  
SMALL AIRCRAFT, ROTORCRAFT, GLIDERS,  
BALLOONS, & AIRSHIPS**

**BIWEEKLY 2011-18**

**Biweekly 2011-18**

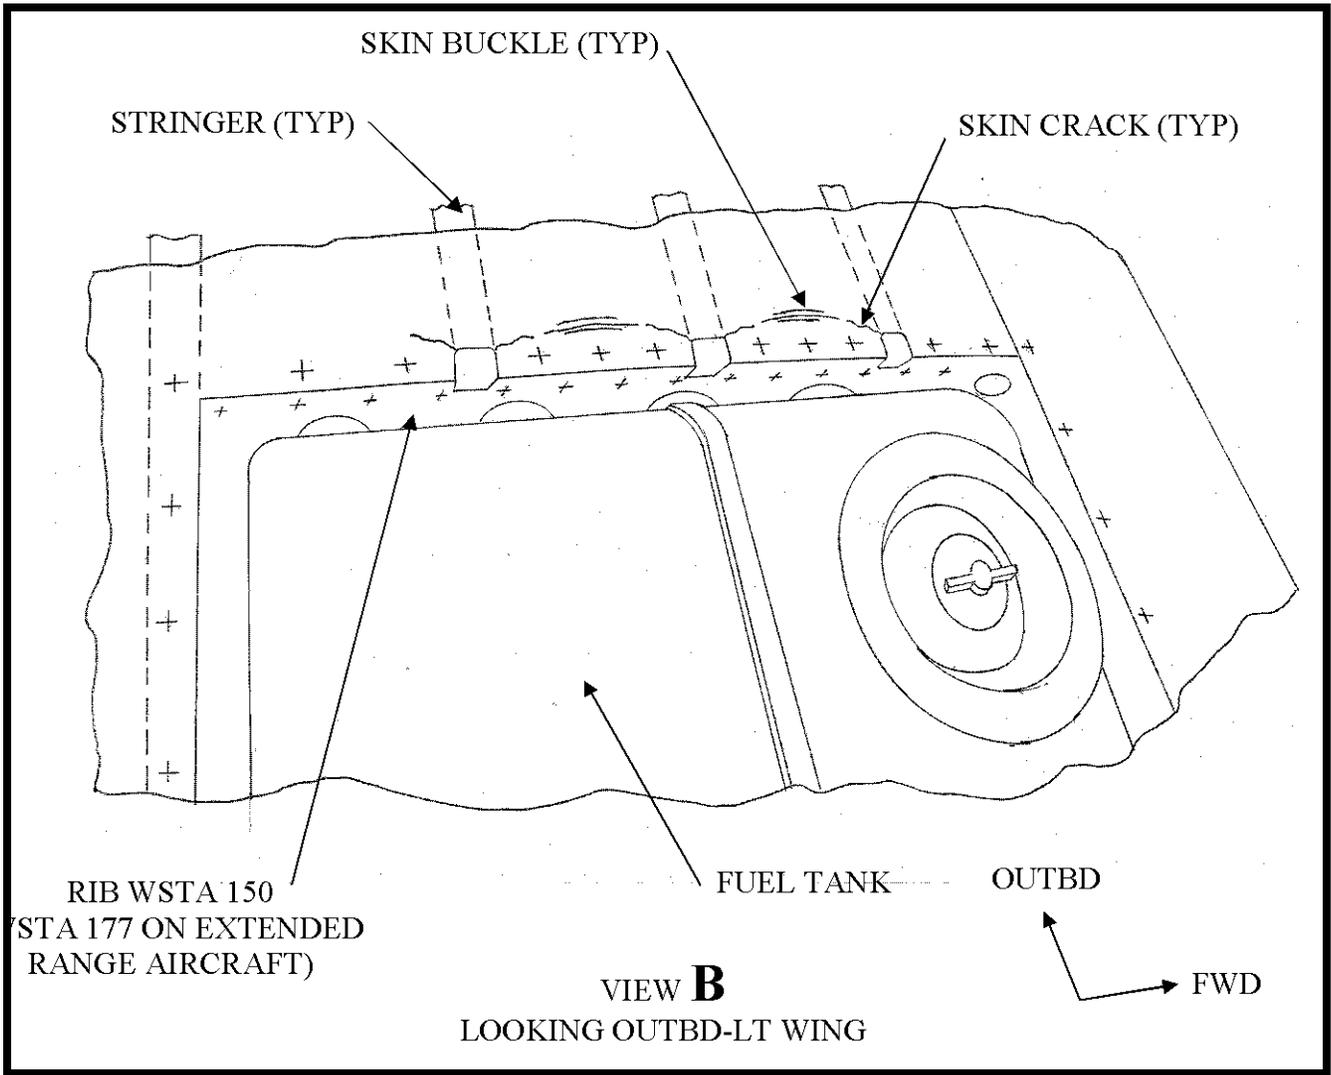
Figure 3

- (3) Cracking of the upper wing skins. Pay particular attention to any wrinkles, the radius between stiffeners at WSTA 150 (under fuel tank covers), and unreinforced access holes (See View B, Figure 3).

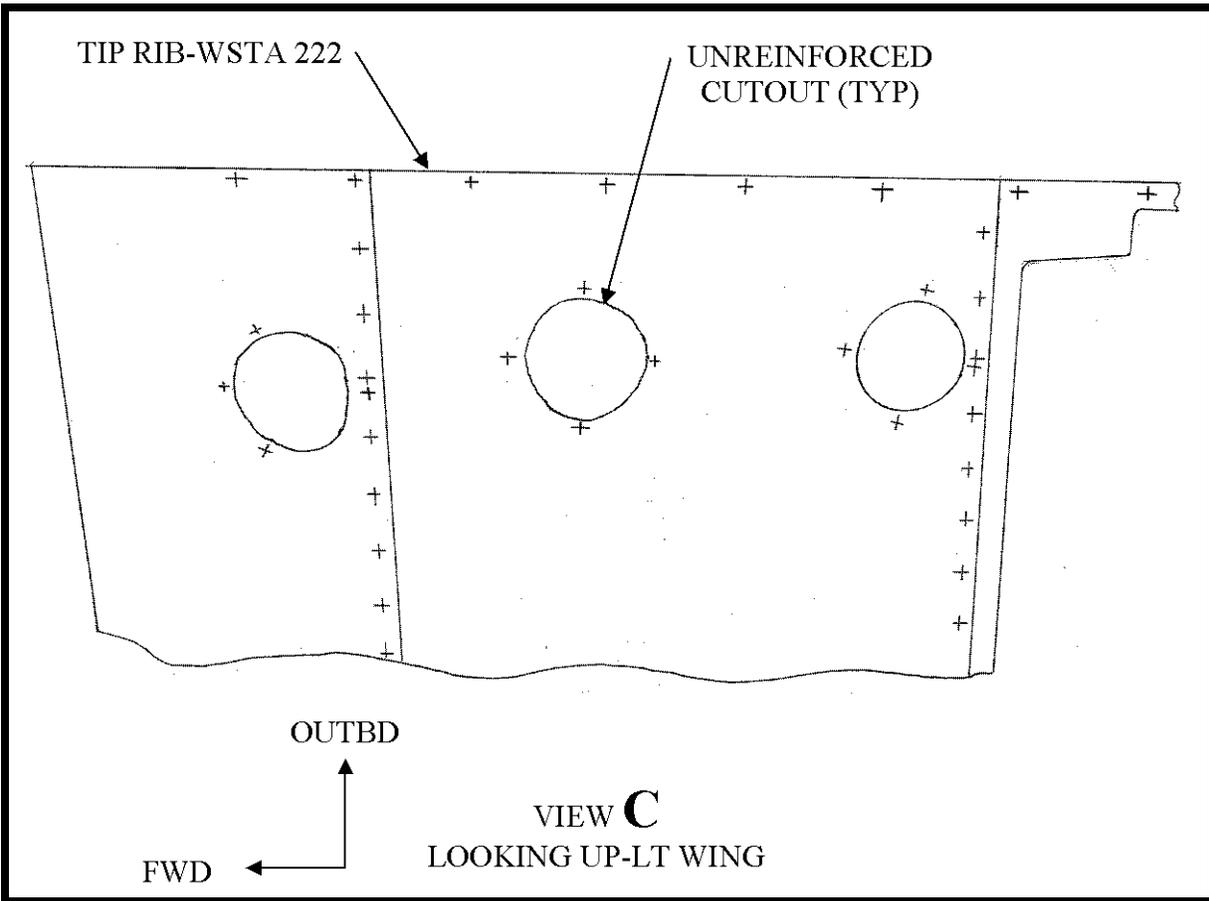
Figure 4

- (13) Inspect wing skins for unreinforced cutouts. (See View C, Figure 4).
- (14) Inspect the upper spar cap horizontal flanges for open holes (See View D, Figure 5).

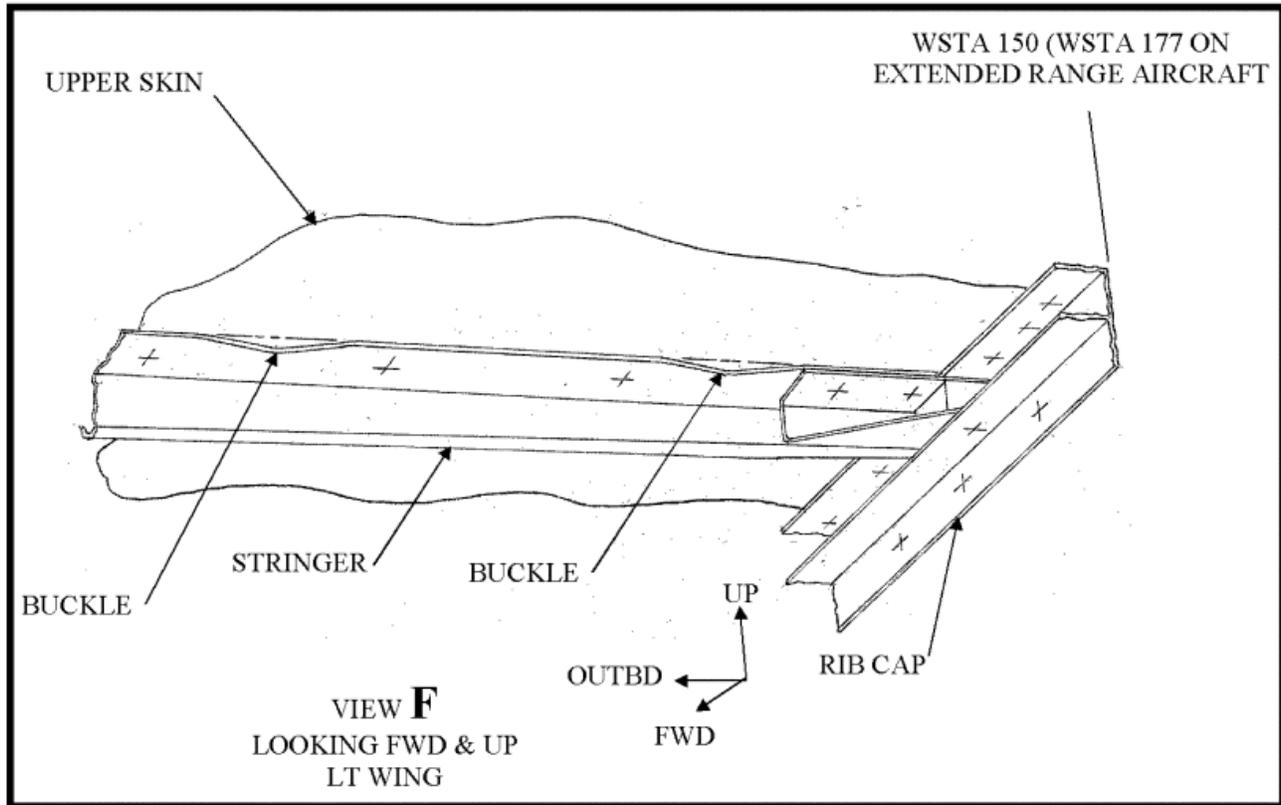
Figure 7

- (10) Inter-rivet buckling of the stringers attached to the upper surface skin, outboard of the fuel tank access covers (See View F, Figure 7).
- (11) Inspect rib at WSTA 222 for damage. Trimming of the rib may have been done to allow installation of fuel lines (See View A, Figure 2). Repair in accordance with AC 43.13-1B, Chapter 4, paragraph 4-58(g) and Figure 4-14, or by using another FAA-approved method that restores equivalent strength of the wing rib.

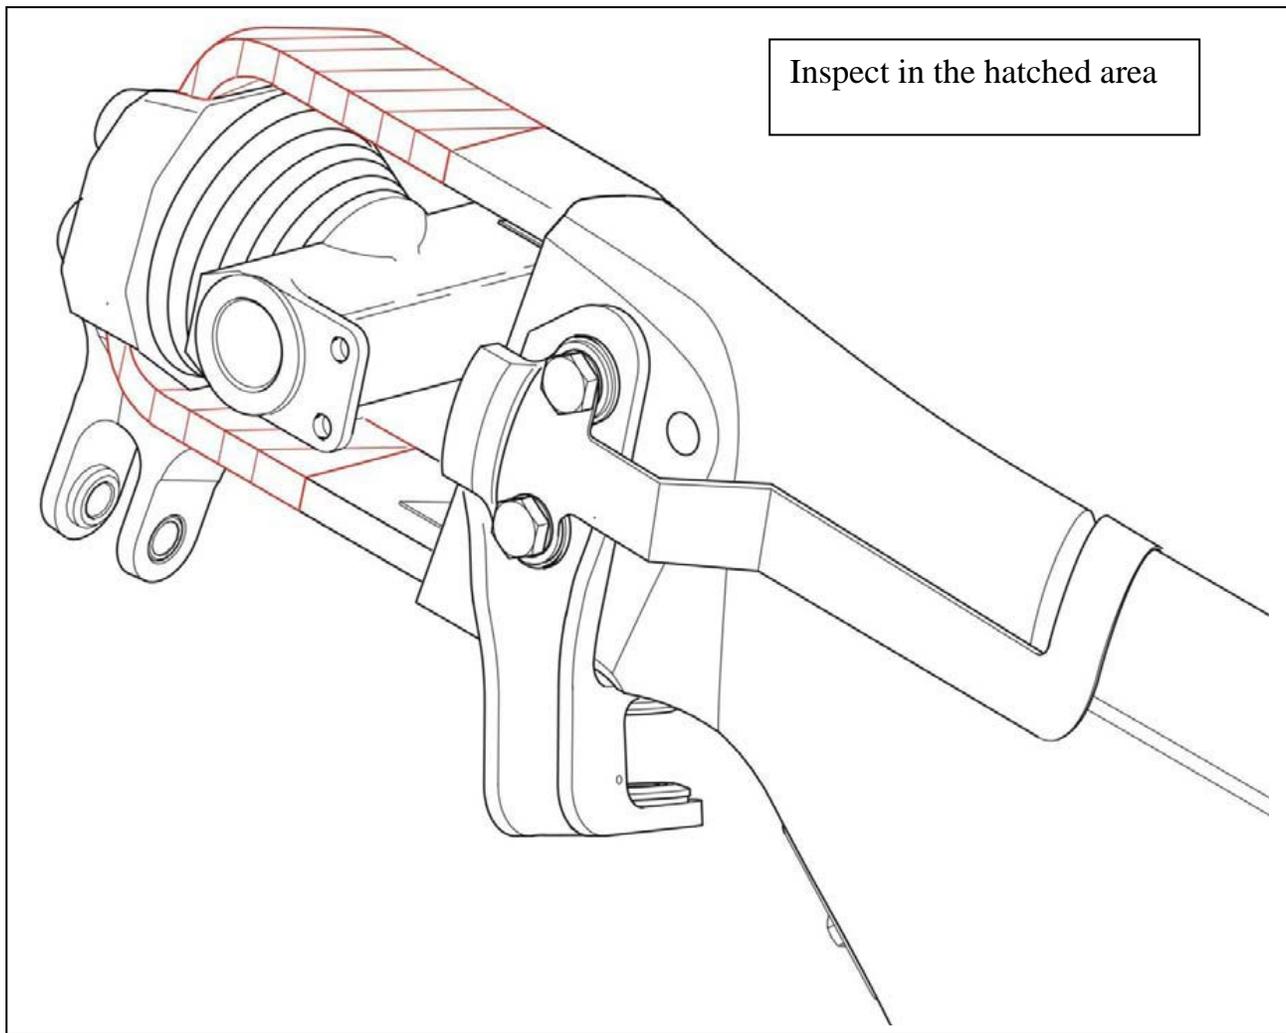
(c) Within 25 hours TIS, and thereafter at intervals not to exceed 25 hours TIS, visually inspect the T/R blade for a crack or damage that exceeds the limits of the applicable maintenance manual. Inspect in the area depicted in the following figure using a mirror, magnifying glass (5X or greater), and light source; or borescope.

- (d) If there is a crack, or if there is damage that exceeds the limits of the applicable maintenance manual, before further flight, replace the T/R blade with an airworthy T/R blade.
