[Docket No. 2002-SW-17-AD; Amendment 39-13330; AD 2003-20-12]

Airworthiness Directives; Eurocopter France Model AS 350B3, SA-365N, N1, AS-365N2, AS 365N3, and EC 155B Helicopters

ACTION: Final rule.

2003-20-12 Eurocopter France: Amendment 39-13330. Docket No. 2002-SW-17-AD.

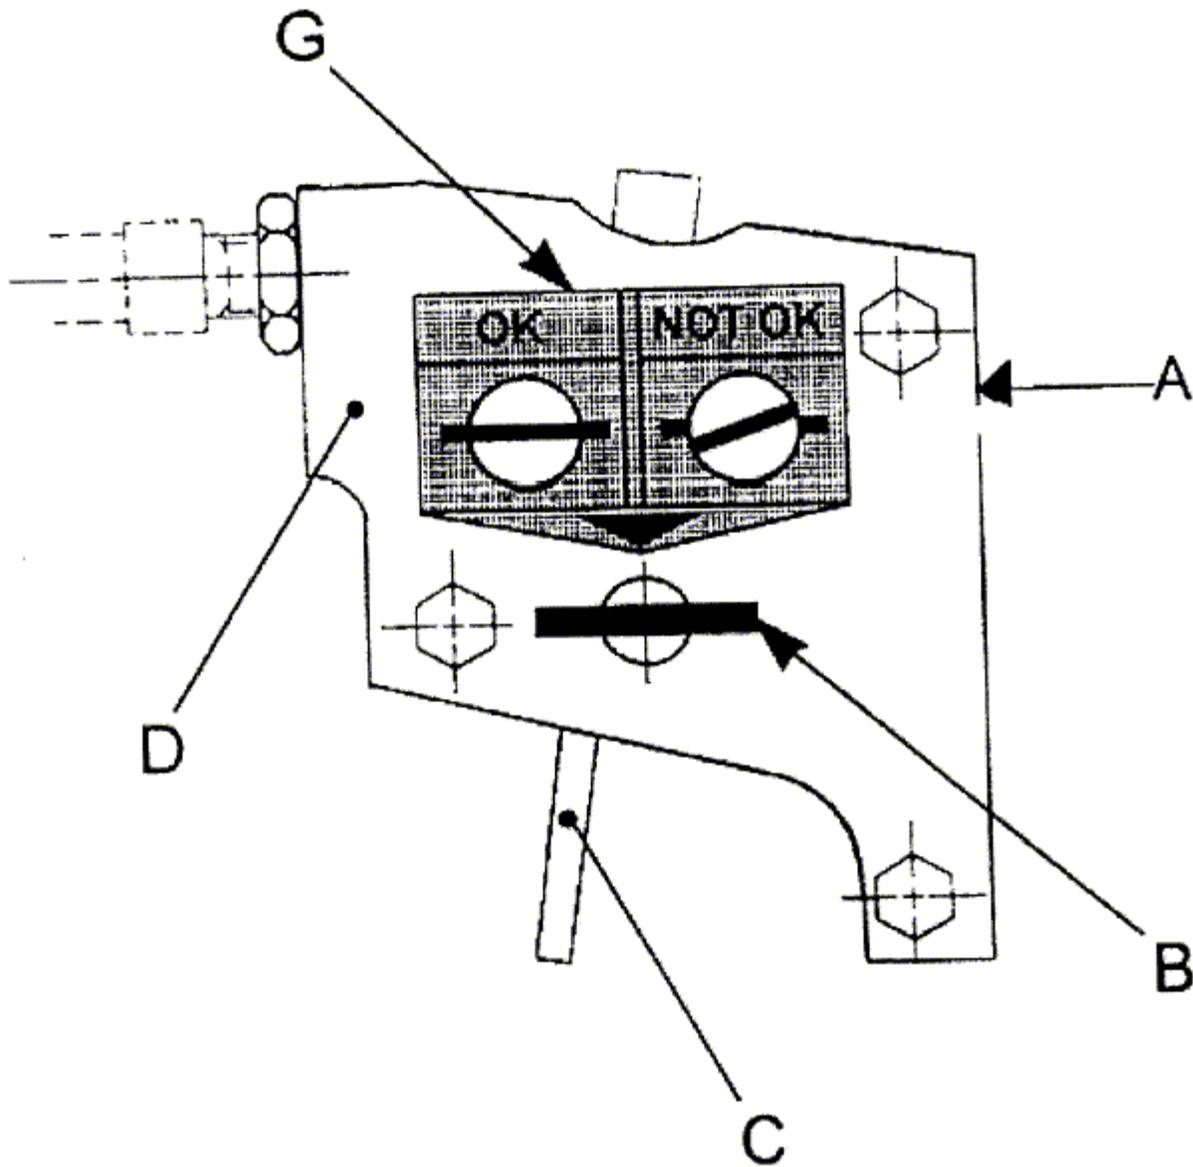
To detect internal corrosion of the Siren cargo hook locking catch (locking catch), which can cause the locking catch to return to an incomplete locking position, undetectable by the operator, and result in an unexpected cargo load release, accomplish the following:

(a) For cargo hook, P/N AS-21-5-7, with Amendment B incorporated, before the first use of the cargo hook on each day that the cargo hook is used, check for corrosion on the locking catch as follows. Amendment B has been incorporated if the letter "B" is marked on the amendment identification plate of the release unit of the cargo hook and placard "G" is installed on the release unit cover plate "D" and reference line "B" is marked over the nut and cover plate as depicted in Figure 1 of this AD. The identification plate "A" is located on cover plate "D", on the opposite side of the electrical connector. See Figure 1:

- (1) With the cargo hook installed, cycle the red manual release control lever several times over its travel range.
 - (2) Return the red manual release control lever to the initial position.
 - (3) Determine whether the section of reference line (B) marked on the bolt (A) and the section of reference line (B) marked on the cover plate (D) form a straight line.
 - (i) If the reference line is straight, the cargo hook is considered airworthy.
 - (ii) If the reference line is not straight, the cargo hook is unairworthy and may not be used.
- (b) The requirements of paragraph (a) may be performed by an owner/operator (pilot) holding at least a private pilot certificate, and must be entered into the aircraft records showing compliance with that paragraph of this AD in accordance with 14 CFR sections 43.11 and 91.417(a)(2)(v).

(c) For cargo hook, P/N AS-21-5-7, without Amendment B, before the next sling load flight, incorporate Amendment B to the cargo hook in accordance with the Accomplishment Instructions, paragraphs 2.A.2.a) and 2.A.2.b), of Eurocopter Alert Telex No. 05.00.39, for Model AS 350B3 helicopters; No. 05.00.41, for Model SA-365N, N1, AS-365N2, and AS 365N3 helicopters; and No. 05A002, for Model EC 155B helicopters; all dated December 20, 2001, as applicable.
