**FEDERAL AVIATION ADMINISTRATION
AIRWORTHINESS DIRECTIVES**

LARGE AIRCRAFT

BIWEEKLY 2016-11

5/16/2016 - 5/29/2016

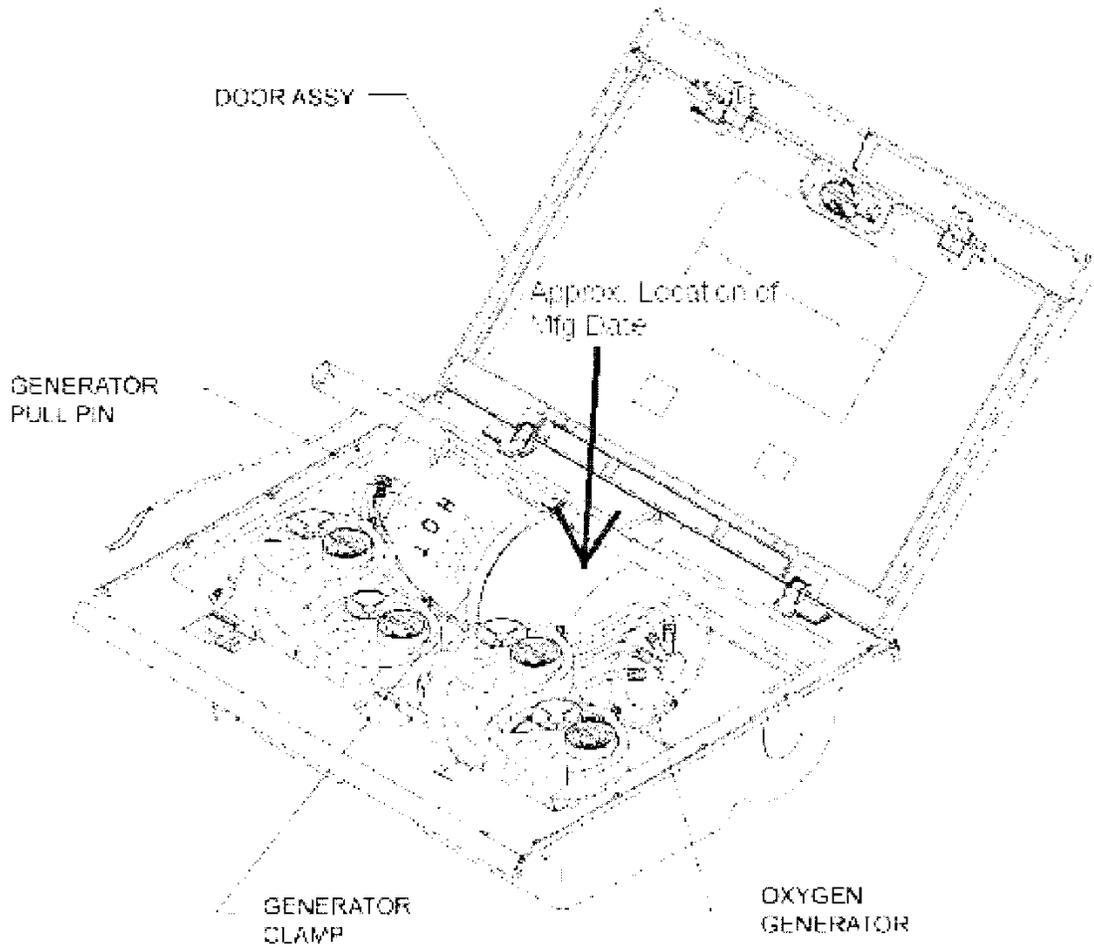
Figure 1 to paragraph (g) of this AD - Location of date (MM-YY)

inspection required by this paragraph, provided the date of manufacture can be conclusively determined by that review.

If, during any inspection required by paragraph (g) of this AD, any passenger chemical oxygen generator having a date of manufacture in 1999, 2000, or 2001 is found: At the applicable time specified in paragraph (h)(1), (h)(2), or (h)(3) of this AD, remove and replace the affected passenger chemical oxygen generator with a serviceable unit, in accordance with the Accomplishment Instructions of B/E Aerospace Service Bulletin 117042-35-001, dated December 10, 2014 (for 15 minute passenger chemical oxygen generators); or Airbus AOT A35W008-14, dated December 18, 2014, including Appendix A, undated (for 22 minute passenger chemical oxygen generators); as applicable.
