**FEDERAL AVIATION ADMINISTRATION
AIRWORTHINESS DIRECTIVES**

**SMALL AIRPLANES, ROTORCRAFT, GLIDERS,
BALLOONS, & AIRSHIPS**

BIWEEKLY 2013-13

6/17/2013 - 6/30/2013

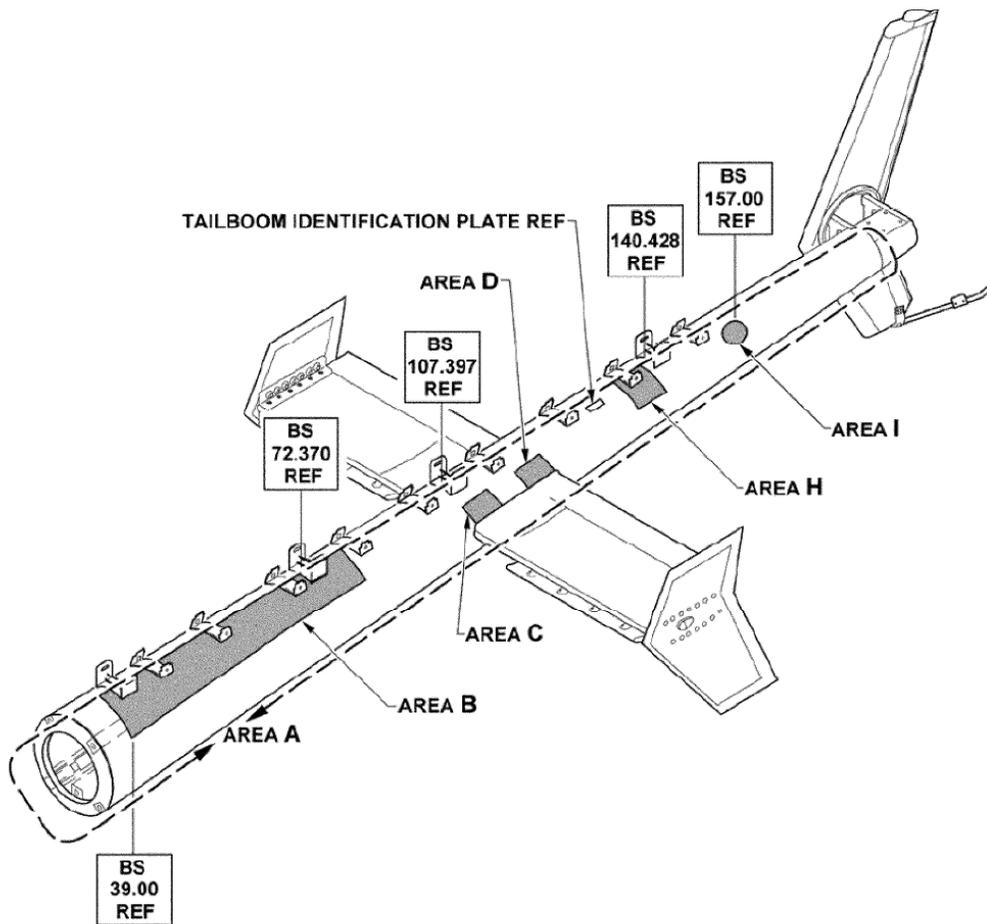
Figure 1 to Paragraph (e)

This AD defines the unsafe condition as high-stress-concentration areas in the tailboom skin that are at risk of cracking. This condition could result in a crack in the tailboom assembly, failure of the tailboom, and subsequent loss of helicopter control.

(A) Before the first flight of each day, visually check for a crack in the "C" and "D" areas depicted in Figures 1 and 2 to Paragraph (e) of this AD. The actions required by this paragraph may be performed by the owner/operator (pilot) holding at least a private pilot certificate, and must be entered into the aircraft records showing compliance with this AD in accordance with 14 CFR 43.9(a)(1)-(4) and 14 CFR § 91.417(a)(2)(v). The record must be maintained as required by 14 CFR 91.417, 121.380, or 135.439; or

(5) If there is a crack in the tailboom assembly, before further flight, replace it with an airworthy tailboom assembly.
